Errata
MSP430G2232 Microcontroller

ABSTRACT

This document describes the known exceptions to the functional specifications (advisories).

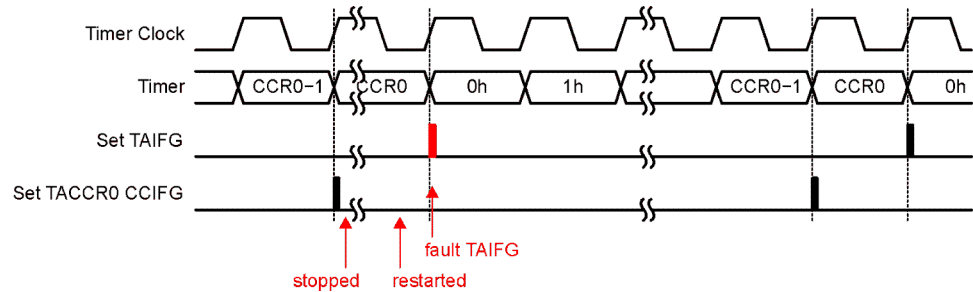
Workaround	Switch capture/compare mode to capture mode before the CCRx register increment. Switch back to compare mode afterwards.
TA16	TA Module
Category	Functional
Function	First increment of TAR erroneous when IDx > 00
Description	The first increment of TAR after any timer clear event (POR/TACLR) happens immediately following the first positive edge of the selected clock source (INCLK, SMCLK, ACLK or TACLK). This is independent of the clock input divider settings (ID0, ID1). All following TAR increments are performed correctly with the selected IDx settings.
Workaround	None
TA21	TA Module
Category	Functional
Function	TAIFG Flag is erroneously set after Timer A restarts in Up Mode
Description	In Up Mode, the TAIFG flag should only be set when the timer counts from TACCR0 to zero. However, if the Timer A is stopped at TAR = TACCR0, then cleared (TAR=0) by setting the TACLR bit, and finally restarted in Up Mode, the next rising edge of the TACLK will erroneously set the TAIFG flag.

Workaround None.
