ABSTRACT

This document describes the known exceptions to the functional specifications (advisories).

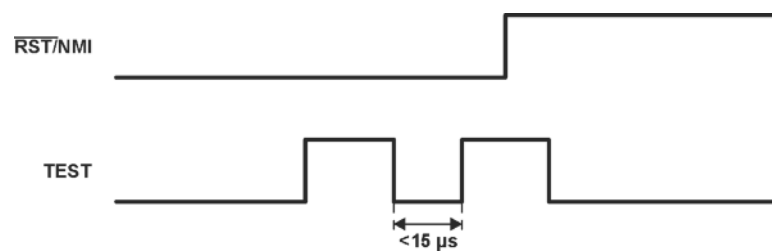
The BSL entry sequence requires that the low phase of the TEST/SBWTCK pin does not exceed 15 μ s. This timing requirement is faster than most PC serial ports can provide, as shown in the following picture. If this requirement is not met, the entry sequence fails and the SYSBSLIND is not set.

Workaround An external hardware solution is recommended to provide the appropriate BSL entry sequence. See [http://processors.wiki.ti.com/index.php/BSL_\(MSP430\)](http://processors.wiki.ti.com/index.php/BSL_(MSP430)) for recommendations on available BSL hardware.
