Errata
MSP430F5525 Microcontroller

This document describes the known exceptions to the functional specifications (advisories).

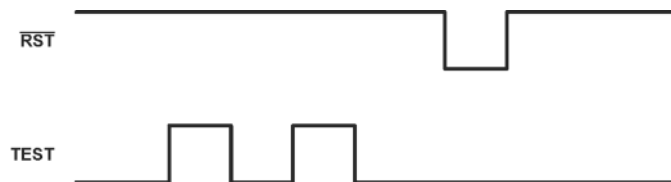
Note: This toggling of TEST pins is not subject to timing constraints. The appropriate level transitions on TEST pin, followed by a RST pulse after 50us, are sufficient to trigger an exit from BSL mode.

- Toggle the TEST pin twice when nRST is high and after 50us pull nRST low.

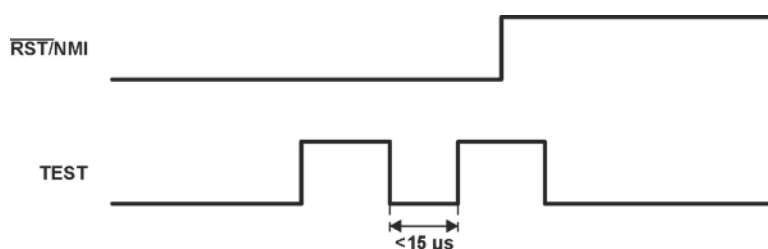
The BSL entry sequence requires that the low phase of the TEST/SBWTCK pin does not exceed 15us. This timing requirement is faster than most PC serial ports can provide, as shown in the following picture. If this requirement is not met, the entry sequence fails and the SYSBSLIND is not set.

Workaround An external hardware solution is recommended to provide the appropriate BSL entry sequence. See [http://processors.wiki.ti.com/index.php/BSL_\(MSP430\)](http://processors.wiki.ti.com/index.php/BSL_(MSP430)) for recommendations on available BSL hardware.
