AM3517, AM3505 Sitara™ Processors Silicon Revisions 1.1, 1.0

Silicon Errata

Literature Number: SPRZ306E
October 2009–Revised September 2016

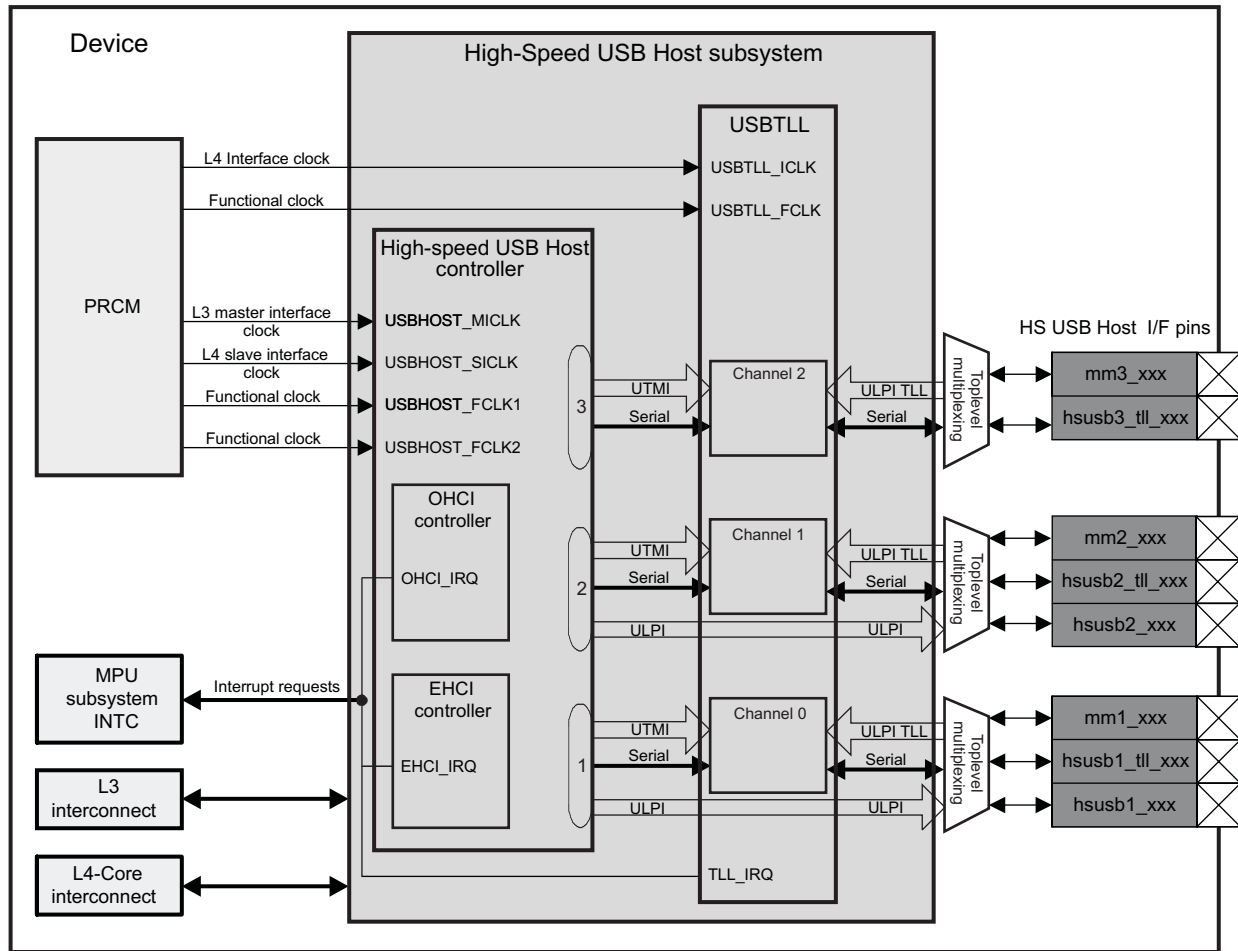
Figure 3. High-Speed USB Host Subsystem Highlight

Please note the following functional limitations when using the high-speed USB host subsystem:

- If one port is configured in the ULPI mode, then all other ports must use the same configuration. Therefore, the ports must be configured high-speed mode or full-speed/low-speed mode. For more information, see [ECHI and OHCI Controllers Cannot Work Concurrently](#).
- USB Port 3 cannot operate in ULPI mode; it can only operate in serial mode.

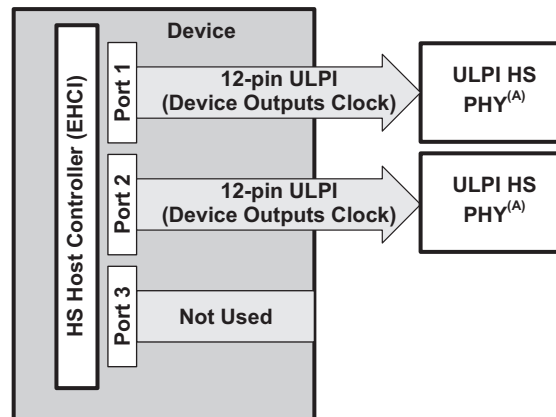
Figure 4. Connecting to High-Speed PHYs Using USB Ports

As shown in Figure 4, USB Port 1 and Port 2 can be used to connect to external high-speed PHYs which include a ULPI port. However, in this case, the external USB PHY must be able to accept a source clock generated by the high-speed USB controller. Also, in this usage model the USB ports cannot support full-speed and low-speed operation. Therefore, using this approach, USB Port 1 and Port 2 cannot provide a fully compliant USB 2.0 Type-A receptacle; a high-speed USB hub would be required in this case; please see Figure 5.

A. USB port 3 does not support ULPI mode.

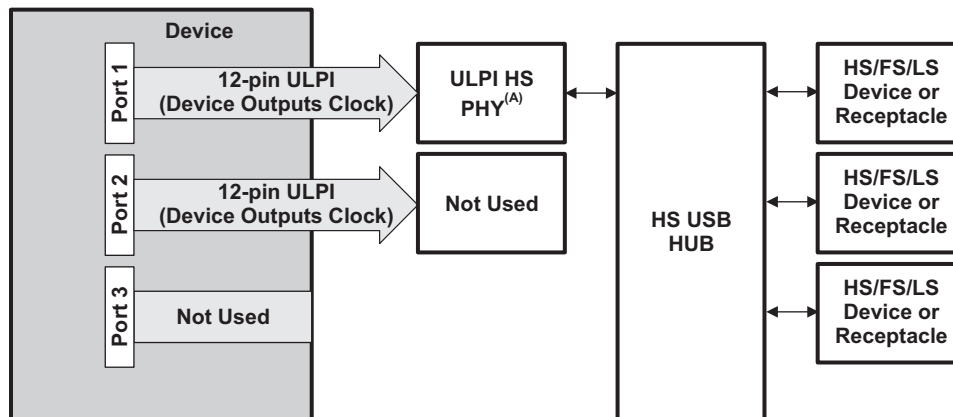
Figure 5. Connecting to a High-Speed USB Hub

A. USB port 3 does not support ULPI mode.

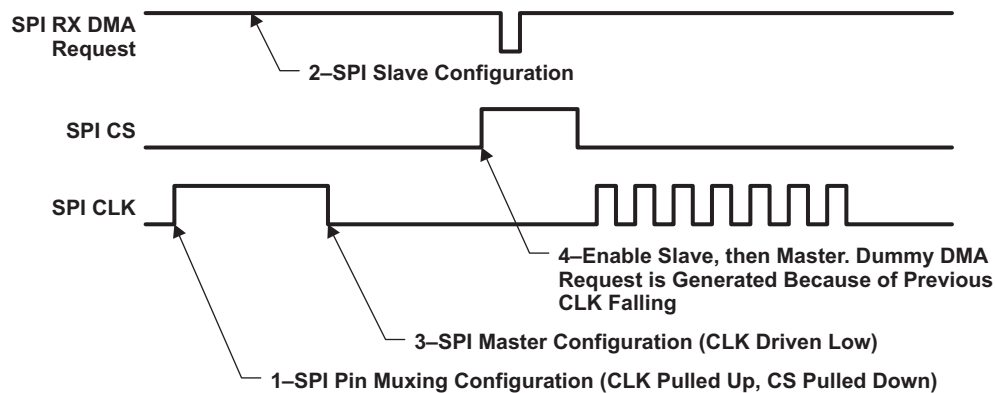
Figure 7. SPI Dummy DMA RX Generation

Details A dummy DMA RX request is generated as soon as the SPI is configured in *slave* mode and a SPI clock edge is detected. The dummy DMA RX request is generated during module configuration, when the module is not performing an SPI transfer. The dummy DMA RX request occurs as soon as the SPI interface signal sensitivity is changed compared to the default value.

The dummy DMA RX request is generated because the mechanism to avoid dummy data capture on a CS glitch is done regardless of channel activation.

Workaround(s) Avoid conditions where the SPI is in *slave* mode and the SPI clock toggles (see examples below).
