DM50x SoC for Radar and Vision Analytics Silicon Revision 2.0

This document describes the known exceptions to the functional specifications for the device.

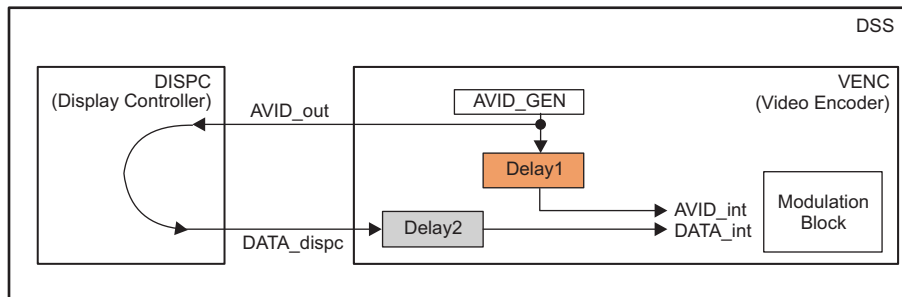
Figure 1. VENC and Display Controller

DESCRIPTION When the DSS is used to display analog video via the VENC interface, the DSS to VENC interface drops 22 pixels of data in the bottom/right corner of the video frame. The expected behavior is for every pixel of the video data to be properly managed from the memory/frame buffer, through the DSS via the VENC, to the cvideo_tvout pin. The DSS to VENC interface ignores/drops 22 pixels worth of data in the bottom line, right most pixels of the video frame. This can result in perceived image, for example a box drawn on the periphery of the display, will have a noticeable missing line at the bottom right hand corner.

The issue is due to a two cycle difference in the expected versus actual delay between the VENC and the Display Controller (DISPC).

For the design to work, Delay1 should be equal to Delay2. In the hardware implementation it is Delay1 = Delay2 +2. This results in the first two pixels of every line being missed.

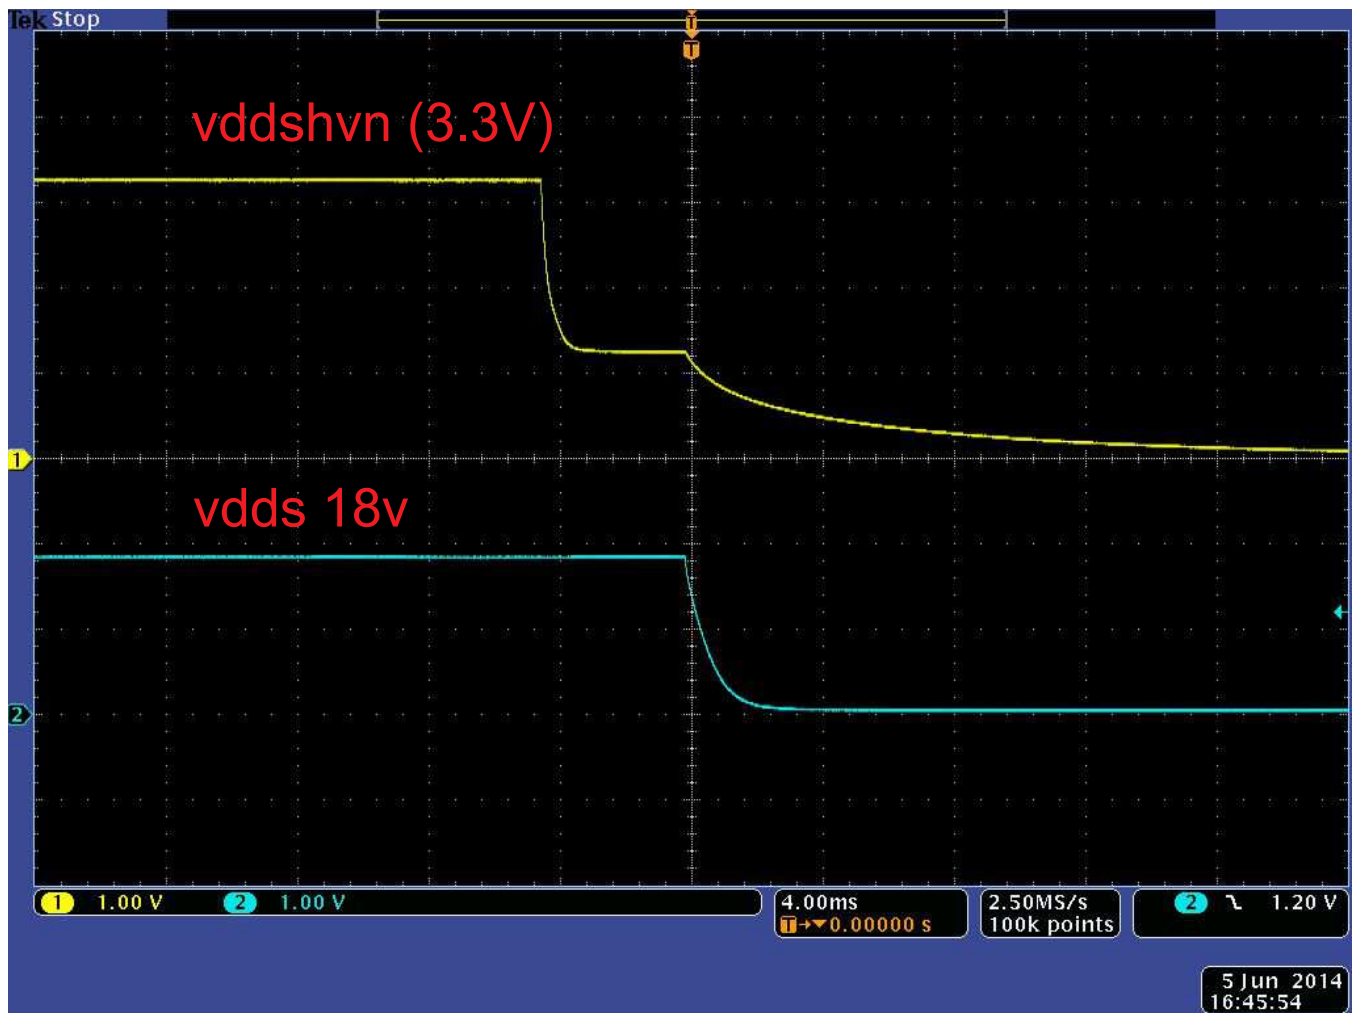
Figure 3. PAB_RevA

A subset of the SOC's LVCMOS IOs (refer to DM for details) have a pull-up resistor that is active by default, including during reset and power-down. The SOC's IOs that have internal or external pull-ups will stay at Plateau Level (<1.5V) during the power-down. If other ICs on the board that are interfaced to the SOC's LVCMOS signals use a separate supply then it's possible that the other IC's signals can be pulled to the Plateau Level while its power supply is off.

The root cause of the plateau is related to the LVCMOS IO buffer Dual Voltage detection circuitry. The LVCMOS Dual Voltage IO includes voltage comparator circuitry to determine if the IO is in 3.3V mode or 1.8V mode. During powerdown of vddshvn domains, a current path in the internal bias transistors results in the vddshvn rail being held to an intermediate voltage level (<1.5 V). This path can consume at most 500 uA per IO - worst case estimate is ~150 mA (based on 280 IOs) from the vdds18v supply

In general, TI recommends using the same supply source for connected components. E.g., a single LDO should drive vddshvn and the related 3.3V external components.
