Flash Read Error and Susceptibility for MSP430F54xxA

This document provides a description of the issue referred to as “Flash Read Error” impacting the current version of the MSP430F54xxA device derivatives. It also provides guidance in assessing whether and the extent to which the issue may affect a given application. Specific actions and customer recommendations are set forth in the **PCN #20100910003A**.

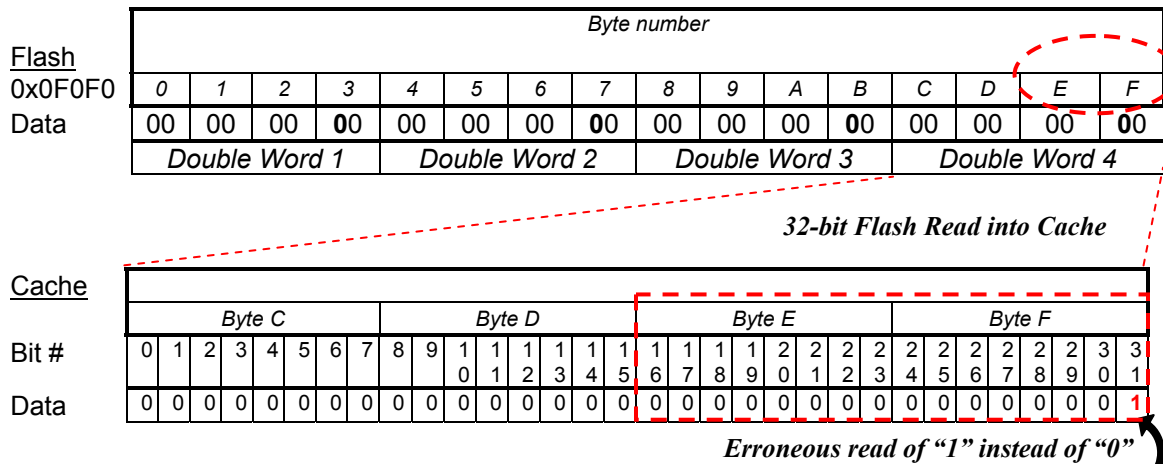
Figure 2. Error illustration for MSB of Double Word #4

Example: This illustration considers 16 bytes of flash data starting at address 0x0F0F0 and all contain the value 0x00. A CPU instruction execution triggers an access of the Flash word (at 0x0F0FE) and saves it to CPU register R5:

Instruction: mov.w &0x0F0FEh, R5

Result: Valid: R5= 0000h
Invalid: R5= 8000h

The read operation by the CPU of address 0x0F0FE will actually trigger the reading of double word #4 from flash (data from 0x0F0FC to 0x0F0FF), which is then stored into the 32-bit cache. The uppermost two bytes (0x0F0FE and 0x0F0FF) make up the 16-bit word located at 0x0F0FE. The result of the read in the case of a flash read error is an invalid readout of the MSB for the given double word access. Instead of the expected logic "0", a logic "1" may be erroneously read out and stored in the cache for CPU computation: 0x8000 is erroneously read out and moved to R5 instead of 0x0000. This potential error applies to the MSB for each double word as indicated by the bold "0"s in Figure 2 at each 4th byte.

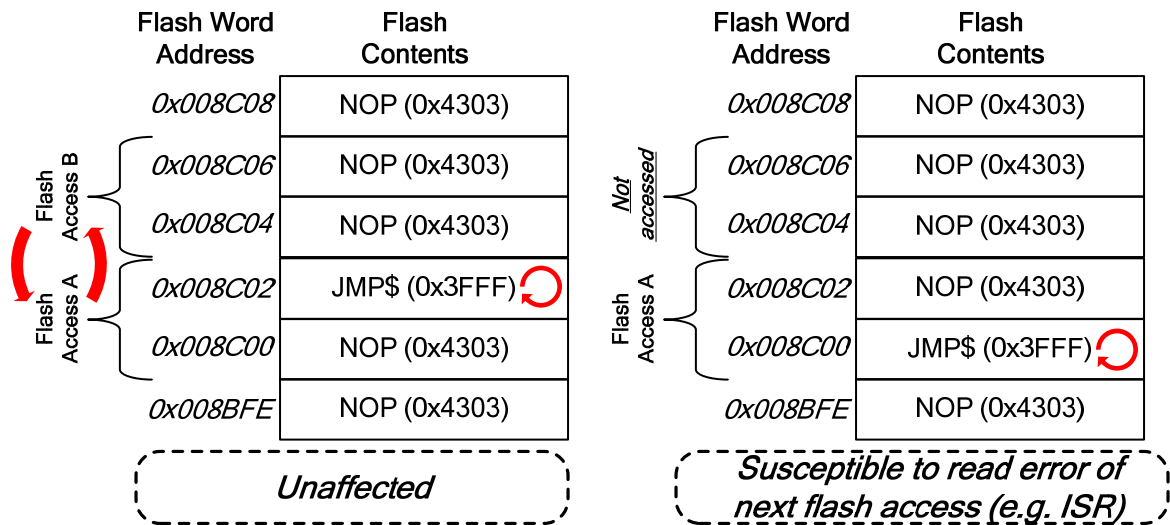
Figure 3. JMP\$ Alignment and Read Error Behavior

Figure 3 shows the relationship of the JMP\$ instruction position in memory and the behavior of the Flash access. On the right, the JMP\$ is at the lower word of the double word fetched from flash. This placement results in the CPU being able to execute entirely from the cached double word containing the JMP\$ instruction which stops flash access activity. Execution of the JMP\$ in such a memory alignment for a time exceeding the idle time discussed in section 3.4 can result in a read error on the next flash access – e.g. servicing an active ISR.

However, when the JMP\$ instruction resides in the upper word of the double word memory fetch, as shown in the left portion of Figure 3, the cache continuously alternates between flash accesses A and B which keeps the flash access constant and unaffected by the read error on a subsequent ISR service fetch.

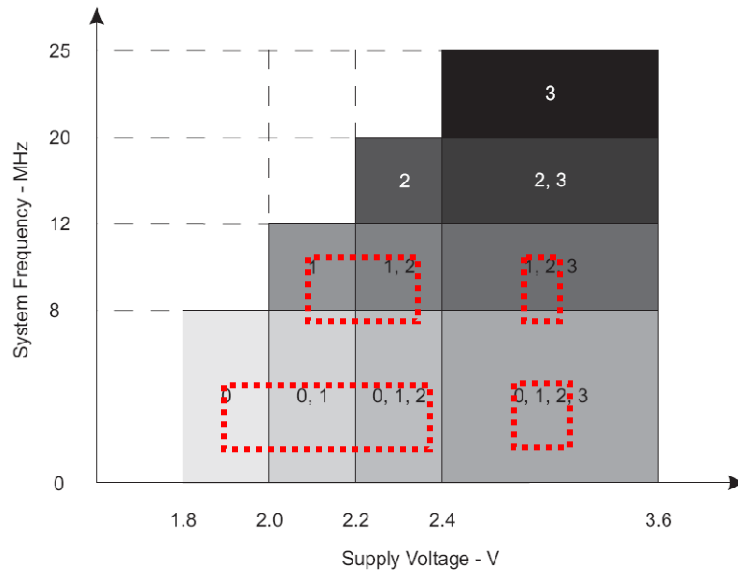
Figure 4. Core Voltage Settings With Reduced Susceptibility

The Vcore settings 0 and 1 and corresponding operating ranges are highlighted. These Vcore level settings result in reduced susceptibility to the flash read issue vs levels 2 and 3.

While all Vcore settings when used under the proper Vcc and clock frequency ranges are valid for device operation, usage of Vcore level 2 and 3 settings are twice as likely to result in flash read errors at susceptible bit locations compared to levels 0 and 1.

Operating the device at an internal core voltage level 0 or 1 can reduce the likelihood of flash read error occurrence by as much as 50% versus operation at level 2 and level 3.

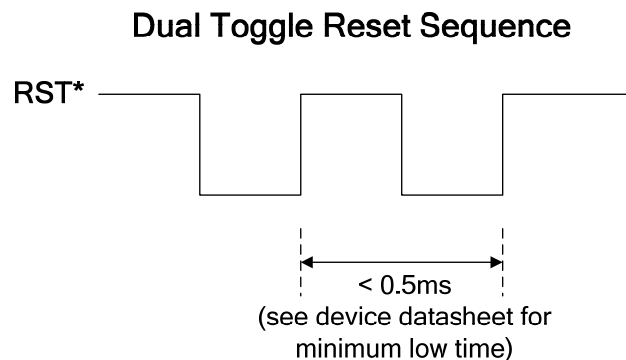
Figure 5. Recommended RST signal

Resetting the device via the RST pin can also be affected by the flash read error. When RST is asserted flash access will stop. When the assertion time of the RST signal is longer than the idle time discussed in section 3.4, the first flash access after RST is released can be affected. Flash will first be accessed by the CPU at the location containing the factory programmed bootcode. The bootcode is always executed after a BOR and loads factory stored calibration values and assesses the BSL configuration. If the flash read error occurs the access to start the bootcode is invalid and the device will enter a LPM4-like state without beginning user code execution, requiring reset or power cycle to restart.

To minimize the potential of encountering the flash read error effects upon reset of the device, issuance of 2 external reset pulses externally to the RST pin where the duration of each low reset pulse and the time between pulses is less than the idle time discussed in section 3.4 is an effective methodology. For worst case, a time of 0.5msec or less as shown in Figure 5 is recommended.
