Stellaris® LM4F232H5QC Rev A1/A3/B0 Errata

Note: The Stellaris LM4F232H5QC microcontroller has been replaced by the identical Tiva™ C Series TM4C123GH6PZ microcontroller.

This document contains known errata at the time of publication for the Stellaris LM4F232H5QC microcontroller, revisions A1, A3, and B0. Additional errata that applies to revisions A1, A3, and B0, as well as revisions following B0 can be found in *Stellaris® LM4F Microcontrollers Silicon Revisions 6 and 7 Errata (SPMZ856)*. Read both documents for a complete list of errata for your device.

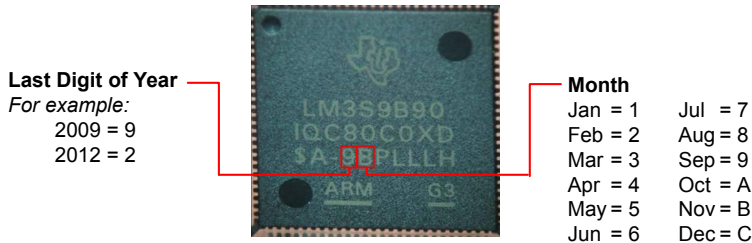
Note: To determine the date code of your part, look at the first two characters following the dash on the third line of the part markings (highlighted in red in the following figure). The first number after the dash indicates the last decimal digit of the year. The second character indicates the month. Therefore, the following example shows a date code of 9B which indicates November 2009.
