TMS320VC5441
Digital Signal Processor
Silicon Errata

SPRZ190C
June 2002 – Revised April 2006

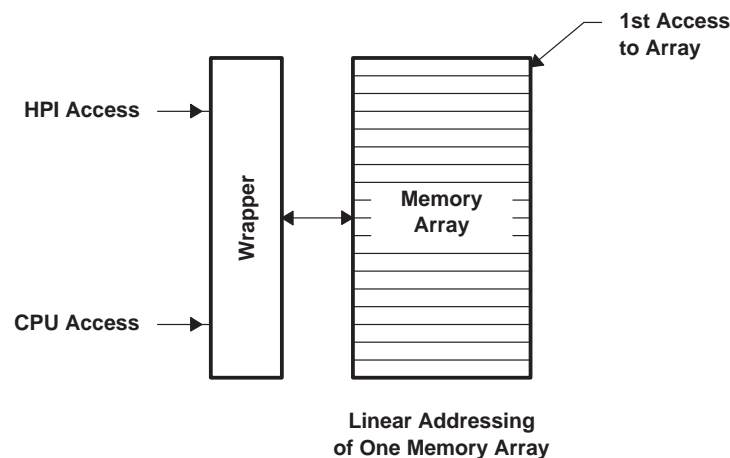
Figure 3. Linear Addressing

Details: During testing of the 5441 devices, an issue was found on the 5441 digital signal processor (DSP) that affected the initial access to memory blocks. This includes accesses performed by the DSP CPU or by a host using the HPI peripheral. The **first** access to any local memory block, regardless of the address within the block, may be erroneous (i.e., erroneous data is either read from or written to only the first address location accessed). Depending on the application, the first memory access could be the first logical address in the memory array, the last, or anywhere in between.

The problem is related to the memory array clock circuitry after a Power-On Reset (POR). Correct operation is to turn on the clock circuitry so that the memory arrays are initialized and then turn off the memory clocks for power savings. However, the clock circuitry does not always initialize fully before the clock output is turned off. As a result, the memory arrays are not initialized after the device is powered. An initial access to the memory array turns on the clock circuitry completely and the invalid memory array state is cleared.

In order to be certain that no failure occur during normal operation, all local memory arrays should be “dummy” accessed at least once after POR. For shared memory, at least two consecutive and contiguous “dummy” accesses must be performed. The memory array block configuration (from an HPI perspective) is shown below:

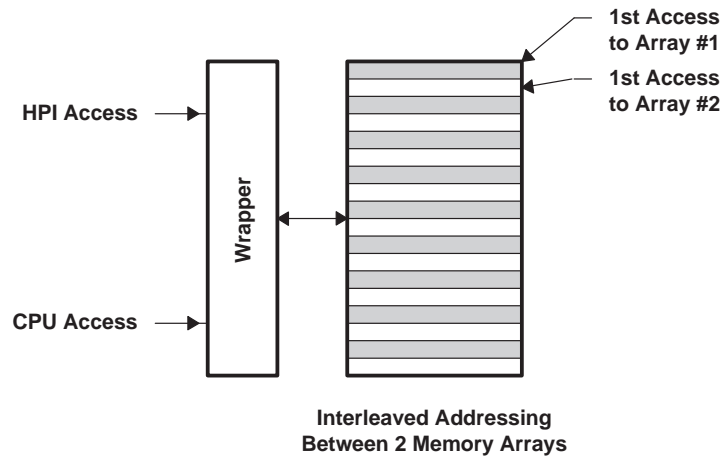
Figure 4. Interleaved Addressing

The memory access failure also exists in shared memory. However, the memory architecture differs slightly for shared memory and may appear to fail in more than one address location. The multiple failures occur because the logical memory blocks consist of two physical memory arrays that are interleaved — even address locations in one array and odd address locations in the second array. In shared memory, the failure may appear to be in either or both the first access to the even address array and the first access to the odd address array.

In either case — local or shared memory — the memory access failure may or may not appear on every memory block. Due to its nature, the failure can be affected by voltage level and temperature. However, if systems are designed within the specified power supply voltage ranges, temperature limits are not exceeded, and the workaround is implemented, then there will not be subsequent failures.
