# **TMS320TCI6486**

## **Digital Signal Processor**

### **Silicon Revisions 2.1, 2.0, 1.2, 1.1, 1.0**

## **Silicon Errata**

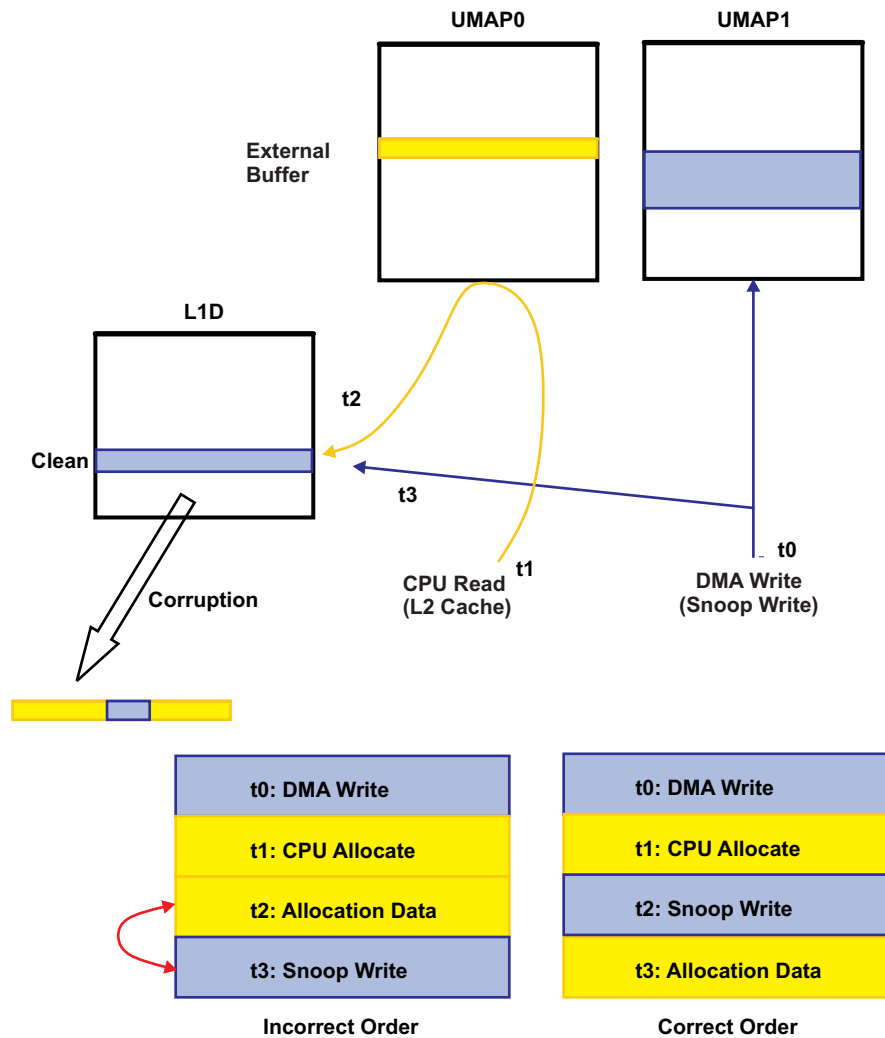
Figure 3. Cache Line Operations Flow

One can identify this issue unambiguously by examining the corrupted memory range in CCStudio using the cache tag viewer. The corrupted data shows up in the include L1D view in a memory window, but not in the exclude L1D view. The cache tag viewer should indicate that the line is also "clean" and the corrupt data should also be visible in its intended destination, which must be in UMAP1 and map to the same L1D set as the corrupted line.

Figure 3 shows the flow of these operations, the incorrect order that causes the issue, and the correct order. The blue line is Cache Line A and the yellow line is Cache line B.

In the description above, all of the conditions must be true for the issue to occur. Our workarounds essentially focus on picking one of the conditions and removing it so that you do not need to worry about the other conditions.

To prevent this sort of race condition, programs should discard inbound DMA buffers in UMAP1 immediately after use and keep a strict policy of "buffer ownership" such that a given buffer is owned only by the CPU or the DMA at any given time.

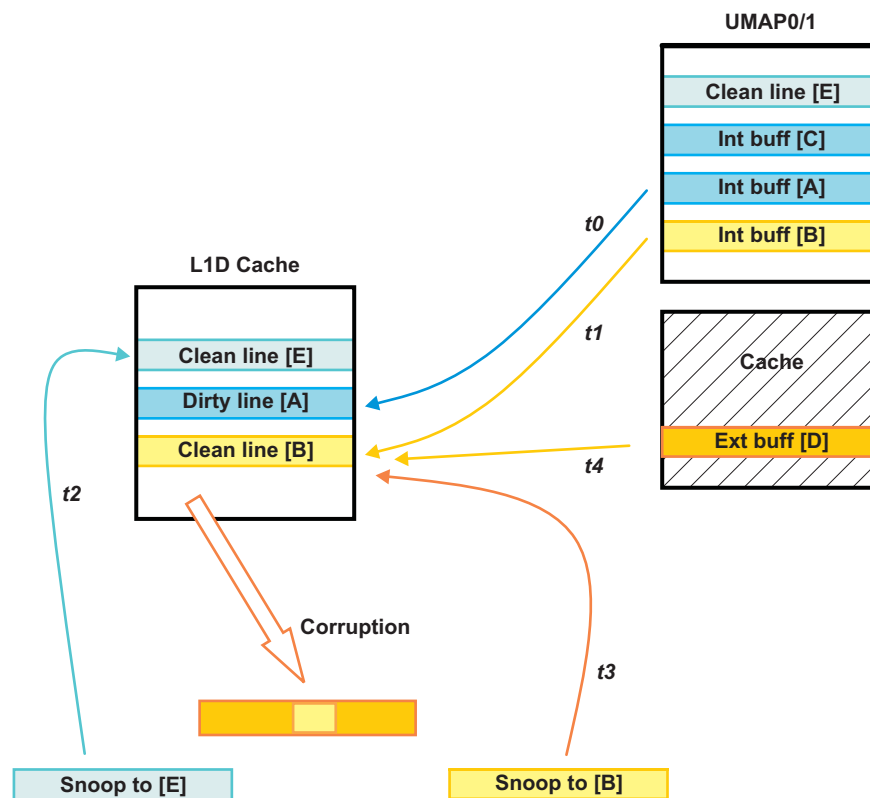
**Figure 5. Sequence of Events**

- (A) The snoop-write to Cache Line E, from Step 1 above, is now in process and blocking the snoop-write to Cache Line B from Step 2.
- (B) While Step A is going on, Cache Line A has either now been evicted and/or replaced by Cache Line C from Step 4 above and Cache Line B (the intended target of the delayed snoop-write) is now replaced with Cache Line D from Step 3 above.
- (C) Once the first snoop-write from operation C1 completes, the second (delayed) snoop-write mentioned in Step A to Cache Line B should be killed since Cache Line B was replaced in the operation in Step B. Instead, it is not killed and the line cached (which is now actually Cache Line D) is now updated incorrectly.

1. Cache Line D now holds data that was corrupted by the operation in Step C above (as a result of Step 2 above).
  - A subsequent read of this data returns a corrupted value.
  - Subsequent writes to this cache line also cause the corrupted values to be committed to lower levels of memory.

Figure 5 shows the sequence of events.

A compiler flag (`--c64p_dma_l1d_workaround`) has been added to the latest Code Generation Tools to resolve this potential issue. This flag can be utilized for all code in the system or used on particular files/functions that may be susceptible to the conditions listed in this advisory.

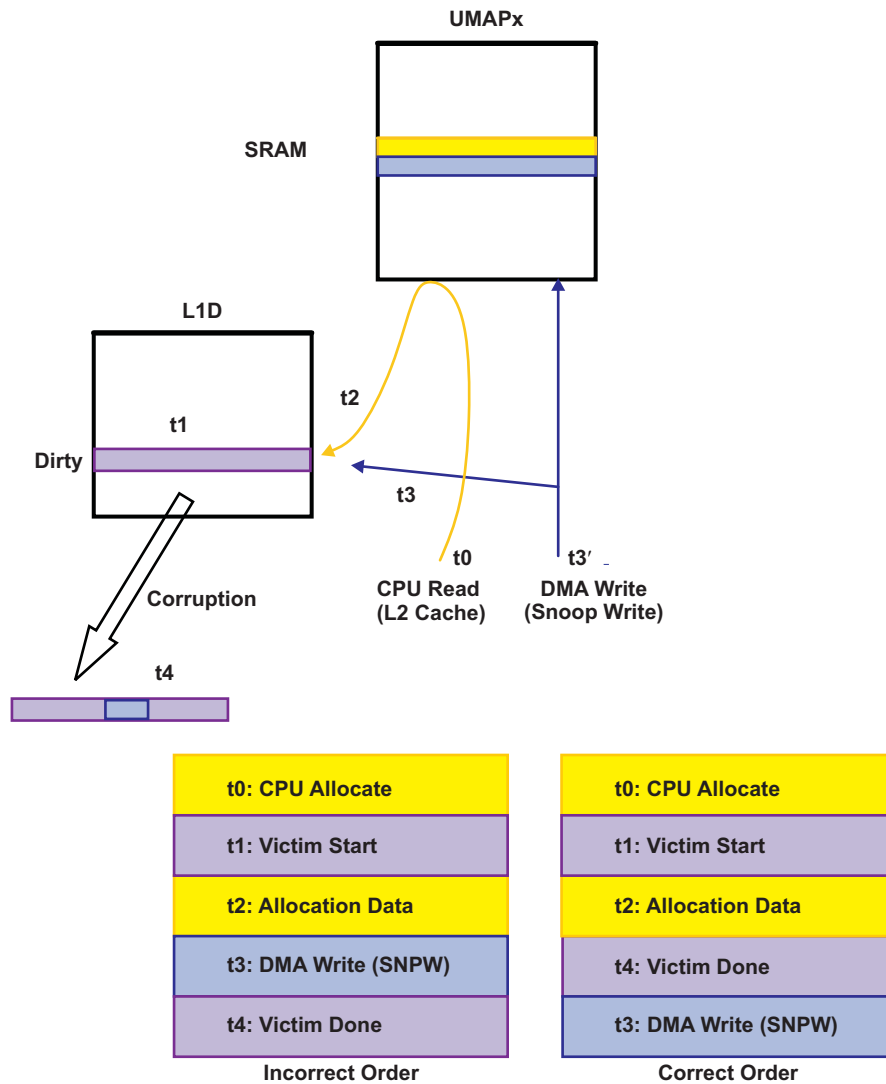
Figure 8. Sequence of Events

Corruption only happens when the DMA accesses an L1D cache line that the CPU also writes to. This results in DMAs that may match victim lines leaving L1D. Thus, it can affect buffers that the CPU fills with writes and the DMA reads, as well as buffers where both the DMA and CPU write. It does not affect DMA buffers that the CPU only reads.

[Figure 8](#) shows the sequence of events.

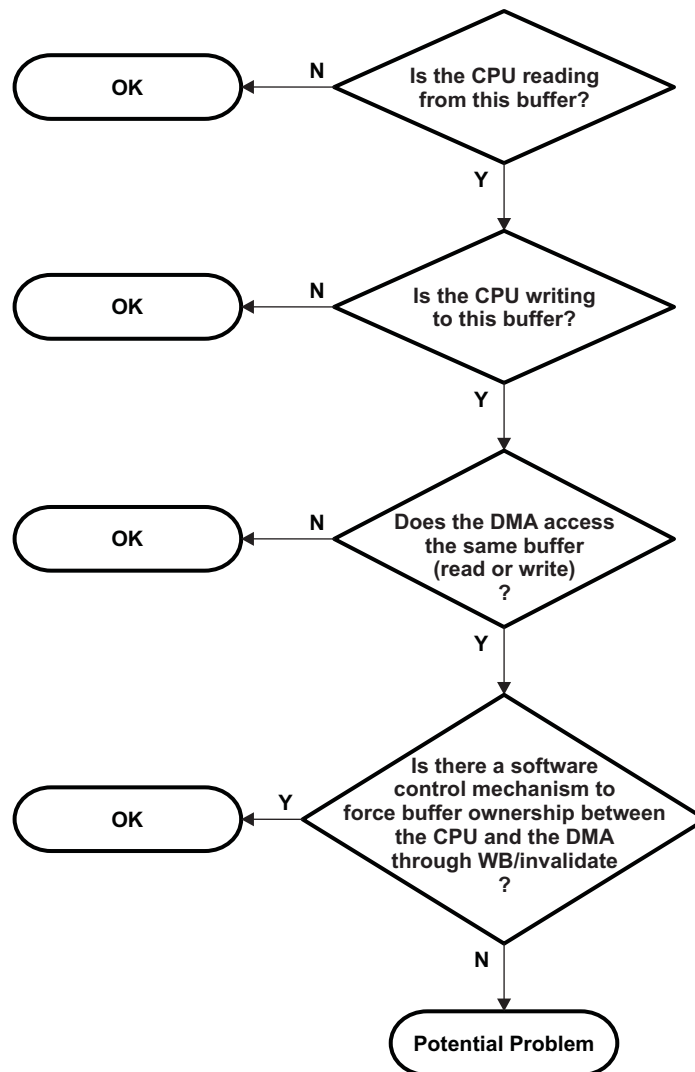
**Figure 9. Decision Tree**

With all the steps above, it is fairly painful to determine if a particular buffer has the potential to see this issue. Figure 9 is a simple decision tree to help make a determination for a particular buffer.

If you approach one of the "OK" fields, then the buffer should not have a potential of being affected. If you arrive at "Potential Problem," see the workarounds below.

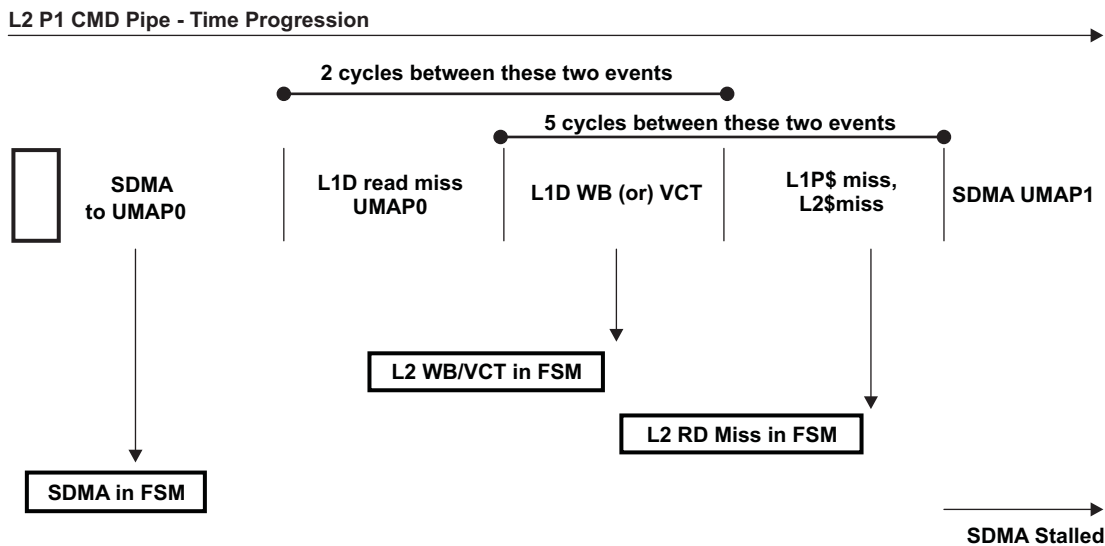
Figure 10. Timing Between Transactions

The SDMA in item 1 sets up a bank conflict for the L1D\$ read in item 2. The L1D\$ allocate in item 2 prevents the L1D\$ write/victim (item 3) from advancing, so it is stuck in the pipeline. This occurs at the same time as an L1P\$ allocate that also results in an L2 access to external memory (item 4), which is also in the same pipeline stage as the L1D\$ write/victim (item 3). At this point, the L1P\$ allocate (item 4) advances to the next pipeline stage but the L1D\$ write/victim (item 3) is still stuck waiting on the L1D\$ allocate (item 2). This now sets up the pipeline for the stall condition, which is actually triggered by an SDMA to UMAP1 (item 5). This is what causes further SDMAs to stall. After the L1P\$ allocate (item 4) is complete, item 2 resolves, allowing item 3 to resolve, thus, freeing the SDMA pipeline again. Therefore, the stall is effectively for the length of the L1P\$ allocate in item 4.

Note that the above four conditions do not guarantee that you will see a stall; it may stall depending on the timing between the transactions. Items 2 and 3 must occur within two CPU cycles of each other and items 3 and 4 must occur within five CPU cycles of each other. [Figure 10](#) shows the timing relationship.

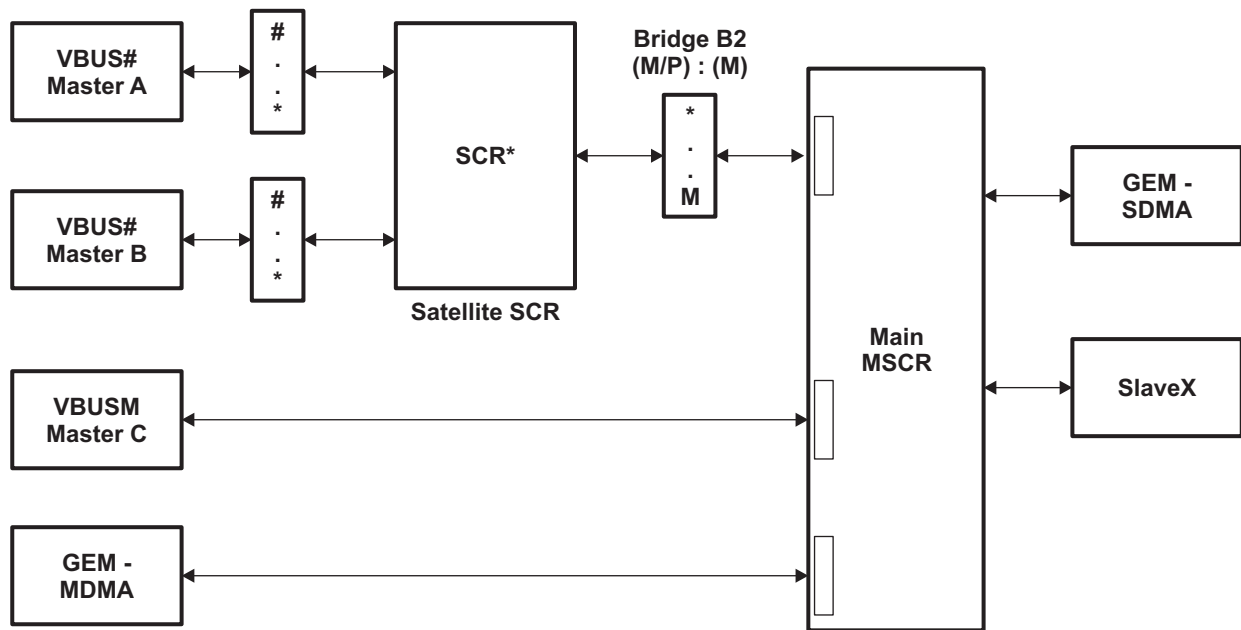
Figure 12. Data Pipelined SCR

A load (either cacheable or non-cacheable) from another core's L1D or L2 memory can additionally create a deadlock condition. When the load is issued, the read command is propagated to the SDMA port of the other core through a shared cross-connect bridge that is shared with either TC0 or TC1 and GEM MDMA traffic from two other GEMs. When the load is issued, if a victim is generated in L1D cache, then the SDMA may stall until the load completes. If other masters are issuing commands through the shared cross-connect bridge, then the bridge may fill due to the stalled SDMA before the read command can propagate through the bridge and complete. The TC16486 device has two cross-connect bridges (Xconn1 and Xconn2). GEMs 0, 1, 2, and TC0 use cross-connect bridge 1. GEMs 3, 4, 5, and TC1 use cross-connect bridge 2. In summary, a deadlock can occur if the following is true:

- GEMx issues a read to any of other GEM's L1D or L2 SRAM through cross-connect bridge 1 or 2.
- Any of the other GEMs or TCx on the same cross-connect bridge issue commands to GEMx L2.

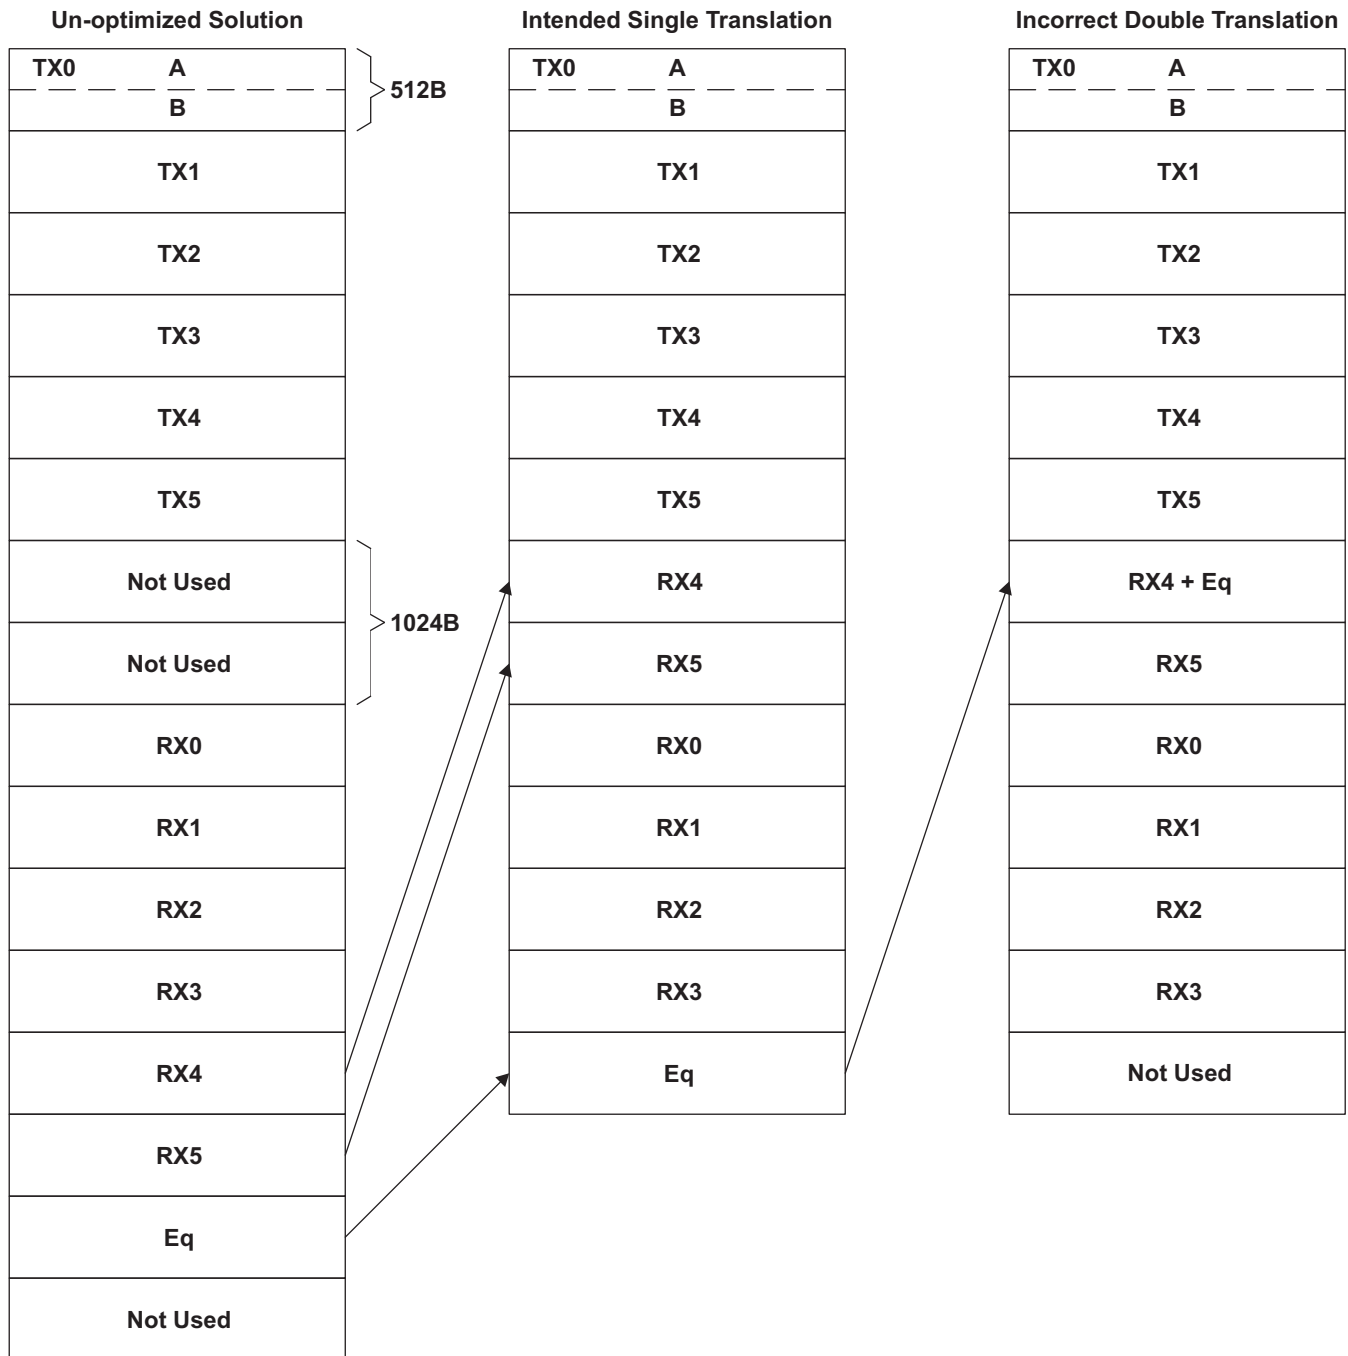
**Figure 17. Bitmap Memory Address Translation**

**Details:** The bitmap memory for receive channel 4 will be corrupted if an error occurs on any TSIP channel. This results in the receive data for channel 4 (associated with GEM4) being lost for frame intervals beginning with the first error until the issue is addressed and the receive channel 4 bitmap has been reinitialized and activated. Corruption is due to a double translation of the address going to the memory used for bitmaps and error queues (see [Figure 17](#)). [Figure 18](#) shows a bitmap memory snapshot where the TSIP receive channel 4 bitmap has been corrupted.

If an error occurs during execution of the normal application, then a TSIP error interrupt is asserted for every channel that experiences an error. This error interrupt is asserted to the corresponding DSP subsystem. The DSP subsystem that receives the error interrupt must correct the error condition to avoid prolonged loss of data on its own channel as well as on channel 4. When DSP subsystem 4 receives an error it must determine whether the error is due to its own failure and, if it is, that error must be corrected first.
