TMS320DM6446

Digital Media System-on-Chip

Silicon Revisions 2.3, 2.1, 1.3, 1.2, and 1.1

Silicon Errata

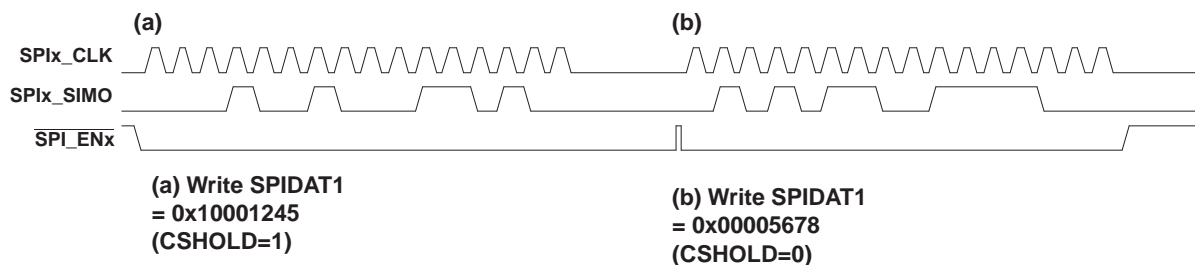
Figure 3. Actual CSHOLD Behavior–32-Bit Writes to SPIDAT1

Instead, what actually occurs is that SPI_ENx is momentarily de-asserted at the beginning of the second write, as illustrated in Figure 3.

Workaround(s): For each word in the sequence of words during which $\overline{\text{SPI_ENx}}$ should be held low, write to the SPIDAT1 register with the CSHOLD bit set to '1'. Follow this by a write to only the CSHOLD field of SPIDAT1, setting CSHOLD = 0 to de-assert $\overline{\text{SPI_ENx}}$. See Figure 5 for an illustration.

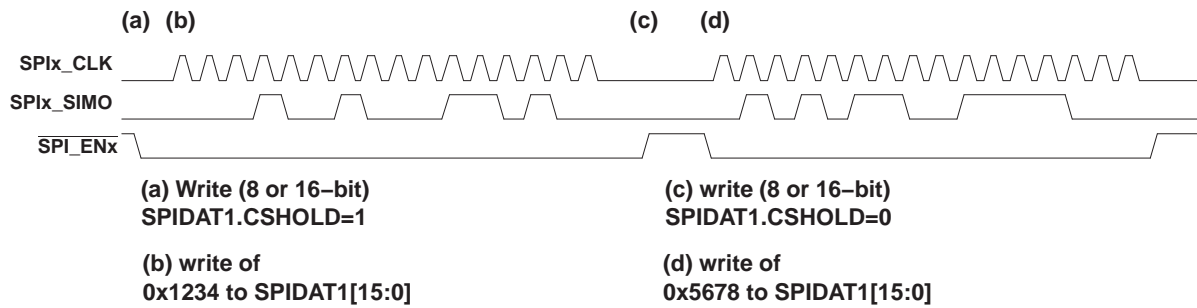
Figure 4. Actual CSHOLD Behavior—Halfword Writes to SPIDAT1

Both Figure 2 and Figure 3 assume that SPIDAT1 is written using a single 32-bit write instruction. If SPIDAT1 is instead written using an 8-bit or 16-bit instruction to write to the CSHOLD field, followed by a 16-bit write to the transmit shift register field of SPIDAT1, then what actually occurs is illustrated in Figure 4. This is the same case illustrated in Figure 3 except that the de-assertion of SPI_ENx lasts for the duration between writing a '0' to the CSHOLD field and writing new data to the transmit shift register.

Alternatively, only write to the SPIDAT1 CSHOLD field before and after the transfer to toggle the $\overline{\text{SPI_ENx}}$ pin. During the transfer, write only to the data field of SPIDAT1[15:0] using 16-bit (halfword) write commands. For an illustration, see Figure 6.

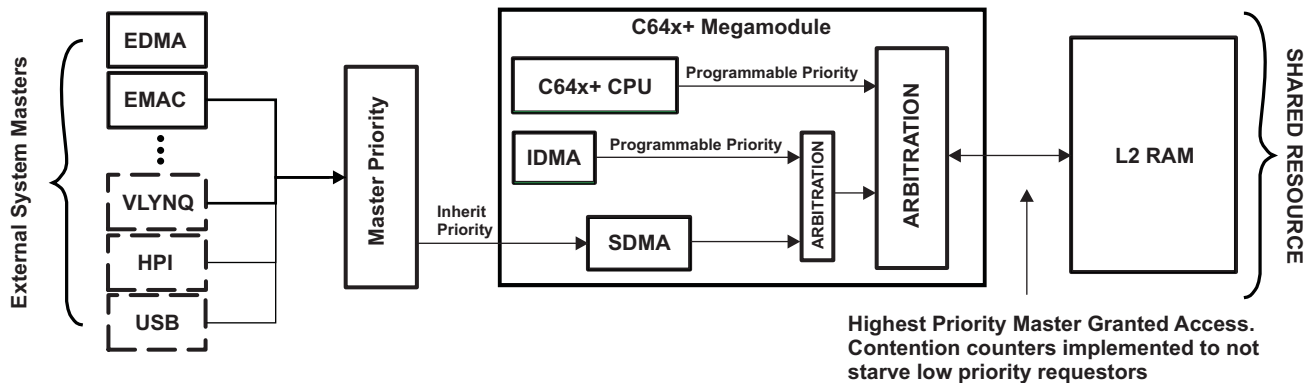
Figure 8. Priority Arbitration Scheme for L2 RAM

Ideally, the BWM arbitration will grant equal L2 bandwidth between equal priority DMA and CPU requests. Instead, when requests arrive at the BWM such that the CPU priority is *lower than or equal to* the DMA priority, the bandwidth is always granted in favor of the CPU over the DMA. In the case of successive CPU requests, it is possible for the CPU to block all DMA requests until the CPU traffic subsides. [Figure 8](#) shows a high-level diagram of the arbitration scheme used for L2 RAM requests.

When the SDMA has finished sending all of its commands to the L2 controller, the C64x+ Megamodule drops the effective transfer priority to seven. The L2 Controller uses this effective priority to arbitrate the SDMA command with the CPU.

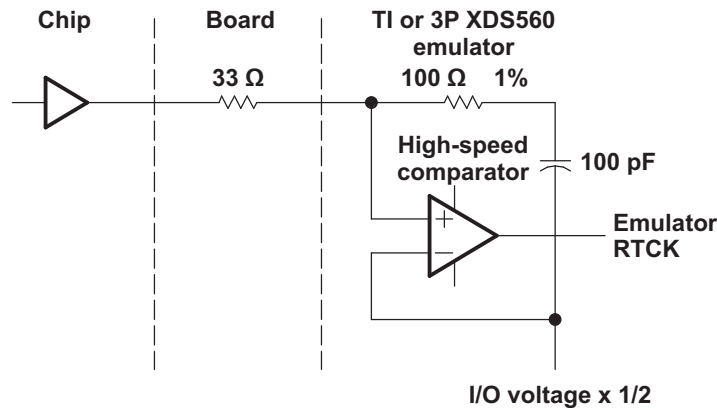
Figure 10. Typical Emulation Interface Circuit

Figure 10 illustrates the typical hardware interface between the TMS320DM644x DSP and the current TI or third-party debug controller pod. This combination of debug controller pod and DSP may not work reliably for two reasons:

- The RTCK and TDO buffers have approximately 100 Ω output impedance and rise and fall time of 5 ns and 4 ns respectively to minimize EMI and switching noise.
- The emulation pod is designed for a low impedance high drive output buffer with less than 3-ns rise/fall time. The debug controller pod expects the chip to drive the AC termination inside the emulation pod shown in Figure 10.

The 100 Ω chip buffer impedance, combined with 33 Ω series termination on the target board creates a voltage divider at the debug controller pod terminal with a RC time constant on the order of 10 ns. The slow 10 ns rise time causes the debug controller pod input to oscillate as the signal passes through the switching threshold. In addition, at faster debug controller pod operating frequencies (max TCK = 34 MHz), the RTCK and TDO signals are not able to swing to the full range (0 V - 1.8 V), instead these signals swing between 0.4 V and 1.45 V.

Workaround: Four solutions are recommended, based on the selected debug controller pod and DSP target combination.

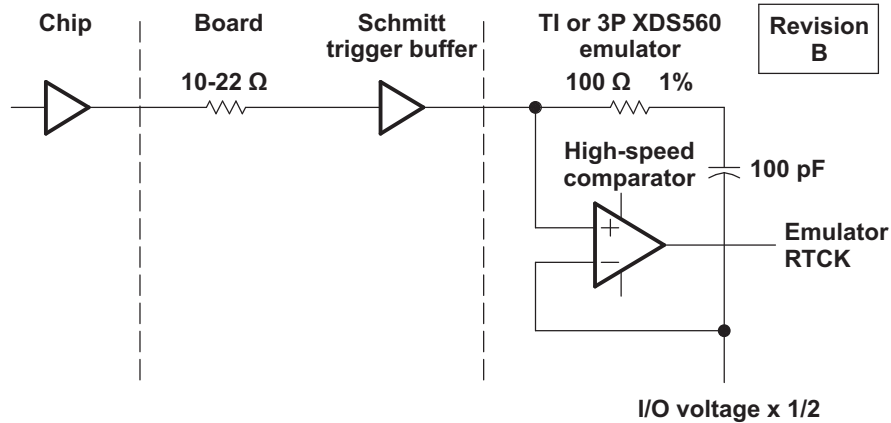
Figure 12. New Target Design with Existing Fielded Debug Controller Pods

- (d) The Tpd delay for the new buffer is rated at a nominal at 1.1 nS. The delay induced by this buffer in the RTCK line will increase the TDI setup time (Tsu) time by approximately 1.1 nS and decrease the hold time (Th) by 1.1 nS relative to RTCK.
- (e) The delay induced by this buffer in the RTCK line will decrease the TDI setup time (Tsu) by approximately 1.1 nS and increase the hold time (Th) by 1.1 nS relative to RTCK.

2. New Target Board Designs/Existing Debug controller pods:
 - (a) When designing a new target board to be used with an existing debug controller pod, it is recommended that a buffer is added to the RTCK net and the series resistor is changed. See [Figure 12](#).
 - (b) The series termination resistor utilized should be a 10 Ω, (or 22 Ω depending on net lengths), instead of the original 33-Ω value.
 - (c) The recommended buffer for the RTCK line is a TI SN74AUC1G17, Single Schmitt-Trigger Buffer. The buffer characteristics for RTCK is shown in [Table 9](#).
