**OMAP-L137
C6000 DSP+ARM Processor
Silicon Revisions 3.0, 2.1, 2.0, 1.1, and 1.0**

Silicon Errata

Literature Number: SPRZ291
October 2008–Revised June 2014

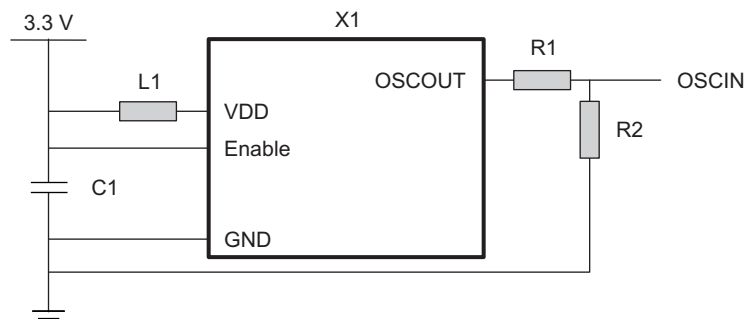
Figure 1. External 3.3V Clock Source

On all silicon revisions, certain design elements make this device susceptible to radiated noise during an ESD strike, as described in the standard IEC 61000-4-2. Exposure to the electrical noise caused by the ESD can cause soft device failures due to noise coupling on the system clock (OSCIN). ESD events within the IEC spec range do not cause permanent device damage and full functionality is recoverable with a device reset. The sensitivity to this noise issue is primarily due to the 1.2V oscillator/clock input implemented on this device. The low voltage range, coupled with slow rise and fall times, provides a lower noise margin than other TI devices with higher voltage internal oscillators (for example, 1.8V or 3.3V oscillators).

If ESD robustness is a concern, it is strongly recommended to avoid using the internal oscillator as a clock source. An external 3.3V clock source with a resistor voltage divider as in [Figure 1](#) can be used to externally generate the required 1.2V input clock. By using an external clock input with fast rise/fall times (less than 5 ns), the noise margin improves significantly, increasing ESD noise resistance.

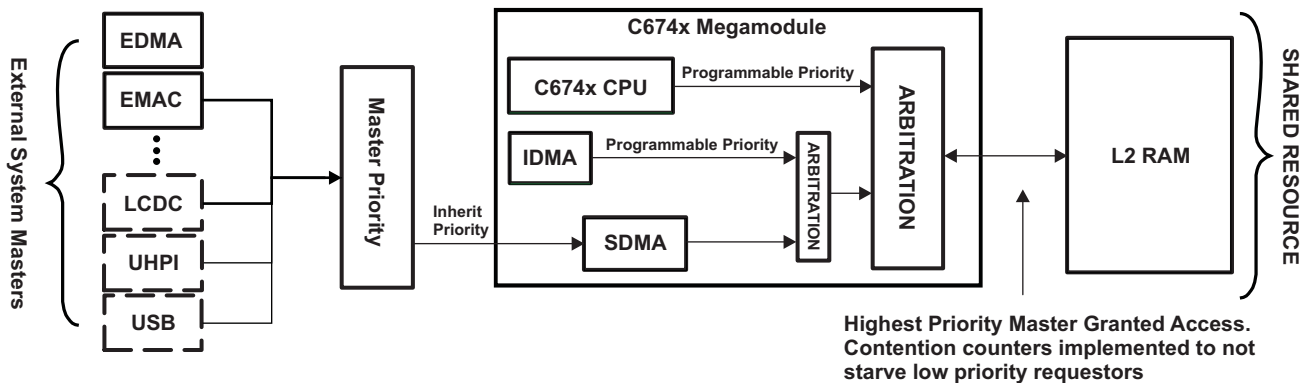
Figure 2. Priority Arbitration Scheme for L2 RAM

Ideally, the BWM arbitration will grant equal L2 bandwidth between equal priority DMA and CPU requests. Instead, when equal priority DMA and CPU requests arrive at the BWM, bandwidth is always granted in favor of the CPU over DMA. In the case of successive CPU requests, it is possible for the CPU to block all DMA requests until CPU traffic subsides. Additionally, some command logic in the BWM uses priority level 7, which can also result in SDMA stalls when the CPU is also programmed to priority level 7. [Figure 2](#) shows a high level diagram of the arbitration scheme used for L2 RAM requests.

Workaround(s) Configure DMA and CPU requests to different priority levels. The CPU should not be set to priority level 7. There is no penalty for setting the IDMA and SDMA priorities equal to each other.

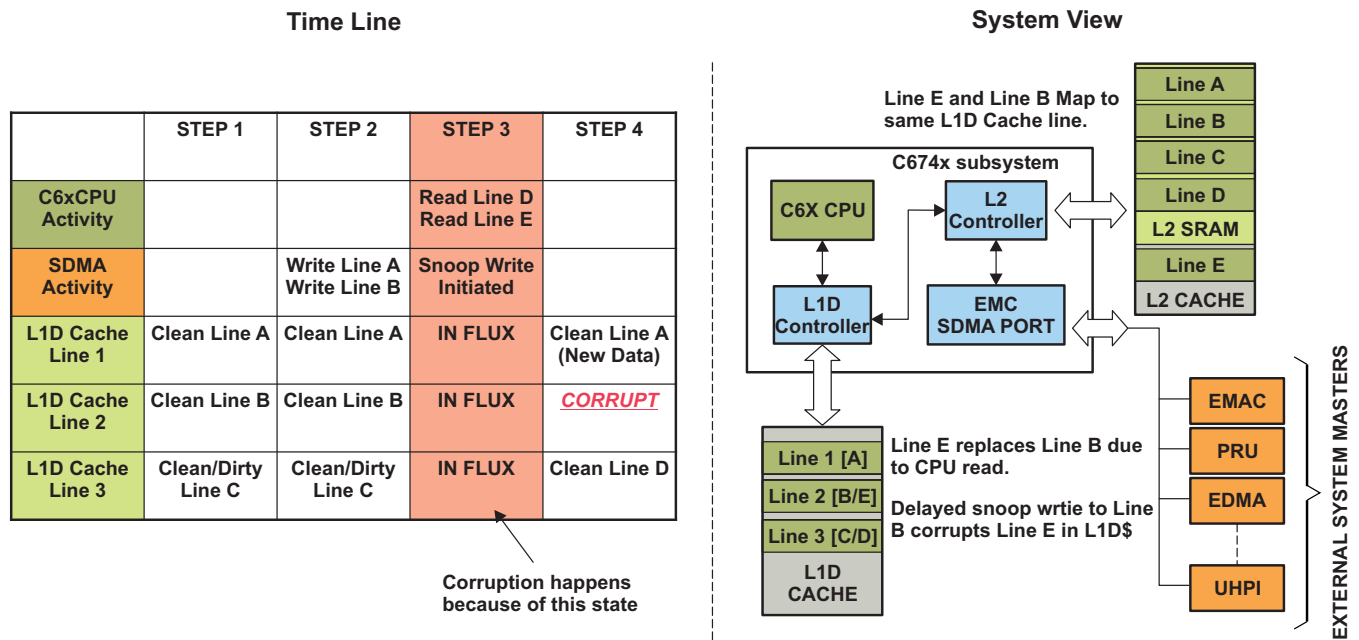
Figure 3. Example of L1D Cache Corruption

An L1D cache-line corruption event occurs when all of the conditions in the following steps are met (see [Figure 3](#)):

- Line E in L2 cache is read as a cache hit. Line E is destined to replace Line 2 in L1D Cache, which also has a snoop write pending for the updated Line B content.

- Line D in L2 SRAM is read. Line D will replace Line 3 in L1D cache.
4. When the snoop write operation completes, Line 2 in L1D cache now contains the updated L2 SRAM Line B data instead of the L2 cache Line E data.

The correct behavior would have been to kill the pending snoop write initiated to update L1D cache Line 2 with the updated L2 SRAM Line B data in Step 3. The L1D cache should have evicted Line B and replaced it with Line E data. Instead, the snoop write operation continues and does not complete until after the L1D cache Line 2 has already been replaced with L2 cache Line E data. The snoop write instruction overwrites the L1D cache Line 2 (containing L2 cache Line E data) with the updated L2 SRAM Line B data.

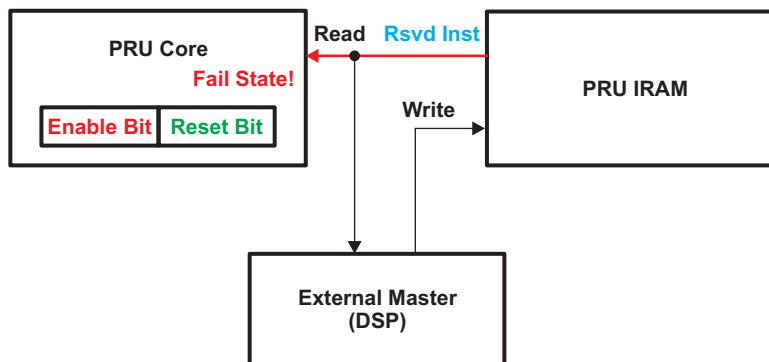
Figure 5. Boot Failure on Power-On

When the device is first powered-on, the read bus from the PRU IRAM is not initialized and will contain random values (see Figure 5). Under unpredictable circumstances, the random value on the read bus may resemble a reserved instruction which can be interpreted by the PRU when the core is reset and not enabled.

If the PRU core executes this reserved instruction, it will not be able to properly execute the first functional op-code in the PRU IRAM when the core is later enabled. In this fail state, the PRU will never acknowledge to the DSP that the reset vector table was successfully initialized and the DSP will be stuck in a polling loop waiting for the PRU to complete its task.

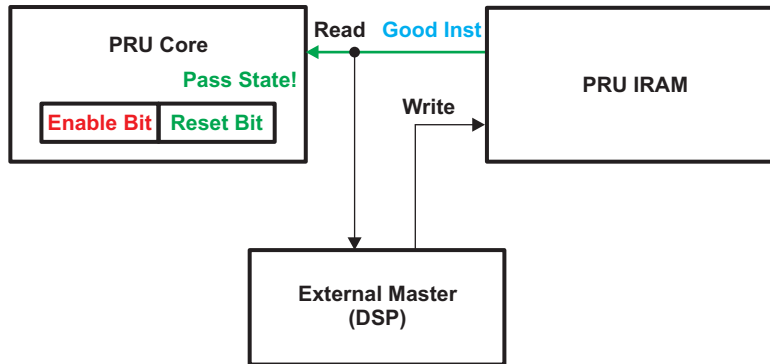
Figure 6. Secondary Reset

Although the PRU core execution is stuck, the PRU IRAM read bus is now initialized with a non-reserved instruction that was fetched from the IRAM by the PRU core (see

Figure 6). If a secondary reset is provided to the device (either POR or WARM), the PRU will be able to execute its functional instructions as expected.

Note that in order to recover from this fail state with a secondary reset, the DSP must be allowed to execute its boot ROM up to the point where the PRU has fetched a known instruction from the PRU IRAM. The approximate count of 15k cycles into the boot ROM is sufficient.

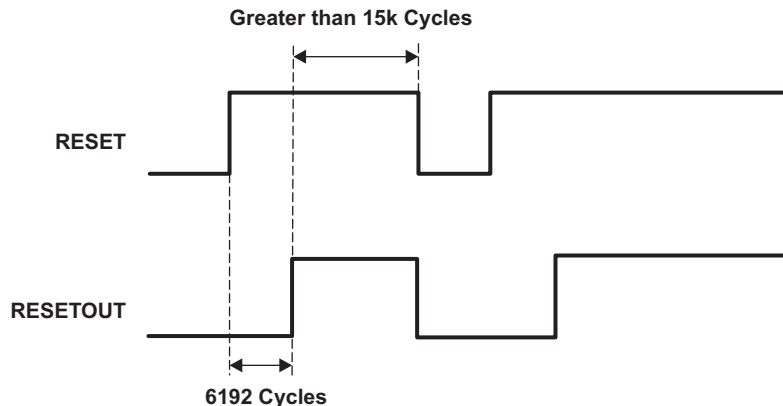
Figure 7. First POR Reset Timing

The 15k clock cycle count does not include the 6192 clock cycles required to complete a device POR reset (see Figure 7). With a 24MHz crystal, the first RESET signal must be asserted high for at least 883us (or approximately 1ms).

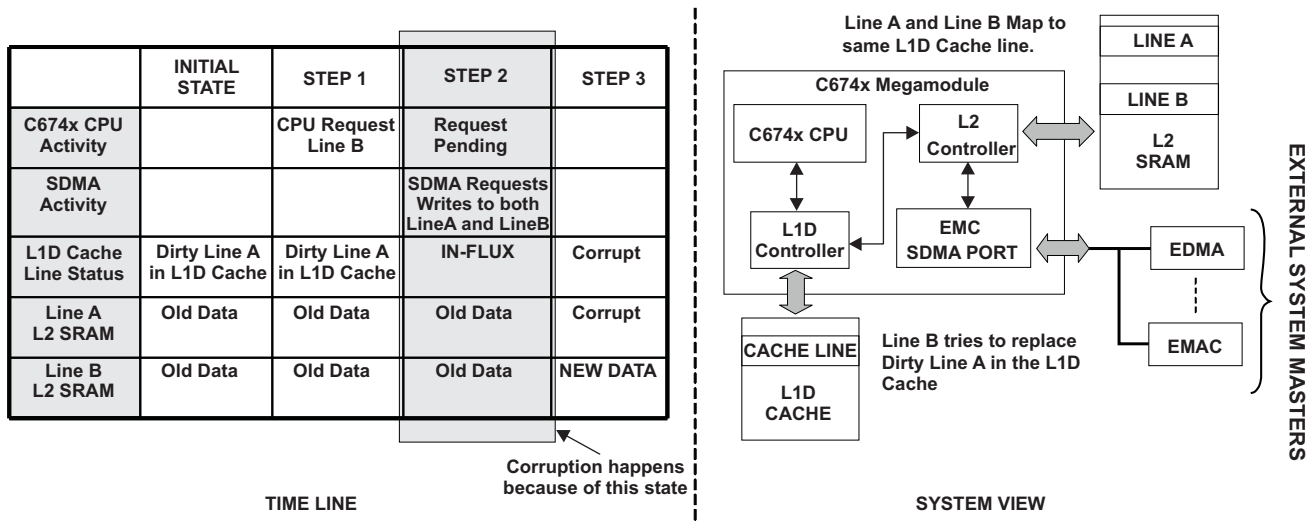
Figure 13. Example of L1D Cache and L2 RAM Corruption

An L1D cache-line corruption event occurs when all of the following conditions are met:

1. L1D cache evicts a dirty line (Line A) while allocating a new line (Line B) in the same set/way (cache Lines A and B consist of 64-bytes each). In order for this to happen, the following will have taken place:
 - (a) Line A was previously read by CPU because L1D is a read-allocate cache,
 - (b) Line A is dirty because its value was modified by CPU, and
 - (c) Line B is read by CPU
2. Both Line A and Line B are associated with L2 RAM, and
3. While the original L1D victim write-back from condition (1) is in progress, the SDMA performs both:
 - (a) a read or write operation to Line A in L2 RAM and
 - (b) a write operation to Line B in L2 RAM.

If all of the above conditions are met, the L2 RAM data associated with the Line A victim writeback will become corrupt. Additionally, the Line B data originating from the SDMA write will also become corrupt in L1D cache. [Figure 13](#) shows an example scenario of L1D cache and L2 RAM corruption.

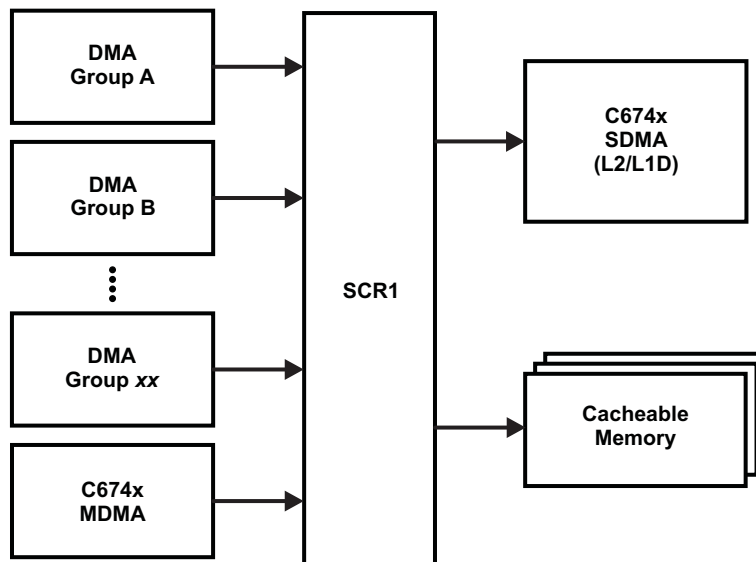
Figure 15. SCR1 System Interconnect

Step 2: The DSP's SDMA asserts itself as not ready and is unable to accept the write data from Step 1, and a cache line writeback is initiated from DSP memory to the same cacheable memory from Step 1. The cache line writeback command also passes through SCR1.

With the above scenario, it is possible for SCR1 to order the write commands from Step 1 in front of the write commands from Step 2. Due to the MDMA/SDMA blocking behavior, the SDMA commands from Step 2 will be waiting for the MDMA traffic from Step 1 to finish, resulting in a deadlock situation at SCR1. Figure 15 is provided for illustrative purposes and is incomplete because of simplification.
