# **AM1707 ARM Microprocessor Silicon Revisions 3.0, 2.1, and 2.0**

## **Silicon Errata**

Literature Number: SPRZ312E  
March 2010–Revised June 2014

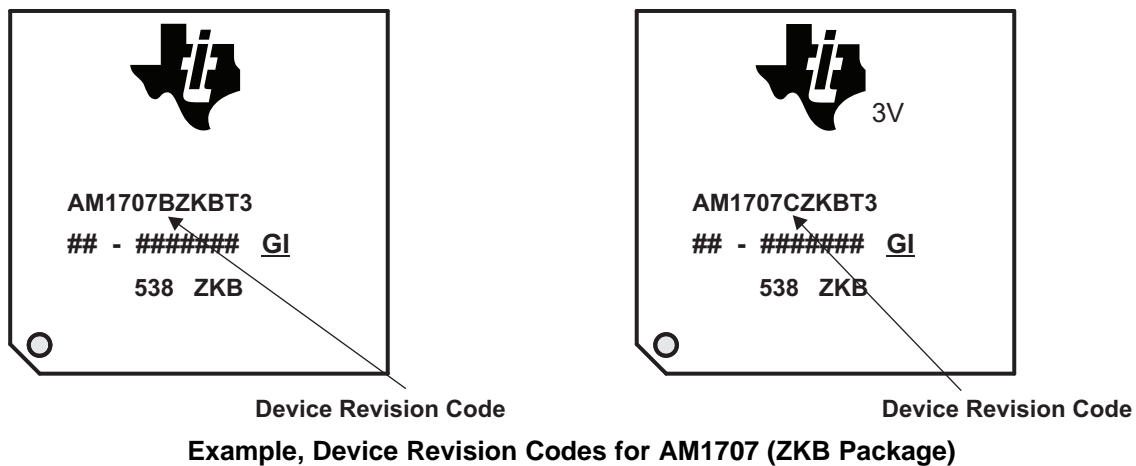
[Example, Device Revision Codes for AM1707 \(ZKB Package\)](#) shows an example of the AM1707 processor package symbolization. The device revision code can be identified by the markings on the top of the package; for example, the "C" between the device number and the package identifier indicates the device revision code (that is, Silicon Revision 2.1) A "D" between the device number and the package identifier would indicate the device revision code for Silicon Revision 3.0.

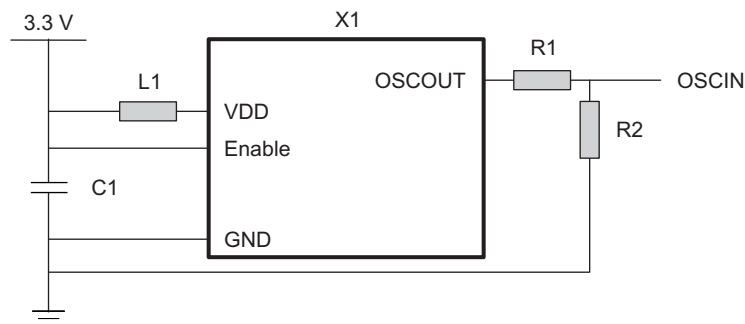
**Figure 1. External 3.3V Clock Source**

On all silicon revisions, certain design elements make this device susceptible to radiated noise during an ESD strike, as described in the standard IEC 61000-4-2. Exposure to the electrical noise caused by the ESD can cause soft device failures due to noise coupling on the system clock (OSCIN). ESD events within the IEC spec range do not cause permanent device damage and full functionality is recoverable with a device reset. The sensitivity to this noise issue is primarily due to the 1.2V oscillator/clock input implemented on this device. The low voltage range, coupled with slow rise and fall times, provides a lower noise margin than other TI devices with higher voltage internal oscillators (for example, 1.8V or 3.3V oscillators).

If ESD robustness is a concern, it is strongly recommended to avoid using the internal oscillator as a clock source. An external 3.3V clock source with a resistor voltage divider as in [Figure 1](#) can be used to externally generate the required 1.2V input clock. By using an external clock input with fast rise/fall times (less than 5 ns), the noise margin improves significantly, increasing ESD noise resistance.

In addition to using an external clock source, several other board and software recommendations specific to this device can improve system-level ESD immunity:

- The OSCIN and OSCVSS (and OSCOUT, if used) should be routed as short as possible to reduce their ability to pick up EMI noise.
- Route the OSCIN signal on inner board layers where it is shield by power and ground planes.
- The processor should be provided as much power supply decoupling as is practical and placed as close to the processor as possible.
- Implement the PLL filtering circuits shown in the device datasheet.
