AM571x (SR 2.0, 1.0) and AM570x (SR 2.1, 2.0) Sitara™ Processors

Errata

Literature Number: SPRZ436H
OCTOBER 2015 – REVISED JULY 2024

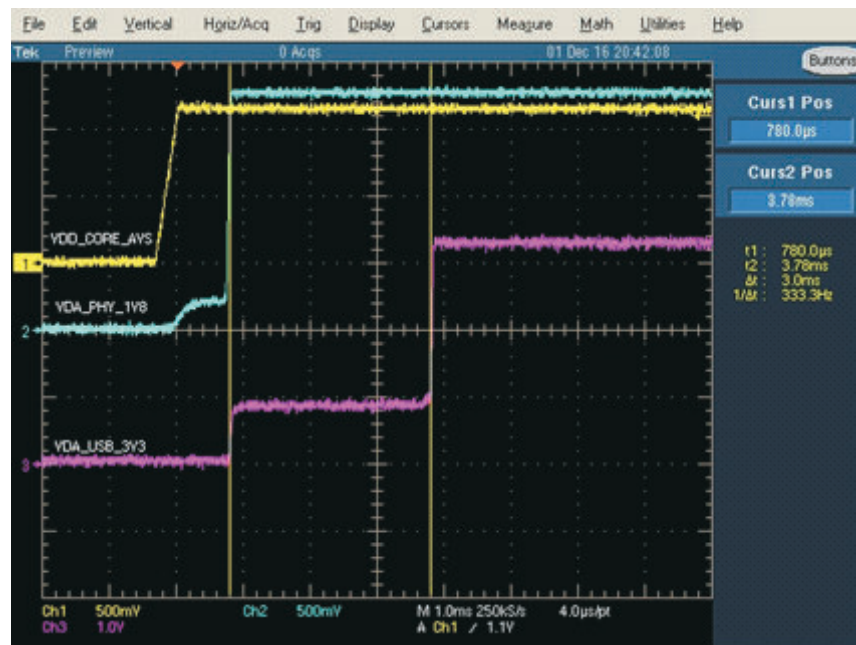
Figure 4-3. Original Power-Up Sequence

An unintended leakage current path between VDDA_PCIE (1.8 V) and VDDA33V_USB1 (3.3 V) due to ESD protection diode connection across the signal to I/O supply pads exists. This path can allow current to flow from VDDA_PCIE to VDDA33V_USB1. The current flows whenever the voltage level on VDDA_PCIE exceeds VDDA33V_USB by more than a diode drop during certain power-up and power-down sequences.

This leakage current causes the un-energized VDDA33V_USB1 to rise to a ~1 V plateau (see Figure 4-3) due to the power resource's "off impedance" seen between the VDDA33V_USB1 power rail to ground. When the minimum "off impedance" is $\geq 100 \Omega$, the SoC leakage current is small and sustainable with no SoC reliability impacts.

Note: Figure 4-3 shows in VDA_PHY_1V8 rail a plateau approximately 250 mV documented in i931, VDD to VDDA_"PHY" Current Path.

TI recommended Power Delivery Networks (PDNs) could have multiple different PMIC LDO power resources connected to the VDDA33V_USB1 rail. The LP87332D/LP873220 PMICs have a minimum OFF resistance equal to 150Ω so a PDN using these PMICs would not exceed safe leakage current level and could continue to use the original SoC power sequences. However, the TPS65916 PMICs have a minimum OFF resistance equal to 30Ω and would exceed the safe leakage current limit. As a result, any PDN using TPS65916 PMICs must implement the power sequencing as shown in DM version C or later. The specific sequence changes are:
