Errata

DRA72x (SR 2.0, 1.0) and DRA71x (SR 2.1, 2.0) SoC for Automotive Infotainment

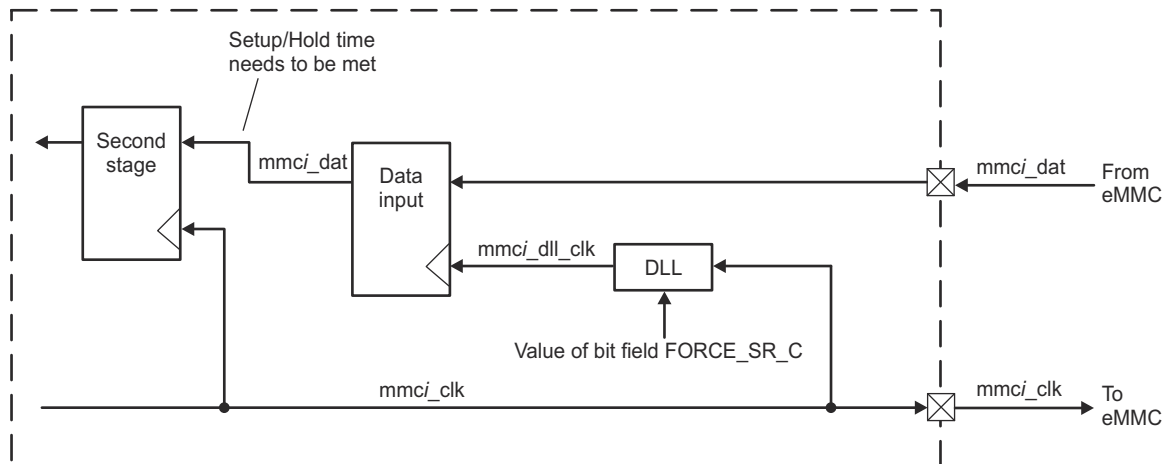
Figure 2-1. Simplified SoC 192-MHz Mode DLL Block Diagram

Internal to the MMC module, a second stage latch is used to recapture data captured by DLL delayed clock, `mmc_i_dll_clk`. The second stage latch captures with the original transmitting clock, `mmc_i_clk`.

`mmc_i_dll_clk` and `mmc_i_clk` both run at the same clock frequency. This results in a narrow range of tuning ratio elements, where the delayed `mmc_i_dll_clk` comes in phase with `mmc_i_clk`. If the clocks are in phase, the data captured by the first clock violates the setup and hold time requirements needed for the second stage latch, resulting in incorrectly read data. This is known as tuning re-timing errors.

A DLL tuning algorithm has been implemented that can avoid the tuning re-timing errors. More details on this can be found in App Note [SPRACA9](#). The following notes summarize the updated algorithm:

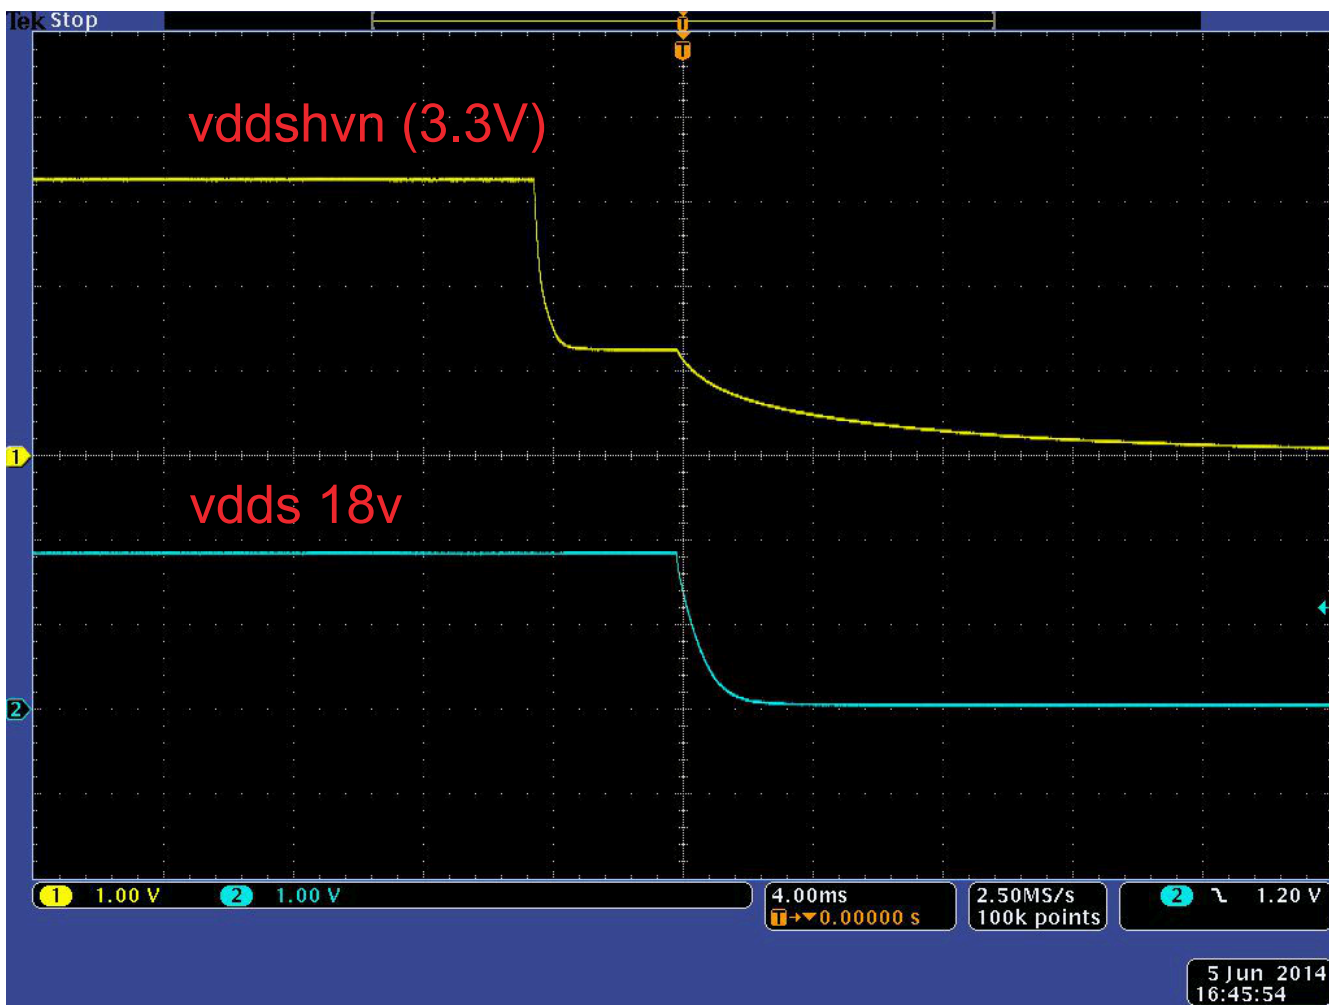
Figure 4-1. PAB_RevA

The Data Manual allows the vddshvn rail (in either 3.3V or 1.8V mode) to power down at the same time or before the vdds18v rail. When the vddshvn rail is powered down before the vdds18v rail, the vddshvn rail stays at Plateau Level (<1.5V) until the vdds18v rail is disabled, as shown in the waveform below.

A subset of the SOC's LVCMOS IOs (refer to DM for details) have a pull-up resistor that is active by default, including during reset and power-down. The SOC's IOs that have internal or external pull-ups will stay at Plateau Level (<1.5V) during the power-down. If other ICs on the board that are interfaced to the SOC's LVCMOS signals use a separate supply then it's possible that the other IC's signals can be pulled to the Plateau Level while its power supply is off.

The root cause of the plateau is related to the LVCMOS IO buffer Dual Voltage detection circuitry. The LVCMOS Dual Voltage IO includes voltage comparator circuitry to determine if the IO is in 3.3V mode or 1.8V mode. During powerdown of vddshvn domains, a current path in the internal bias transistors results in the vddshvn rail being held to an

In general, TI recommends using the same supply source for connected components. E.g., a single LDO should drive vddshvn and the related 3.3V external components.

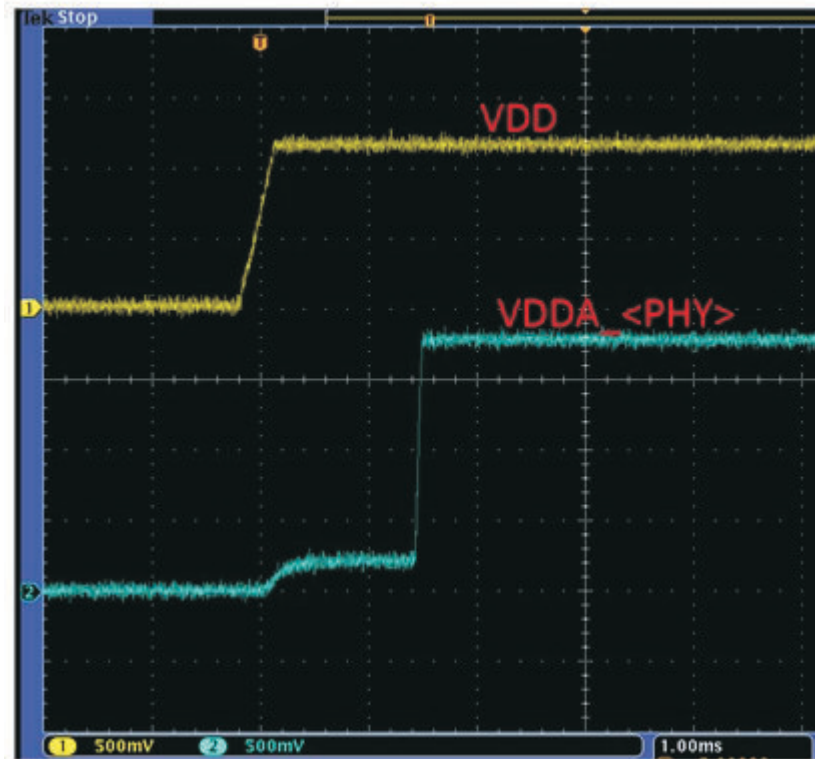
Figure 4-2. Leakage Voltage

The device-specific Data Manual requires Core AVS rail (VDD) to power up before the 1.8 V high speed analog PHY domain(s). When this sequence is followed, the high speed analog PHY domain will have a small step-up to a voltage plateau (< 0.5 V) that aligns to the beginning of the VDD ramp-up, and is maintained until the ramp-up of high speed analog PHY rail, as shown in [Figure 4-2](#). Note the leakage value will differ from system to system, but will be less than 500 mV. The leakage voltage in the provided capture is approximately 250 mV.

A similar condition exist during supply power down sequence. The high speed analog PHY domain(s) are required to be powered down prior to Core AVS rail (VDD), and may cause a small plateau to exist until Core AVS rail (VDD) is ramped down.

The root cause of the voltage plateau during power-up/down sequencing is related to the parasitic diodes in logic blocks which have multiple power sources. This leakage path is not a reliability concern for this device.

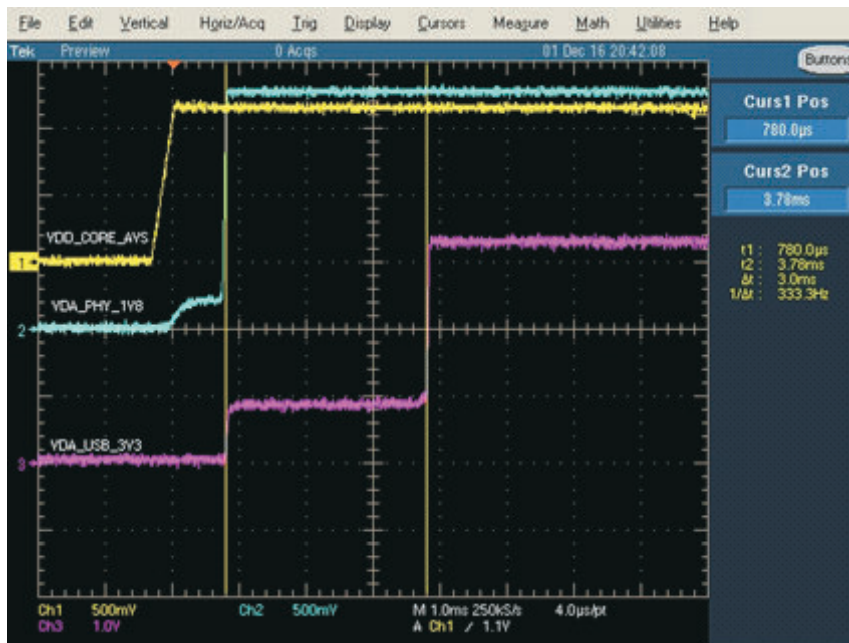
Figure 4-3. Original Power-Up Sequence

An unintended leakage current path between VDDA_PCIE (1.8 V) and VDDA33V_USB1 (3.3 V) due to ESD protection diode connection across the signal to I/O supply pads exists. This path can allow current to flow from VDDA_PCIE to VDDA33V_USB1. The current flows whenever the voltage level on VDDA_PCIE exceeds VDDA33V_USB by more than a diode drop during certain power-up and power-down sequences.

This leakage current causes the un-energized VDDA33V_USB1 to rise to a ~1 V plateau (see Figure 4-3) due to the power resource's "off impedance" seen between the VDDA33V_USB1 power rail to ground. When the minimum "off impedance" is $\geq 100 \Omega$, the SoC leakage current is small and sustainable with no SoC reliability impacts.

Note: Figure 4-3 shows in VDA_PHY_1V8 rail a plateau approximately 250 mV documented in i931, VDD to VDDA_"PHY" Current Path.

TI recommended Power Delivery Networks (PDNs) could have multiple different PMIC LDO power resources connected to the VDDA33V_USB1 rail. The LP8733/32 PMICs have a minimum OFF resistance equal to 150Ω so a PDN using these PMICs would not exceed safe leakage current level and could continue to use the original SoC power sequences. However, the TPS65917/919 PMICs have a minimum OFF resistance equal to 30Ω and would exceed the safe leakage current limit. As a result, any PDN using TPS65917/919 PMICs must implement the revised power sequencing as shown in DM version D or later. The specific sequence changes are:

The following PMIC OTP IDs have been aligned to the revised power sequencing to avoid any leakage current:
