ABSTRACT

This document describes the known exceptions to the functional specifications (advisories). This document may also contain usage notes. Usage notes describe situations where the device's behavior may not match presumed or documented behavior. This may include behaviors that affect device performance or functional correctness.

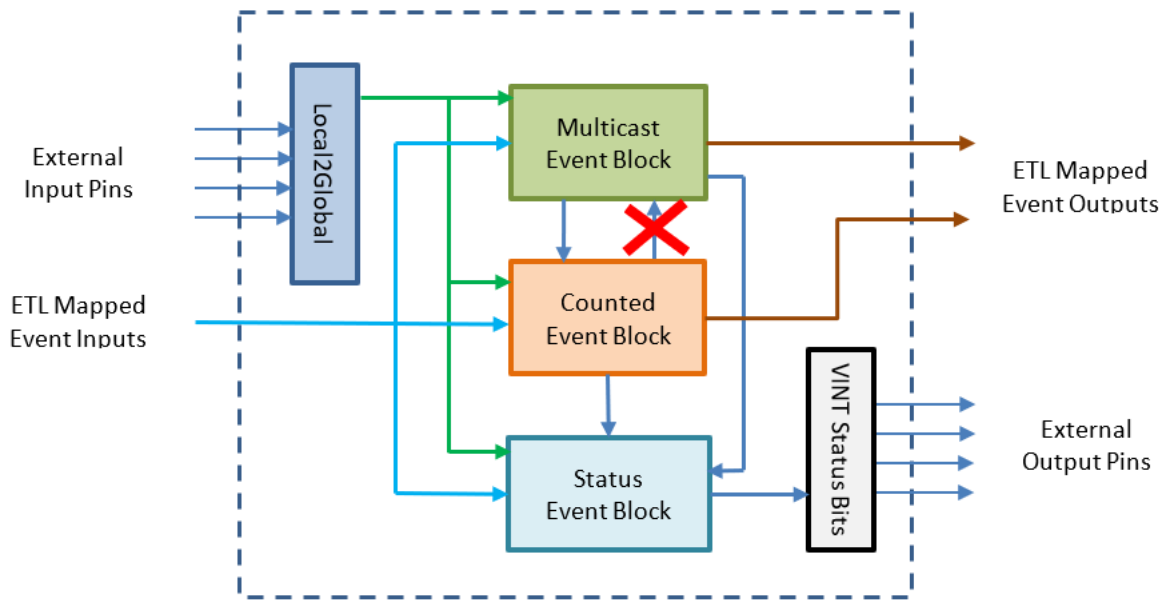
Figure 2-3. Interrupt Aggregator Version 1.0

An issue was found after design that could cause the IA to deadlock. The issue occurs when event “loops” occur between these three processing blocks. It is possible to create a situation where a processing block can not output an event because the path is blocked, and since it can not output an event, it can not take any new input events. This inability to take input events prevents the output path from being able to unwind, and thus both paths remain blocked.

Figure 2-3 shows the conceptual block diagram of IA 1.0. Potential loops are avoided by adopting the policy of not allowing the counted event block to send events to the multicast block. This method was chosen because it is more common to split an event first, and then count one while sending the other elsewhere. With this path blocked by convention, it is not possible for a single event to visit any block more than once and thus not possible for paths to become blocked so long as the outputs remain unblocked.

By following the conventions outlined here, the system is safe from looping hazards that can create a deadlock scenario.
