MSP430F4250 Device Erratasheet

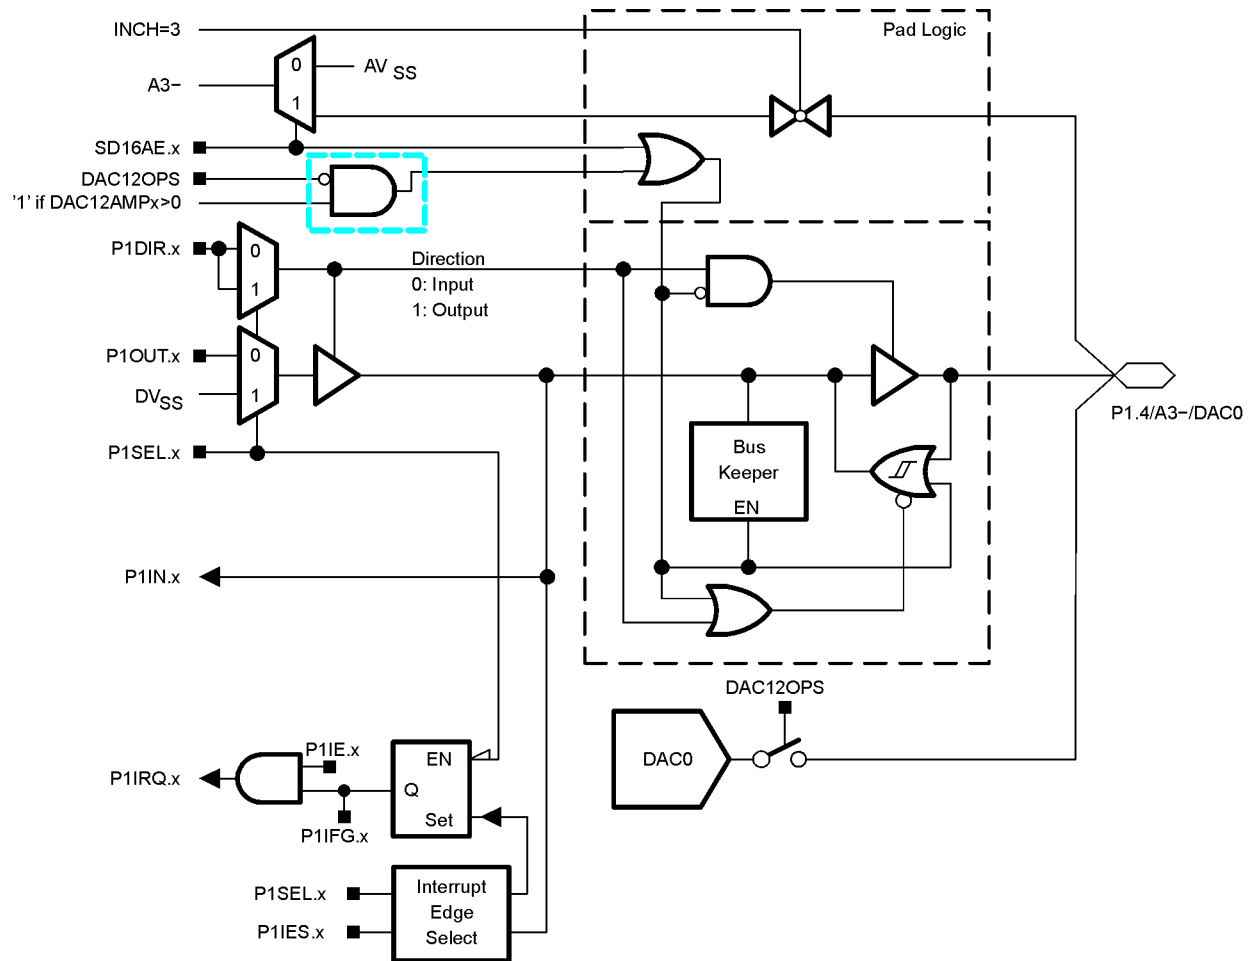
Function P1.4 GPIO function is not disabled when P1.4 = DAC0 output

Description The DAC12OPS control bit used to automatically disable the P1.4 I/O logic is inverted as shown in the figure below. When DAC12 is enabled (DAC12AMPx > 0) and DAC12OPS=0, the port I/O for P1.4 will be disabled. Setting DAC12OPS = 1 to connect the DAC12 output to P1.4 will erroneously enable the port GPIO logic.

Note: x = 4

The P1.4 I/O logic should be disabled when the DAC12 is enabled using the SD16AE.4 analog enable bit. SD16AE.4=1 will disable the P1.4 I/O logic. The A3 SD16_A analog input cannot be used under this condition.

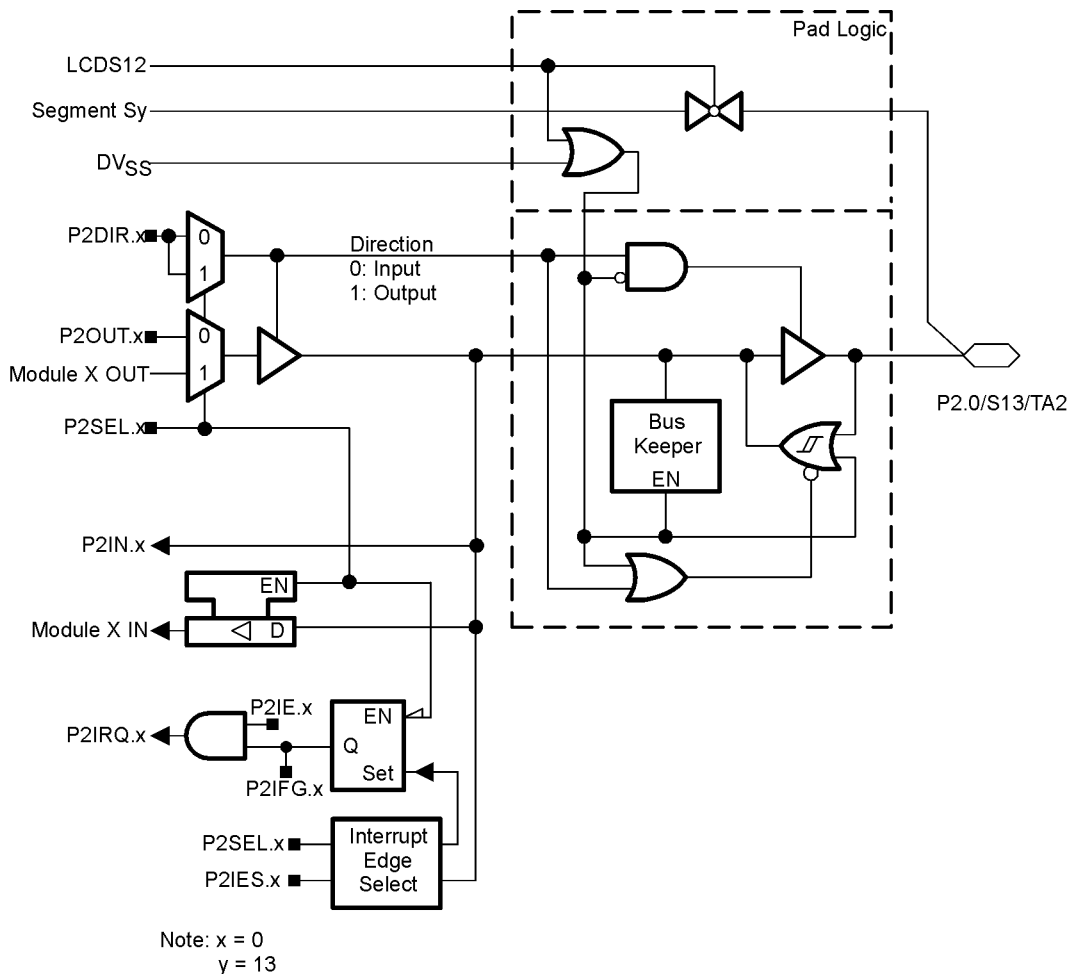
Function P2.0 module function

Description In addition to GPIO and LCD functionality, P2.0 also has Timer_A3 module output capability. When $\text{P2SEL.0} = 1$ and $\text{P2DIR.0} = 1$, P2.0 becomes a TA2 output.

Workaround N/A

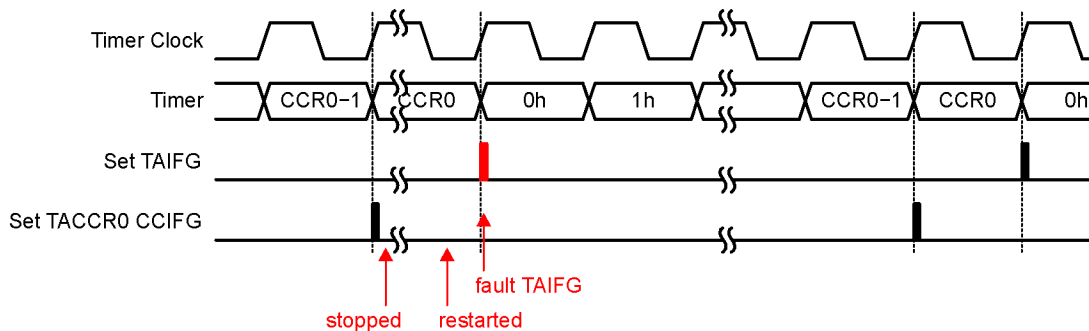
Function TAIFG Flag is erroneously set after Timer A restarts in Up Mode

Description In Up Mode, the TAIFG flag should only be set when the timer counts from TACCR0 to zero. However, if the Timer A is stopped at TAR = TACCR0, then cleared (TAR=0) by setting the TACLR bit, and finally restarted in Up Mode, the next rising edge of the TACLK will erroneously set the TAIFG flag.

Workaround None.
