## MSP430F4260 Device Erratasheet

### 1 Functional Errata Revision History

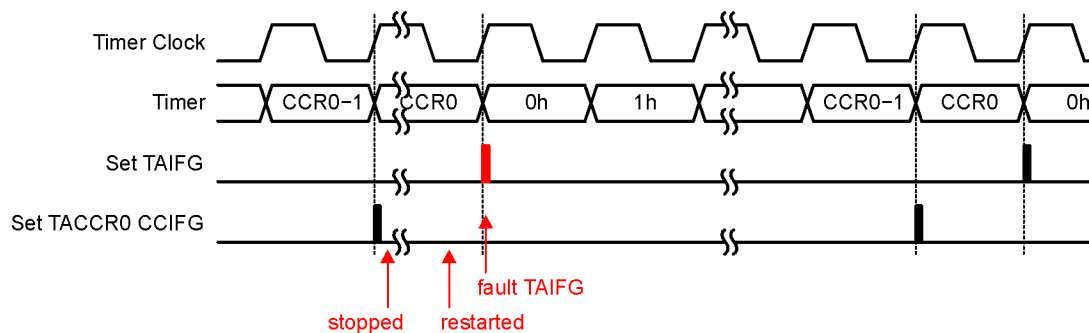
<b>Category</b>	Functional
<b>Function</b>	TAIFG Flag is erroneously set after Timer A restarts in Up Mode
<b>Description</b>	In Up Mode, the TAIFG flag should only be set when the timer counts from TACCR0 to zero. However, if the Timer A is stopped at TAR = TACCR0, then cleared (TAR=0) by setting the TACLK bit, and finally restarted in Up Mode, the next rising edge of the TACLK will erroneously set the TAIFG flag.

<b>Workaround</b>	None.
-------------------	-------
