**ABSTRACT**

This document describes the known exceptions to the functional specifications (advisories).

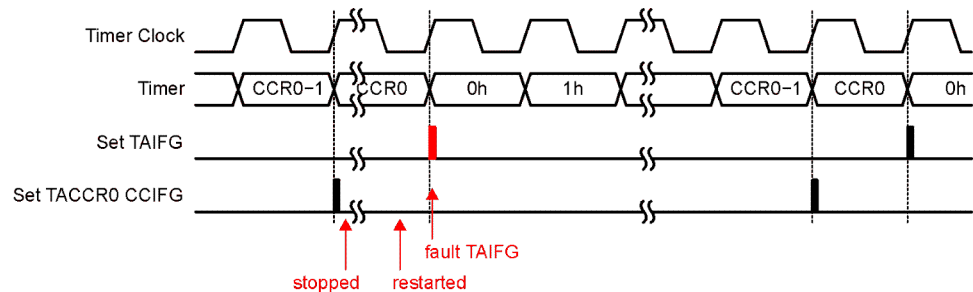
**TA21** *TA Module*

**Function** TAIFG Flag is erroneously set after Timer A restarts in Up Mode

**Description** In Up Mode, the TAIFG flag should only be set when the timer counts from TACCR0 to zero. However, if the Timer A is stopped at  $TAR = TACCR0$ , then cleared ( $TAR=0$ ) by setting the TACLK bit, and finally restarted in Up Mode, the next rising edge of the TACLK will erroneously set the TAIFG flag.

**Workaround** None.
