# Errata

## **MSP430G2001 Microcontroller**

This document describes the known exceptions to the functional specifications (advisories).

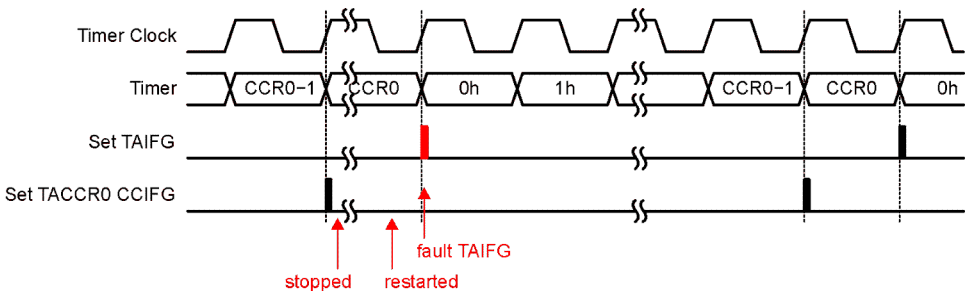
<b>TA21</b>	<b>TA Module</b>
<b>Category</b>	Functional
<b>Function</b>	TAIFG Flag is erroneously set after Timer A restarts in Up Mode
<b>Description</b>	In Up Mode, the TAIFG flag should only be set when the timer counts from TACCR0 to zero. However, if the Timer A is stopped at TAR = TACCR0, then cleared (TAR=0) by setting the TACLK bit, and finally restarted in Up Mode, the next rising edge of the TACLK will erroneously set the TAIFG flag.

<b>Workaround</b>	None.
<b>TAB22</b>	<b>TAB Module</b>
<b>Category</b>	Functional
<b>Function</b>	Timer_A/Timer_B register modification after Watchdog Timer PUC
<b>Description</b>	Unwanted modification of the Timer_A/Timer_B registers TACTL/TBCTL and TAIV/TBIV can occur when a PUC is generated by the Watchdog Timer(WDT) in Watchdog mode and any Timer_A/Timer_B counter register TACCRx/TBCCRx is incremented/decremented (Timer_A/Timer_B does not need to be running).
<b>Workaround</b>	Initialize TACTL/TBCTL register after the reset occurs using a MOV instruction (BIS/BIC may not fully initialize the register). TAIV/TBIV is automatically cleared following this initialization.  Example code:  MOV.W #VAL, &TACTL or MOV.W #VAL, &TBCTL  Where, VAL=0, if Timer is not used in application otherwise, user defined per desired function.
<b>XOSC5</b>	<b>XOSC Module</b>
<b>Category</b>	Functional
<b>Function</b>	LF crystal failures may not be properly detected by the oscillator fault circuitry
