TMS570LC4357 Microcontroller

Silicon Revision A

Silicon Errata

Literature Number: SPNZ180D
June 2013–Revised May 2016

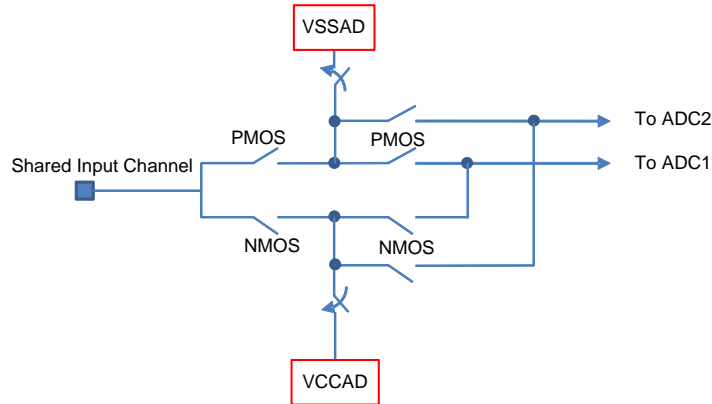
Figure 2. Shared Input Channel in "Open" State

Issue This microcontroller (MCU) has two Analog-to-Digital Converters (ADCs). Some of the input channels are unique to ADC1 while some are shared between ADC1 and ADC2. [Figure 2](#) shows a block diagram of an input channel shared between ADC1 and ADC2.

The PMOS and NMOS switches are open indicating that this shared input channel is not currently being sampled either by ADC1 or by ADC2. Also, there are switches to VCCAD and VSSAD that are closed. If any current is injected into this analog input, any leakage through the open PMOS switch will be shunted to VSSAD. These switches to VSSAD and VCCAD are opened as soon as this shared input channel is being sampled by either ADC1 or ADC2.

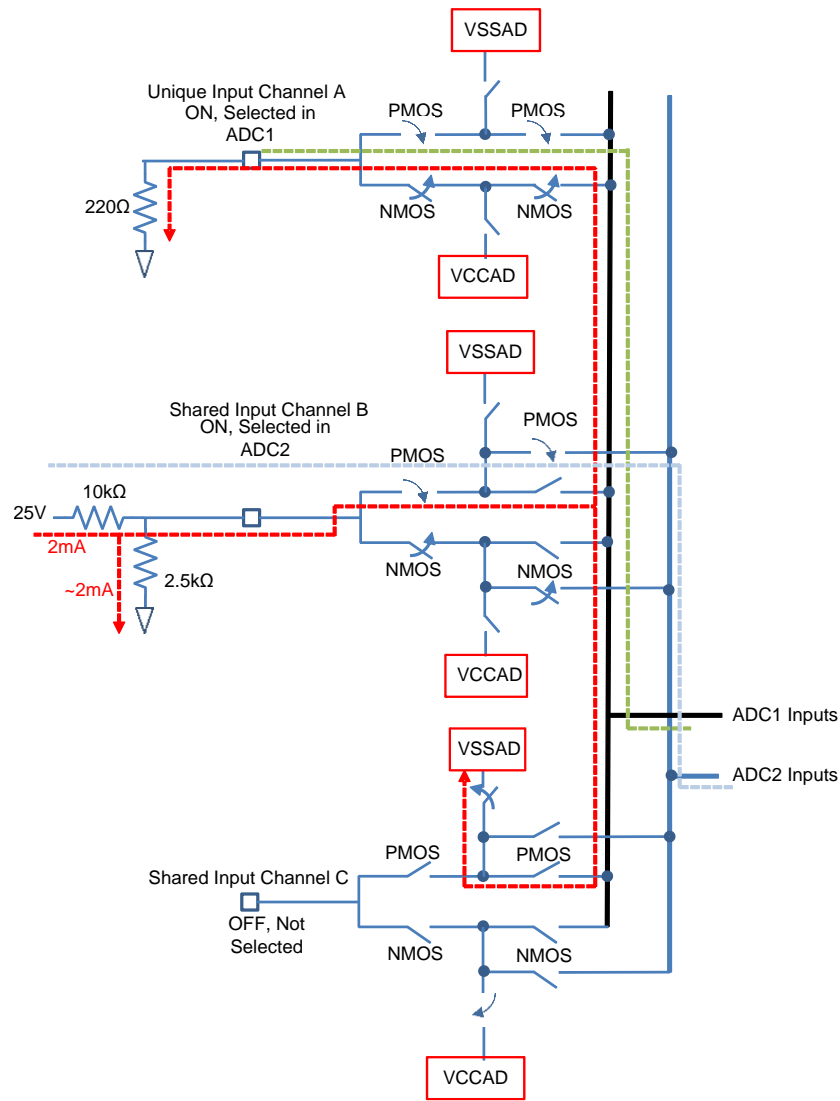
Figure 3. Example ADC1/ADC2 Channel Connection

Figure 3 shows an example where a ADC1 is sampling input channel A which is unique to ADC1, and ADC2 is sampling input channel B, which is a shared-input channel. This is shown by the dashed green and light blue current paths.

Another current path is shown in dashed dark red. This is a current injected into channel B as the input level on terminal B is greater than $V_{CCAD} - 0.3V$. This is a parasitic current that passes through the "open" PMOS switch, and a part of this current flows to ground through the external 220 ohm resistor connected to input channel A. This causes an offset in the conversion result of channel A being sampled by ADC1.

1. Configure the two ADC modules such that their sampling periods do not overlap, or
2. Limit the shared analog input upper limit to be lower than ($V_{CCAD} - 0.3V$). The PMOS leakage is reduced exponentially if the input is lower than $V_{CCAD} - 0.3V$.

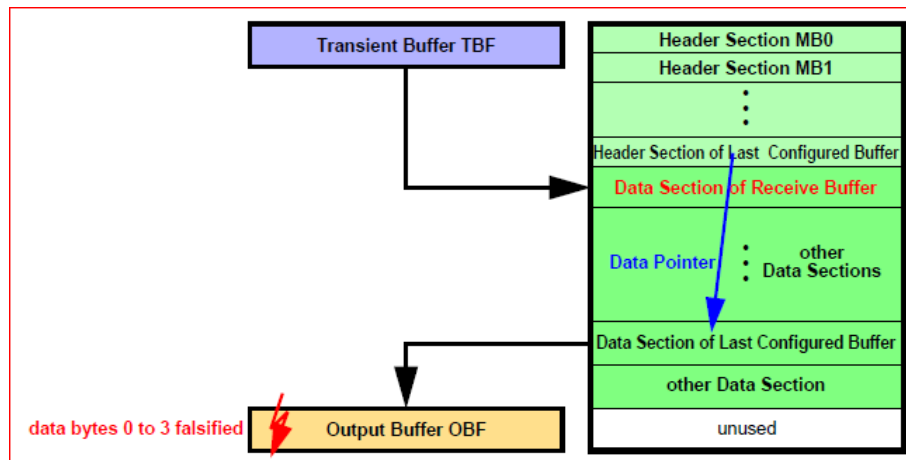
Figure 4. First Fail Mode

- 1) When a message is transferred from the Last Configured Buffer in the Message RAM to the OBF and PLC = 127 it may happen, that at the end of the transfer the OBF word on address 00h (payload data bytes 0 to 3) is overwritten with unexpected data (see Figure 4).

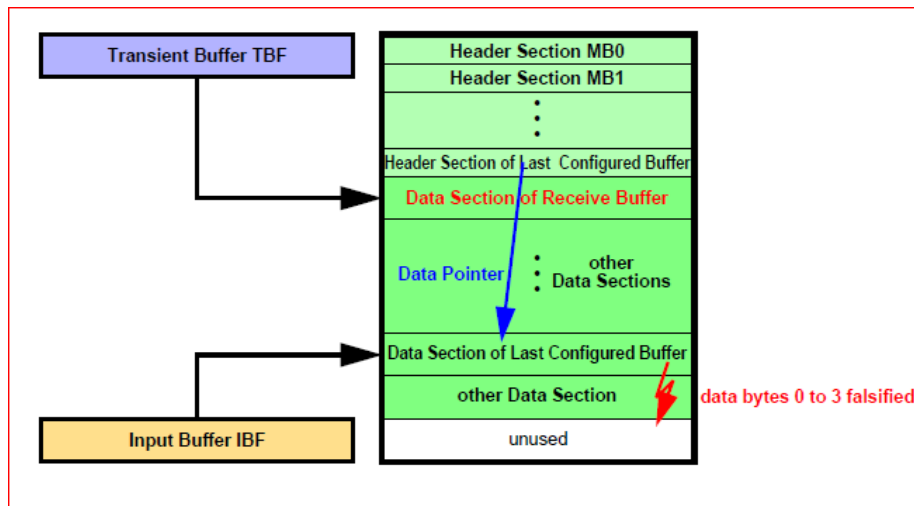
Figure 5. Second Fail Mode

- 2) When a message is transferred from IBF to the Last Configured Buffer in the Message RAM, it may happen, that at the end of the transfer of the Data Section one additional write access overwrites the following word, which may be the first word of another message's Data Section in the Message RAM (see Figure 5).
