TMS570LS31x/21x Microcontroller

Silicon Revision C

Silicon Errata

Literature Number: SPNZ195G
February 2013–Revised May 2016

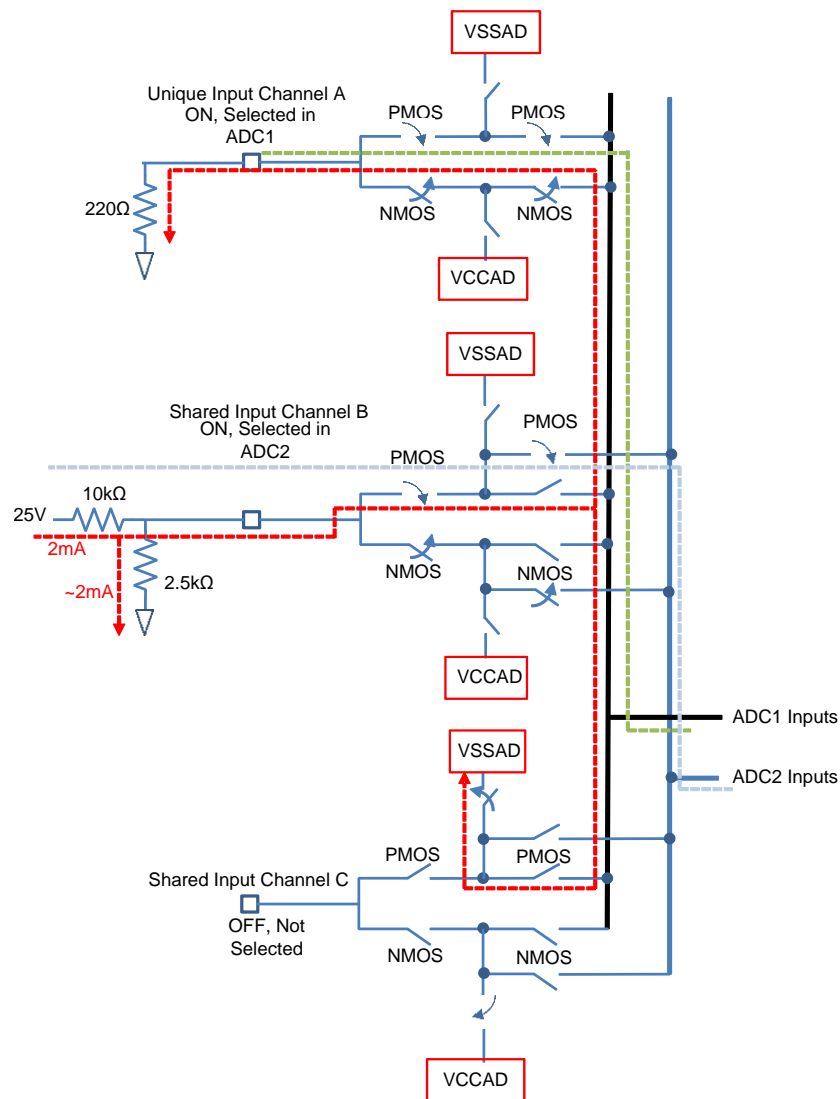
Figure 3. Example ADC1/ADC2 Channel Connection

Figure 3 shows an example where a ADC1 is sampling input channel A which is unique to ADC1, and ADC2 is sampling input channel B, which is a shared-input channel. This is shown by the dashed green and light blue current paths.

Another current path is shown in dashed dark red. This is a current injected into channel B as the input level on terminal B is greater than $V_{CCAD} - 0.3V$. This is a parasitic current that passes through the "open" PMOS switch, and a part of this current flows to ground through the external 220 ohm resistor connected to input channel A. This causes an offset in the conversion result of channel A being sampled by ADC1.

1. Configure the two ADC modules such that their sampling periods do not overlap, or
2. Limit the shared analog input upper limit to be lower than ($V_{CCAD} - 0.3V$). The PMOS leakage is reduced exponentially if the input is lower than $V_{CCAD} - 0.3V$.

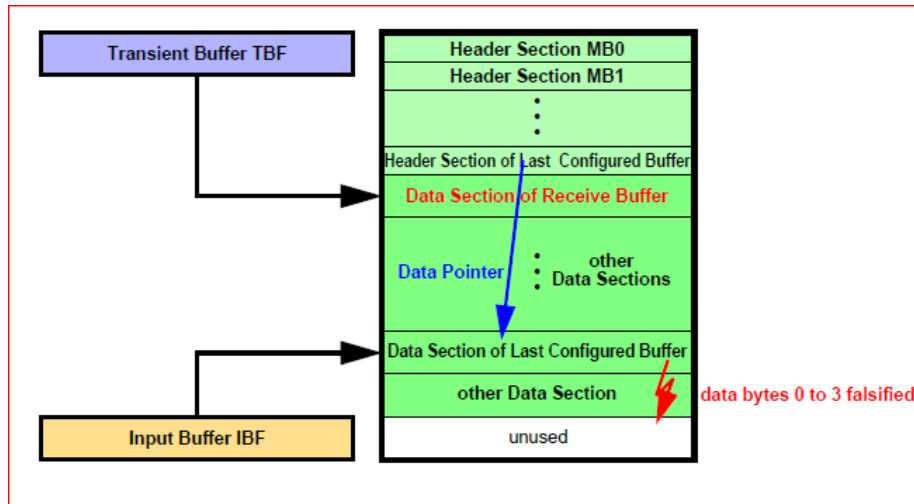
Figure 5. Second Fail Mode

2) When a message is transferred from IBF to the Last Configured Buffer in the Message RAM, it may happen, that at the end of the transfer of the Data Section one additional write access overwrites the following word, which may be the first word of another message's Data Section in the Message RAM (see [Figure 5](#)).
