**IWR6843AOP Device Silicon Errata
Silicon Revisions 1.0 and 2.0**

This document describes the known exceptions to the functional and performance specifications to TI CMOS Radar Devices (IWR6843AOP).

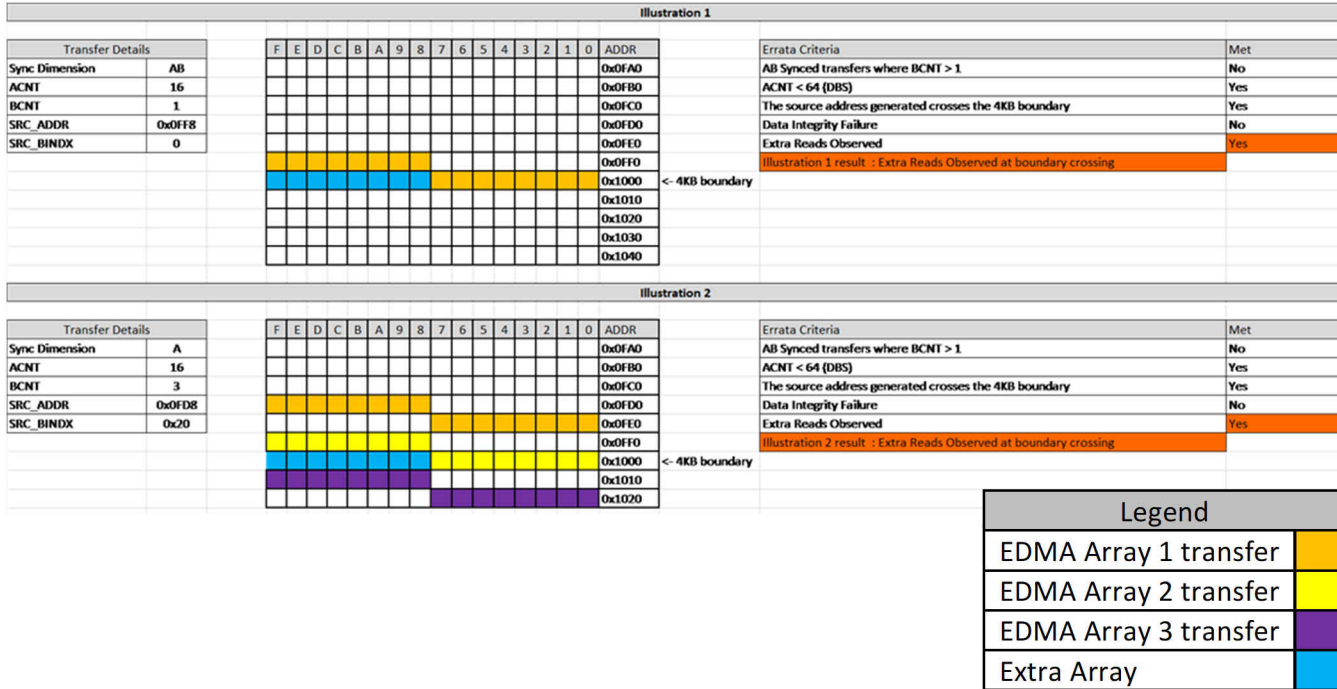
Figure 6-1. Scenario ID #3 – Extra Reads

For each extra read in **Scenario ID #3** for which **Condition [1]** is applicable, each index i above that satisfies the condition results in extra read from starting address SRC_ADDR + (i + 1) * SRCBIDX and of length equal to the distance from the start address to the boundary [that is, 0x1000 – X(i)]. Note: length < ACNT.

For **Scenario ID #3, Scenario ID #4, and Scenario ID #5**– **EXTRA READS**, another workaround besides avoiding the 4-KB boundary cross conditions, is to ensure that buffers involved in this kind of transfer are positioned so that extra reads stay within the physical memory boundaries. If the extra reads go to Reserved space or space blocked by the Memory Protection Unit (MPU), the TPTC generates a bus error interrupt to the processor.

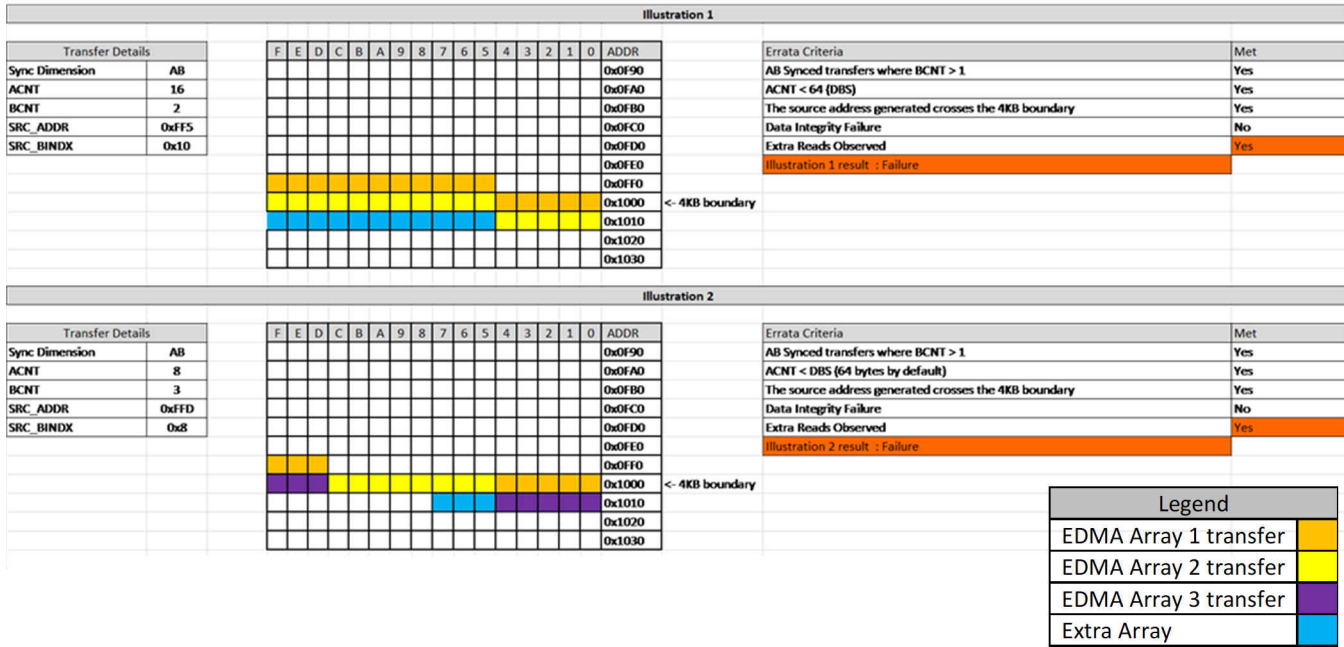
Figure 6-2. Scenario ID #4 – Extra Reads

For each extra read **Scenario ID #4** in for which **Condition [1]** is applicable, there is an extra read from starting address SRC + BCNT * ACNT (=SRCBIDX) of length equal to the distance of the start address to the boundary [that is, length is 0x1000 – X(i)], where i is the index of one and only 4-KB boundary crossing condition. Note: length < ACNT.

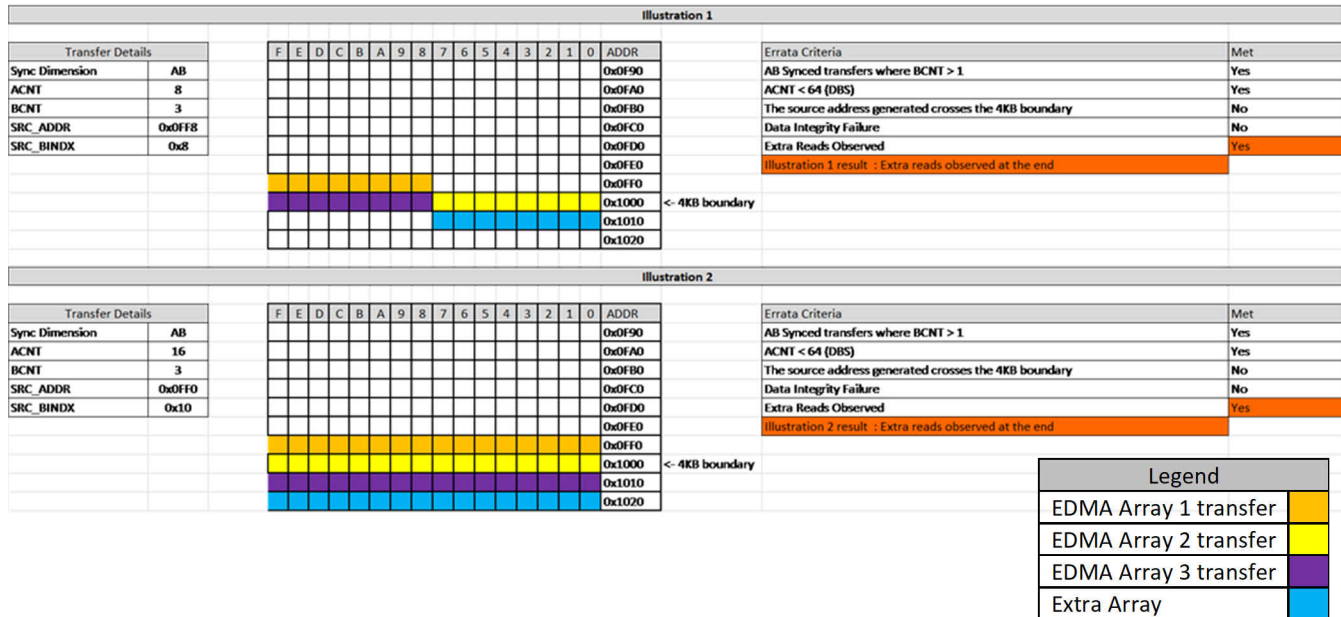
Figure 6-3. Scenario ID #5 – Extra Reads

For the extra read **Scenario ID #5** in for which [Condition \[2\]](#) is applicable, there is an extra read from starting address SRC + BCNT * ACNT (=SRCBIDX) of length equal to the distance of the start address and is of length ACNT.

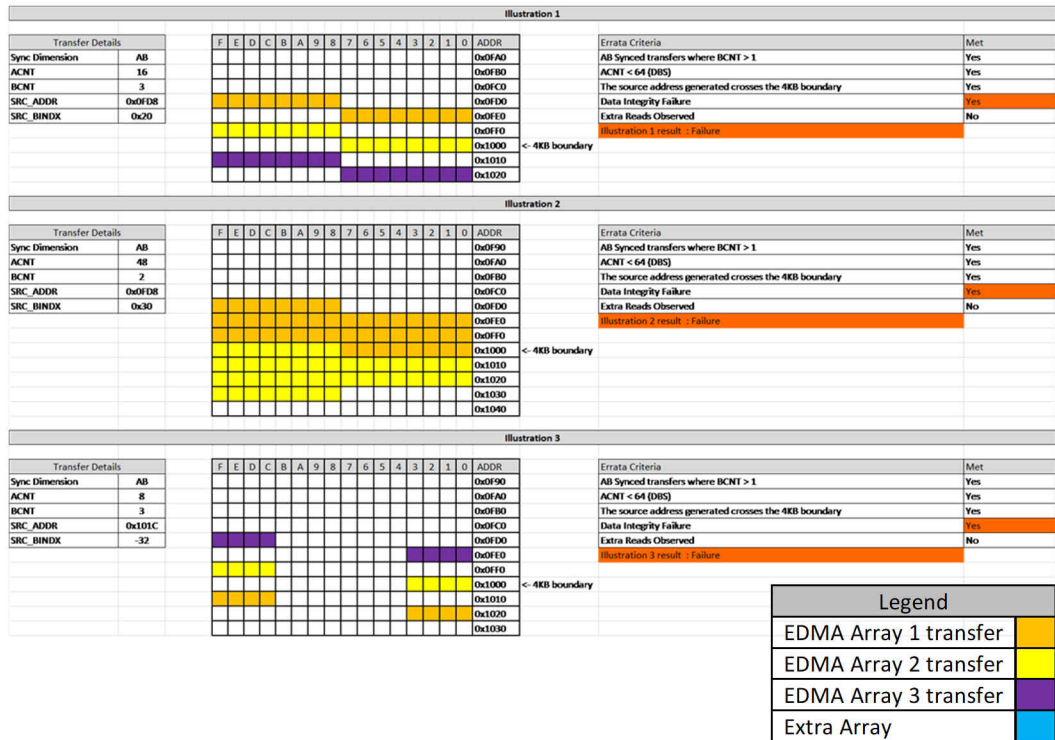
Figure 6-4. Scenario ID #1 – Data Integrity Failure

EDMA TPTC Generates an Incorrect Address on the Read Interface, Causing one or More Data Integrity Failures, Hangs, or Extra Reads

Workaround(s): **Workaround #1 - ALL SCENARIO IDs** (see [Table 6-1](#))

Prevent one or more of the conditions necessary for the problematic scenarios to happen.

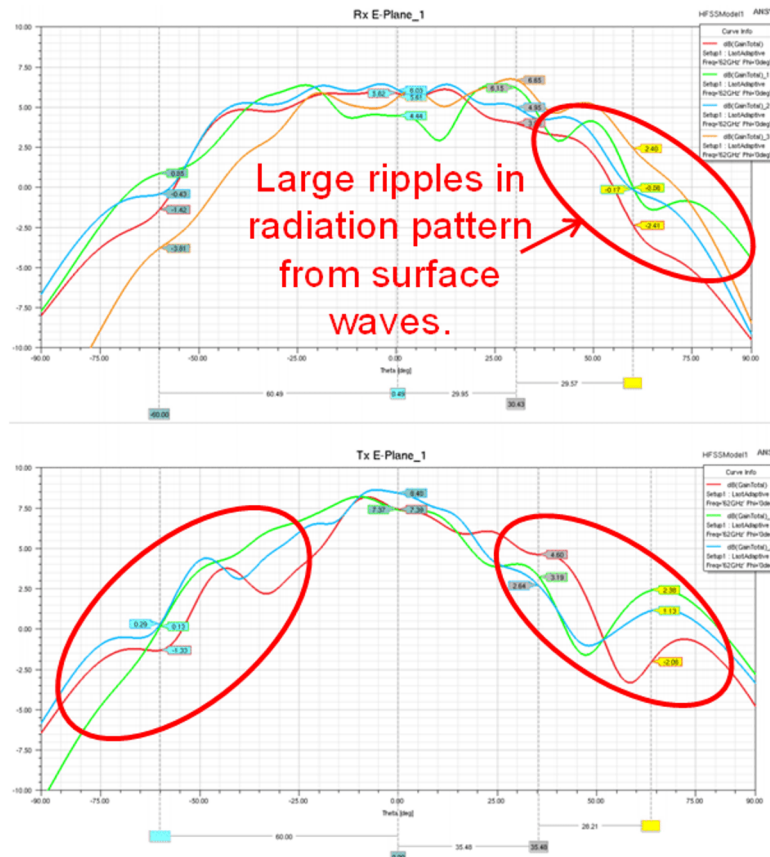
Description: Large PCBs area around the E-plane causes surface waves that create large ripples in the elevation direction of the AoP antenna radiation pattern.

Workaround #1 Keep the Edge of PCB close to the edge of the AoP device in the E-plane to minimize the surface wave ripples.

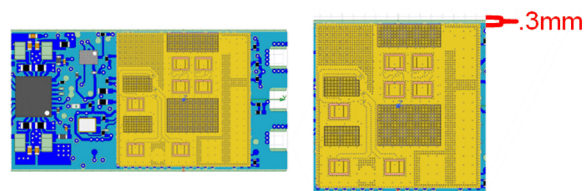
Figure 6-5. Small form factor board with PCB edge less than 0.3mm

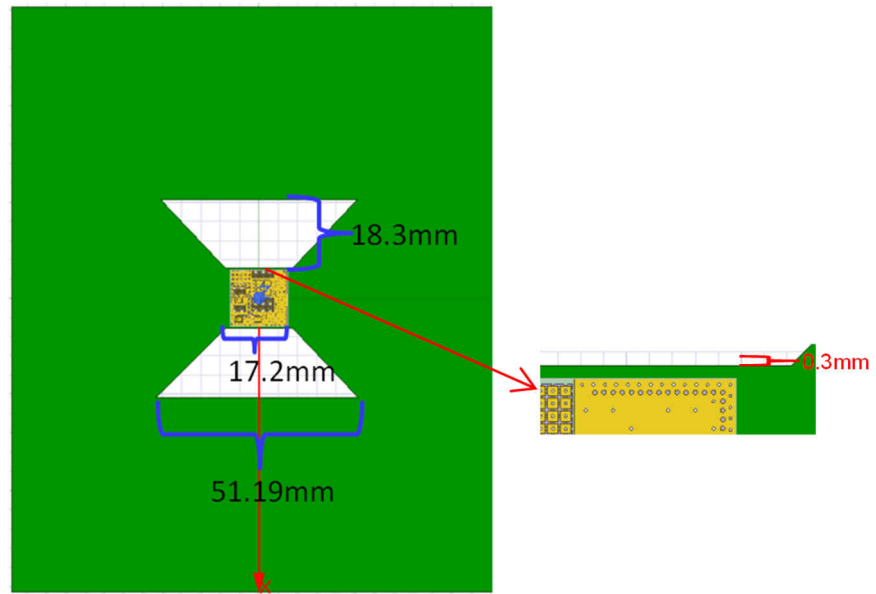
Figure 6-6. Large form factor board with trapezoidal cutout and PCB edge less than 0.3mm

Workaround #2 If a larger board is needed for the solution, a trapezoid cutout with the PCB edge less than <math><0.3\text{mm}</math> from the edge of the AoP should be implemented to minimize the ripples caused by surface waves.
