Errata
IWRL6432W Device Silicon Errata
Silicon Revision 2.1

ABSTRACT

This document describes the known exceptions to the functional and performance specifications to TI CMOS Radar Devices (IWR6432W)

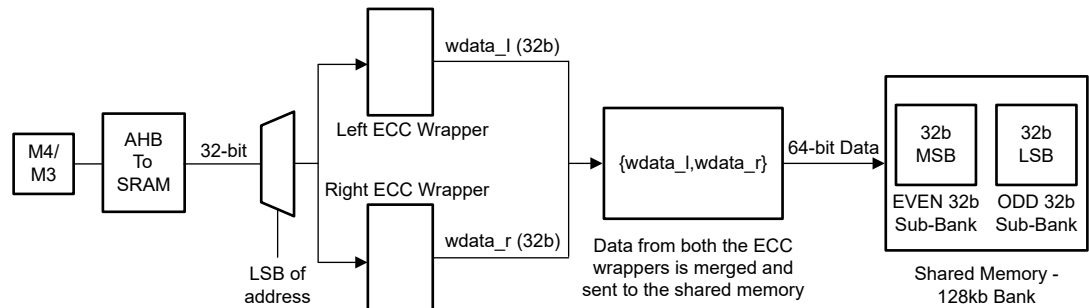
Figure 5-1. Shared Memory Logic Diagram When Shared with M4/M3

Internal shared memory has ODD and EVEN banking structure. For a particular address range, partial write (less than 32 bit) to EVEN bank corrupts same address of ODD bank with next data on the bus. When shared memory is allocated to M4/M3, back to back full word write access to location A followed by sub-word write access to location B corrupts data in location A.

When memory is shared with M4/M3, issue is seen in the following address range:

Memory	Address Range
APP_CPU_SHARED_RAM	0x0048 0000 - 0x004B FFFC
FEC_CPU_SHARED_RAM	0x2120 8000 - 0x2121 FFFC

When shared with M3/M4, the incoming data bit width is 32 bit as shown in the diagram. So, depending on LSB of address, signals are sent to either left or right ECC wrapper.

1. Use shared memories as code memory when shared with processor.
2. Disable ECC for non functional safety devices – ECC is disabled for shared memories in RBL for non functional safety devices.
