## ABSTRACT

This document describes the known exceptions to the functional specifications (advisories).

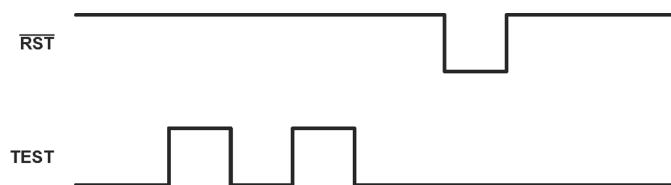
- Toggle the TEST pin twice when nRST is high and after 50us pull nRST low.

Note: This toggling of TEST pins is not subject to timing constraints. The appropriate level transitions on TEST pin, followed by a RST pulse after 50us, are sufficient to trigger an exit from BSL mode.
