ABSTRACT

This document describes the known exceptions to the functional specifications (advisories).

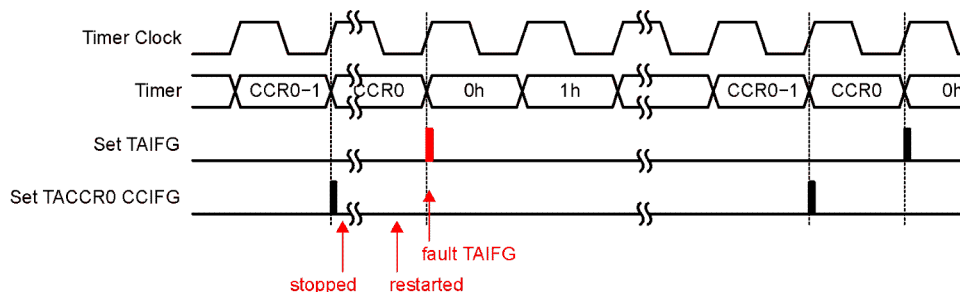
Function TAIFG Flag is erroneously set after Timer A restarts in Up Mode

Description In Up Mode, the TAIFG flag should only be set when the timer counts from TACCR0 to zero. However, if the Timer A is stopped at TAR = TACCR0, then cleared (TAR=0) by setting the TACLRL bit, and finally restarted in Up Mode, the next rising edge of the TACLK will erroneously set the TAIFG flag.

Workaround None.
