Errata
MSP430F4361 Microcontroller

ABSTRACT

This document describes the known exceptions to the functional specifications (advisories).

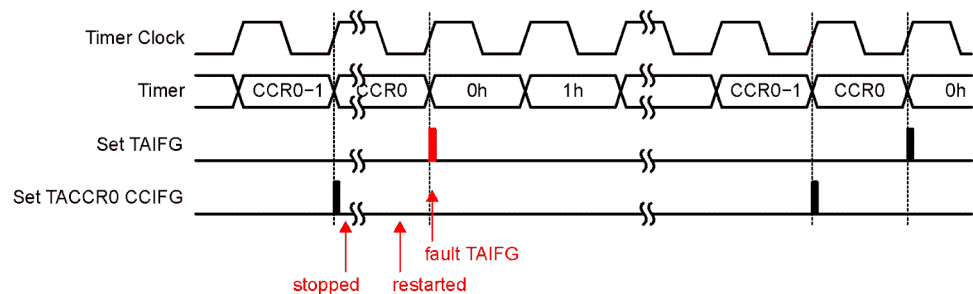
TA21 *TA Module*

Function TAIFG Flag is erroneously set after Timer A restarts in Up Mode

Description In Up Mode, the TAIFG flag should only be set when the timer counts from TACCR0 to zero. However, if the Timer A is stopped at $TAR = TACCR0$, then cleared ($TAR=0$) by setting the TACLR bit, and finally restarted in Up Mode, the next rising edge of the TACLK will erroneously set the TAIFG flag.

Workaround None.

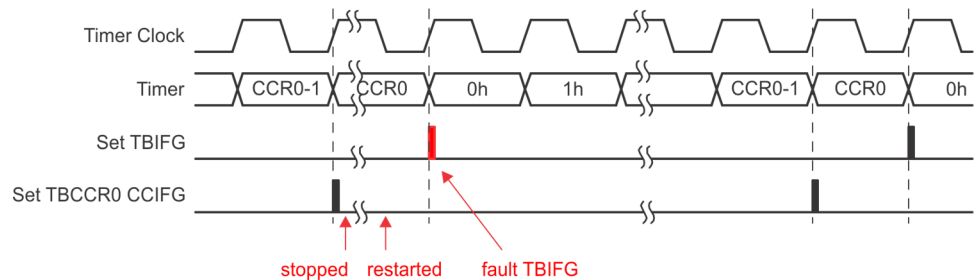
TB24 ***TB Module***

Category	Functional
Function	TBIFG Flag is erroneously set after Timer B restarts in Up Mode
Description	In Up Mode, the TBIFG flag should only be set when the timer resets from TBCCR0 to zero. However, if the Timer B is stopped at TBR = TBCCR0, then cleared (TBR=0) by setting the TBCLR bit, and finally restarted in Up Mode, the next rising edge of the TBCLK will erroneously set the TBIFG flag.

Workaround	None.
-------------------	-------
