Errata  
**MSP430FE423 Microcontroller**

This document describes the known exceptions to the functional specifications (advisories).

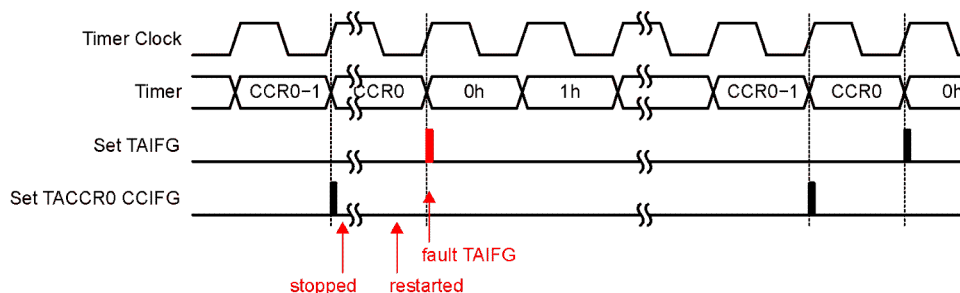
**TA21** *TA Module*

**Function** TAIFG Flag is erroneously set after Timer A restarts in Up Mode

**Description** In Up Mode, the TAIFG flag should only be set when the timer counts from TACCR0 to zero. However, if the Timer A is stopped at TAR = TACCR0, then cleared (TAR=0) by setting the TACLR bit, and finally restarted in Up Mode, the next rising edge of the TACLK will erroneously set the TAIFG flag.

**Workaround** None.
