Errata
MSP430G2855 Microcontroller

This document describes the known exceptions to the functional specifications (advisories).

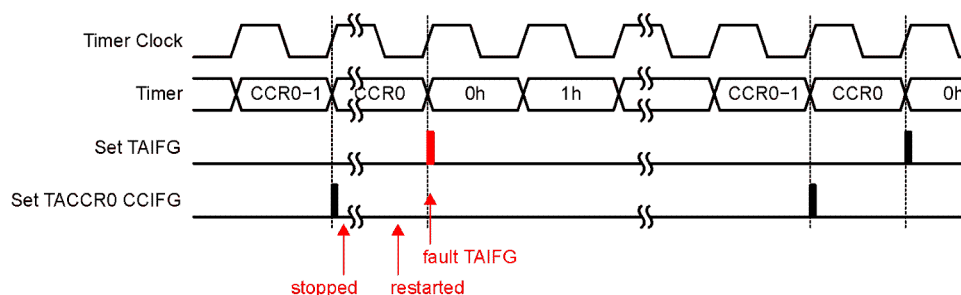
TA21 *TA Module*

Function TAIFG Flag is erroneously set after Timer A restarts in Up Mode

Description In Up Mode, the TAIFG flag should only be set when the timer counts from TACCR0 to zero. However, if the Timer A is stopped at TAR = TACCR0, then cleared (TAR=0) by setting the TACLR bit, and finally restarted in Up Mode, the next rising edge of the TACLK will erroneously set the TAIFG flag.

Workaround None.

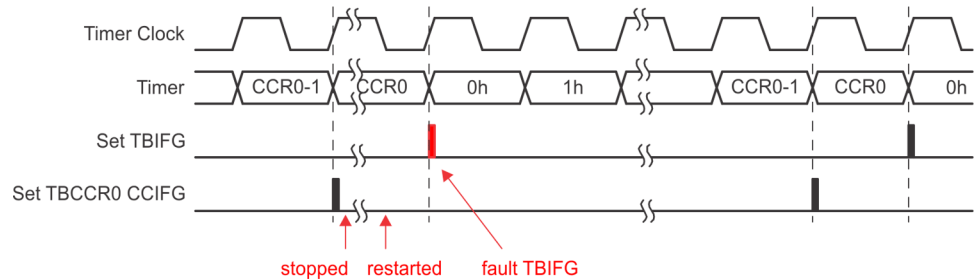
TB24 *TB Module*

Function TBIFG Flag is erroneously set after Timer B restarts in Up Mode

Description In Up Mode, the TBIFG flag should only be set when the timer resets from TBCCR0 to zero. However, if the Timer B is stopped at TBR = TBCCR0, then cleared (TBR=0) by setting the TBCLR bit, and finally restarted in Up Mode, the next rising edge of the TBCLK will erroneously set the TBIFG flag.

Workaround None.
