RM48x Microcontroller

Silicon Revision D

Silicon Errata

Literature Number: SPNZ223B
March 2015–Revised May 2016

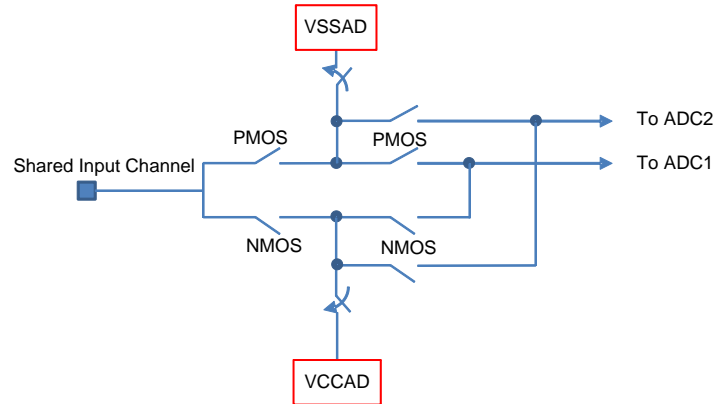
Figure 2. Shared Input Channel in "Open" State

The PMOS and NMOS switches are open indicating that this shared input channel is not currently being sampled either by ADC1 or by ADC2. Also, there are switches to VCCAD and VSSAD that are closed. If any current is injected into this analog input, any leakage through the open PMOS switch will be shunted to VSSAD. These switches to VSSAD and VCCAD are opened as soon as this shared input channel is being sampled by either ADC1 or ADC2.
