OMAP5912
Applications Processor
Silicon Errata

SPRZ209K
December 2003 – Revised December 2007

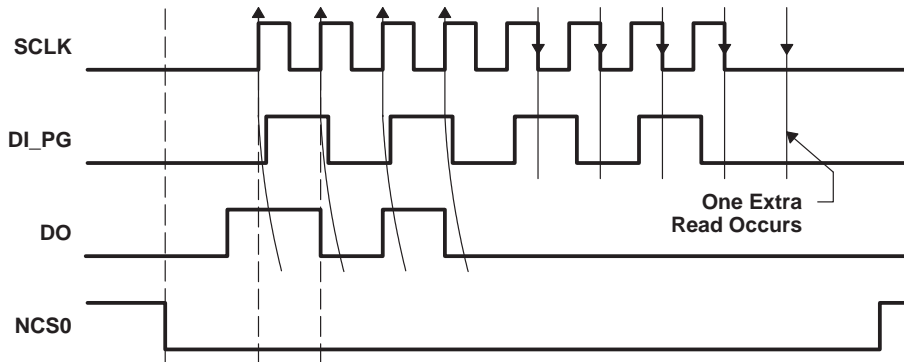
Figure 5. Write (4 Bits) on Rising/Read (4 Bits) on Falling (TX = 0xA, RX and 0x1F = 0x14)

| | CSx_EDGE_RD = 0 CSx_EDGE_WR = 0 | CSx_EDGE_RD = 1 CSx_EDGE_WR = 1 | CSx_EDGE_RD = 0 CSx_EDGE_WR = 1 | CSx_EDGE_RD = 1 CSx_EDGE_WR = 0 |
|---|---|---|---|--|
| SCLK Inverted | <p>Data read on rising edge of SCLK. Data write on rising edge of SCLK.</p> <p>Delay of 2 SCLK cycles between last bit transmitted on rising edge and first bit captured on rising edge.</p> <p>No issue.</p> | <p>Data read on falling edge of SCLK. Data write on falling edge of SCLK.</p> <p>Delay of 2 SCLK cycles between last bit transmitted on falling edge and first bit captured on falling edge.</p> <p>No issue.</p> | <p>Data read on rising edge of SCLK. Data write on falling edge of SCLK.</p> <p>Delay of 1.5 SCLK cycles between last bit transmitted on falling edge and first bit captured on rising edge.</p> <p>Issue found: One extra bit is captured.</p> <p>Workaround: Ignore Bit 0 of the receive data register (shift right one bit). Note that this workaround does not work for a 16-bit data configuration (1 bit is lost).</p> | <p>Data read on falling edge of SCLK. Data write on rising edge of SCLK.</p> <p>Delay of 2.5 SCLK cycles between last bit transmitted on rising edge and first bit captured on falling edge.</p> <p>Issue found: First bit captured will start 2.5 SCLK cycles after the last bit sent instead of 1.5 SCLK as defined in the specifications.</p> <p>Workaround: Do not use this configuration.</p> |

Workaround:

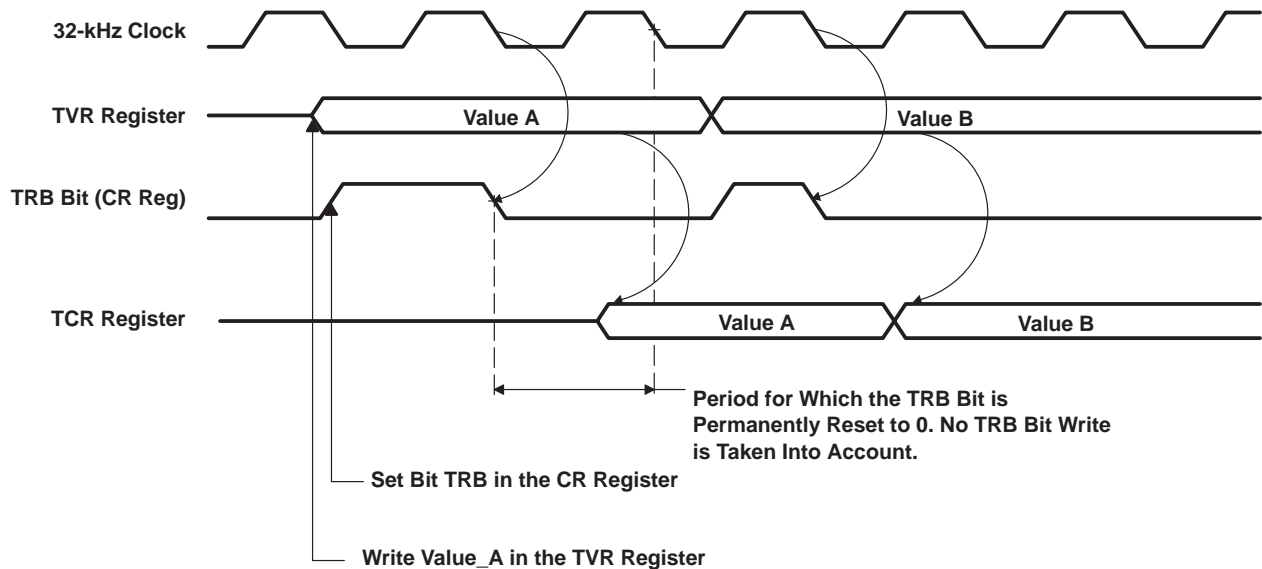
Figure 11. TRB Timing Diagram

Details: The Timer32K Reload Bit (TRB) is used to load the TCR register with the value contained in the TVR register. Once the TCR is loaded, the TRB bit should be automatically reset to '0'. The user should be able to use the TRB bit (by polling) to know when to load a new value in the TVR.

However (see Figure 11), the TRB bit is reset to zero by the falling edge of 32-kHz clock only after a maximum of 1.5 x 32-kHz clock period (or minimum 0.5 x 32-kHz clock period) after the TRB bit is set. The TCR register is loaded after a maximum of 2 x 32-kHz clock periods (or minimum of 1 x 32-kHz clock period) on the rising edge of the 32-kHz clock. After the TRB is reset, there is a one 32-kHz clock period where a new TRB setting will not be taken into account by the module. If the user programs the TVR and updates the TRB bit within this 32-kHz clock period, the new TVR will not be loaded correctly into the TCR.

Workaround: To load a new value into the TCR, poll the TRB bit. When the TRB is equal to '0' (signaling that the previous value has been loaded), the user has to wait for an additional one 32-kHz clock period, before loading a new value in the TVR and setting the TRB bit to '1'.

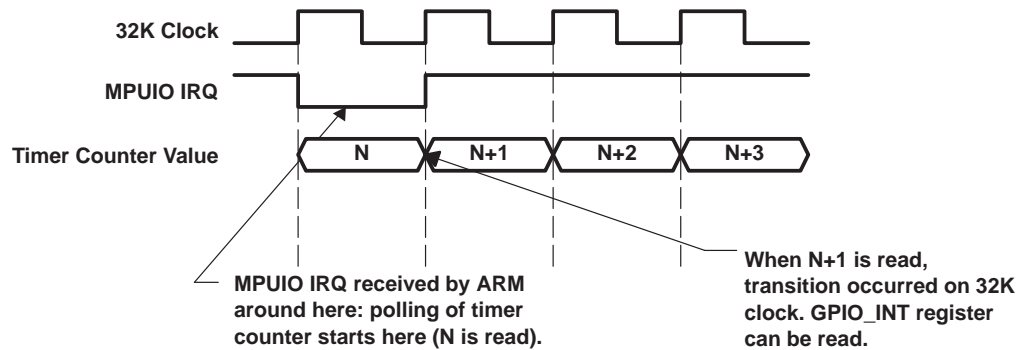
Figure 12. Polling the Timer 32k Timer

Details: The reset of the MPUIO GPIO interrupt is done asynchronously when a GPIO_INT register read occurs. The release of this reset is done synchronously with the ARM_XOR_CLK when the 32-kHz clock is high. A read of the GPIO_INT register while the 32-kHz clock is low or transitioning can result in a deadlock to the state machine that will cause all further interrupts subject to the MPUIO pin to be ignored.

Workaround: After receiving the MPUIO GPIO_INT, the MPU should observe the 32-kHz clock and then read the GPIO_INT register only just after a rising edge on the 32-kHz clock. There are different ways to detect a rising edge on the 32-kHz clock:

- Poll the timer 32k counter until there is an increment (see Figure 12, which describes the procedure)

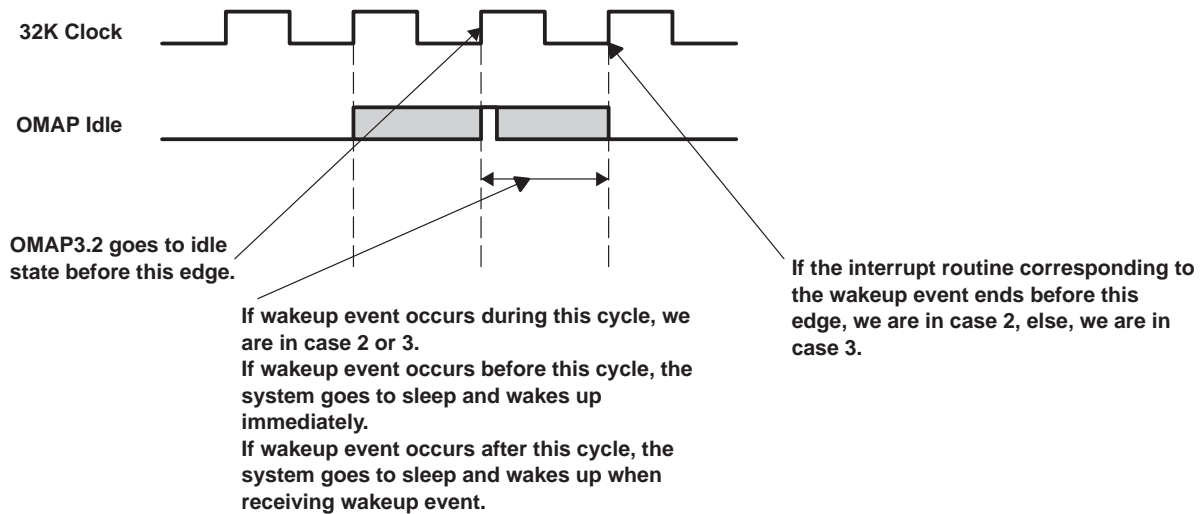
Figure 14. IDLECT1.WKUP_MODE = 1 Possible Effects

1. No noticeable problem. The system wakes up correctly.
2. The OMAP3.2 clock is shut down while the ARM is awake (possibly in the middle of an instruction fetch). The wakeup event is caught, and corresponding interrupt routine has time to complete before the ARM clock is shut down. The system will go to sleep and resume normal operation on the next wakeup event (first wakeup event will be treated at this time). Depending on the time when OMAP3.2 clock was shut down, instruction/data corruption is possible.
3. The OMAP3.2 clock is shut down while the ARM is awake (possibly in the middle of an instruction fetch). The wakeup event is caught, but corresponding interrupt routine does not have time to complete before ARM clock is shut down. The system will resume normal operation. Depending on the time when OMAP3.2 clock was shut down, instruction/data corruption is possible.

Figure 14 summarizes briefly the conditions under which case 1, 2, and 3 may happen.

Workaround: The IDLECT1.WKUP_MODE bit should always be 0 in all OMAP5912 devices.

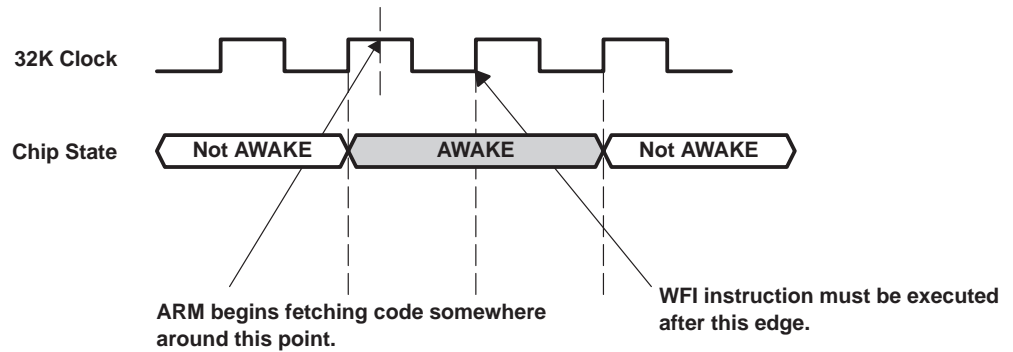
Figure 15. Minimum AWAKE Window Needed for Proper Operation

Details: When the system goes out of deep or big sleep, at least one 32K clock rising edge must occur before the WFI instruction is executed again. If this does not occur, the ULPD will stay in the awake state, and OMAP5912 will remain in idle mode. This will cause the system to hang. The only way to restore the system is to perform power-on reset or MPU reset.

Workaround: The Minimum AWAKE window is needed for proper operation. Software needs to make sure that one 32K clock rising edge occurs between wake up of the device and next WFI instruction execution. This can be done by monitoring 32K counter value.

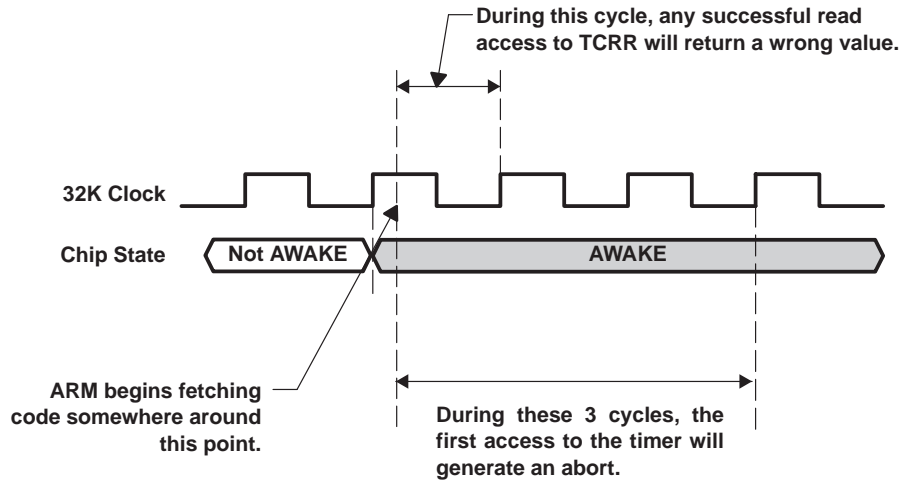
Figure 16. DM Timer Access Timings After Wake Up From Deep Sleep (Functional Clock is 32K Clock)

Details: The following sequence of events may cause a fail on a dual-mode timer's first access:

If the dual-mode timer functional clock is configured to be a 32-kHz clock, then this time can be significantly longer than the time it takes for the MPU to do an access to the dual-mode timer. In which case, if one of the first operations software performs after wakeup is an access to dual-mode timer, then the access is very likely to fail.

Workaround:

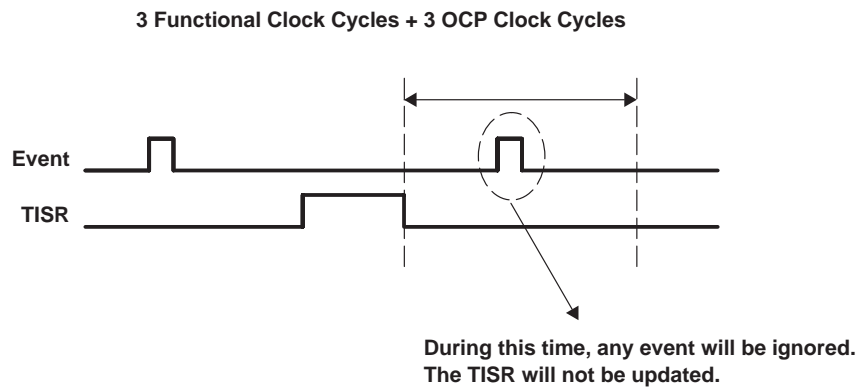
Figure 17. DM Timer Event Ignored Window

After the interrupt gets acknowledged by the TISR and after 3 functional clock cycles + 3 OCP clock cycles, any event of the same type other than the one initially processed, will be ignored, and the corresponding interrupt will be not generated (see Figure 17).

This problem does not occur if the event has a different type: it will be kept in the TISR.

Workaround: There is no workaround.
