TMS320DM647/DM648 Digital Media Processors

Silicon Errata

Literature Number: SPRZ263G
May 2007–Revised November 2011

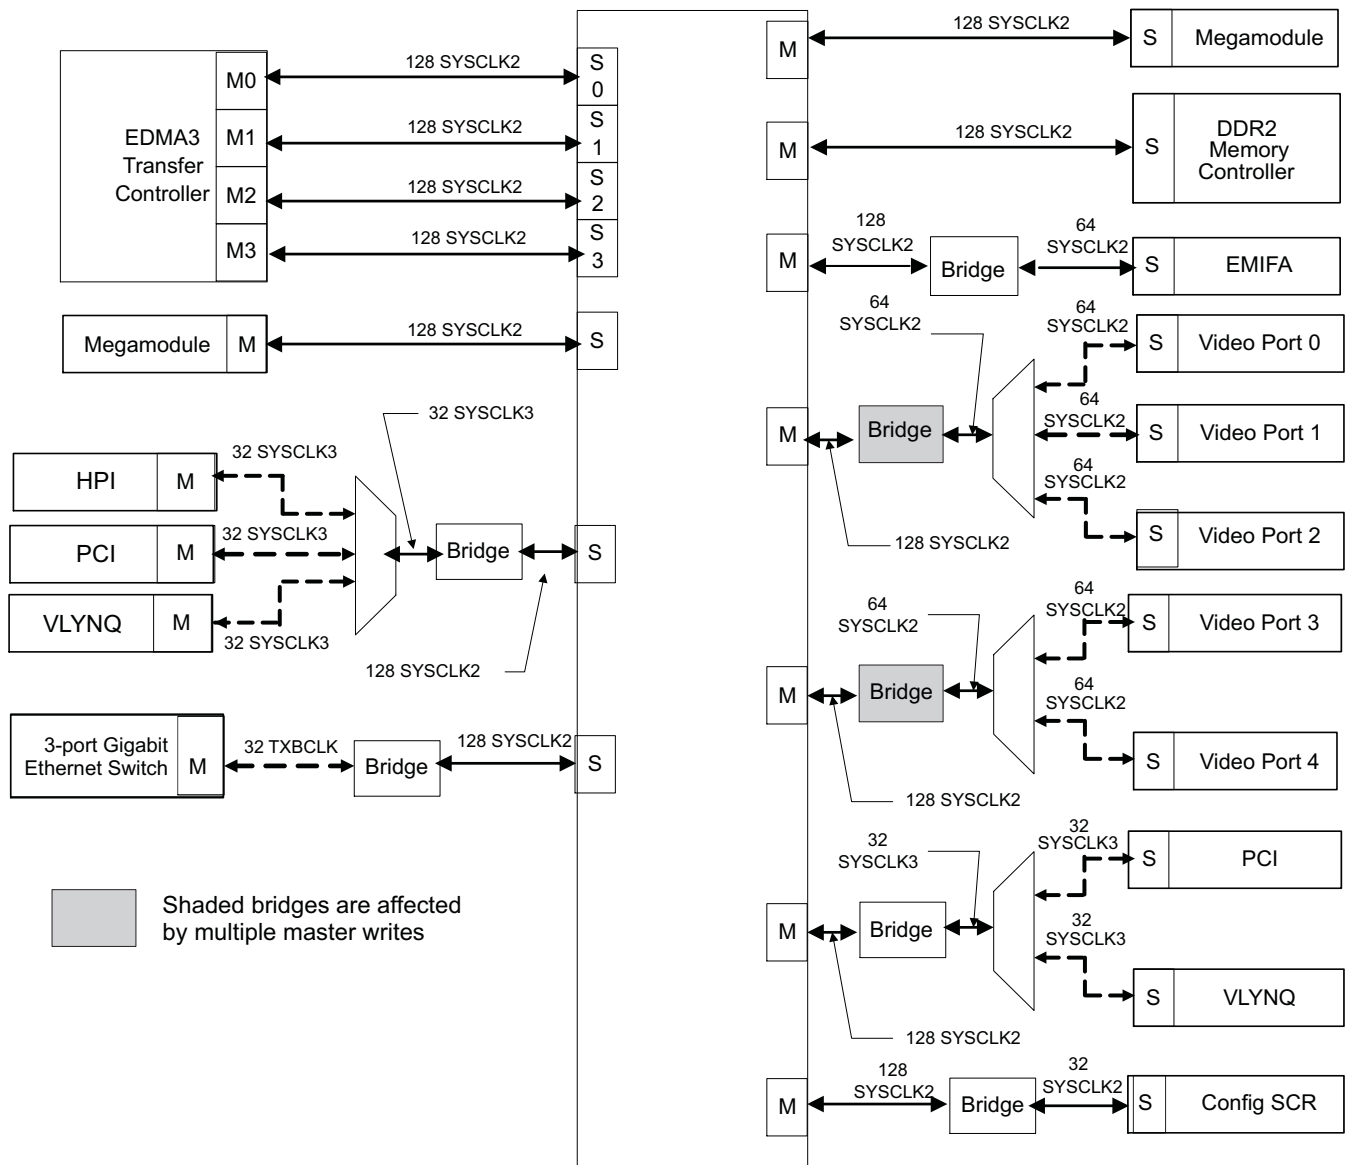
Figure 2. Data SCR (with shading to show affected bridges)

Certain peripheral groups are susceptible to data corruption when multiple masters write to members of the group due to a bridge in the path. On this device there are two groups that are susceptible to the problem. Group one consists of Video Port 0, Video Port 1, Video Port 2; group two consists of Video Port 3, Video Port 4.

Data corruption can happen only when multiple masters (e.g., different Transfer Controllers in the EDMA) write to members of an affected group. See the bridges affected in Figure 2. All read operations and writes from a single source are not affected. Therefore, all writes to members of a group must come from the same master. Different groups can safely have different write masters.

One software workaround is to prevent writing from multiple masters to the same group. For example, software must program a single EDMA port to issue writes to an affected

group as opposed to using 2 EDMA ports.

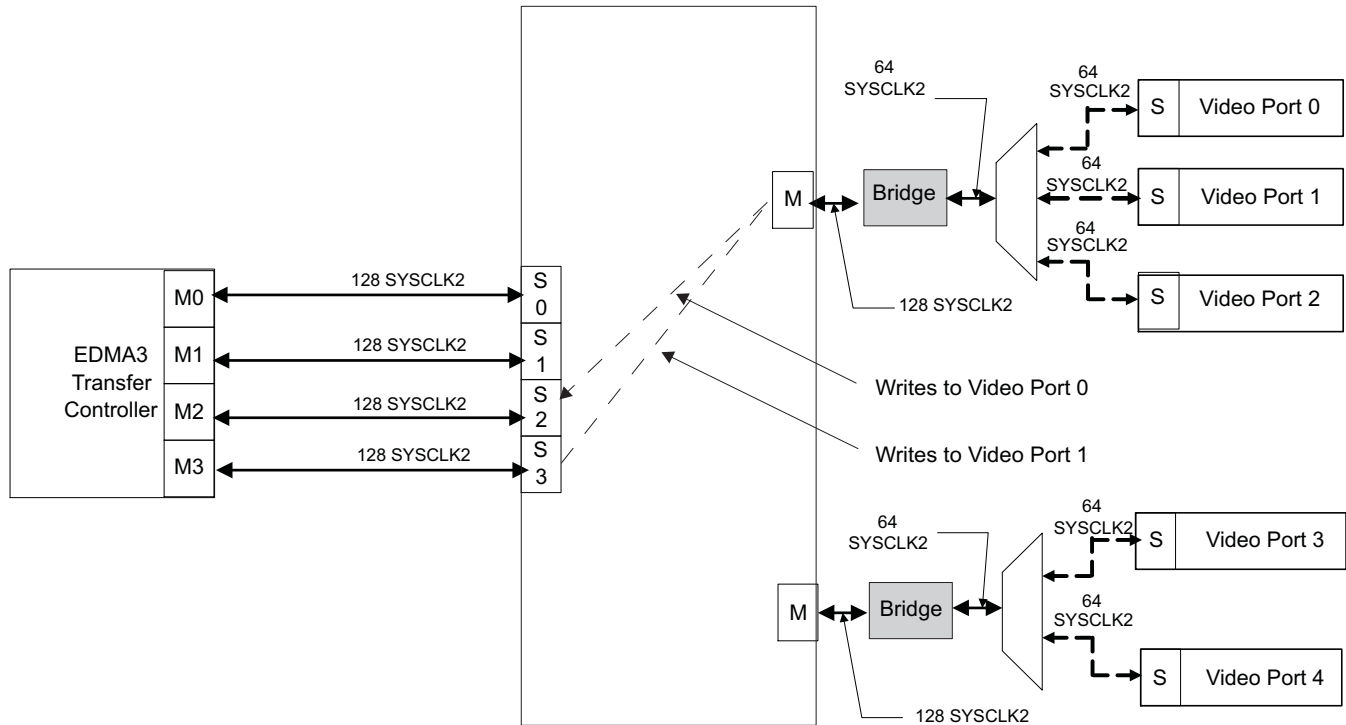
Figure 3. Scenario to Avoid

For example, if Video Port 0 and Video Port 1 are used in display mode and use EDMA3 Transfer Controller 2 for writes to Video Port 0 and EDMA3 Transfer Controller 3 for writes to Video Port 1, then displayed data in Video Port 0 or Video Port 1 or both may be corrupted.

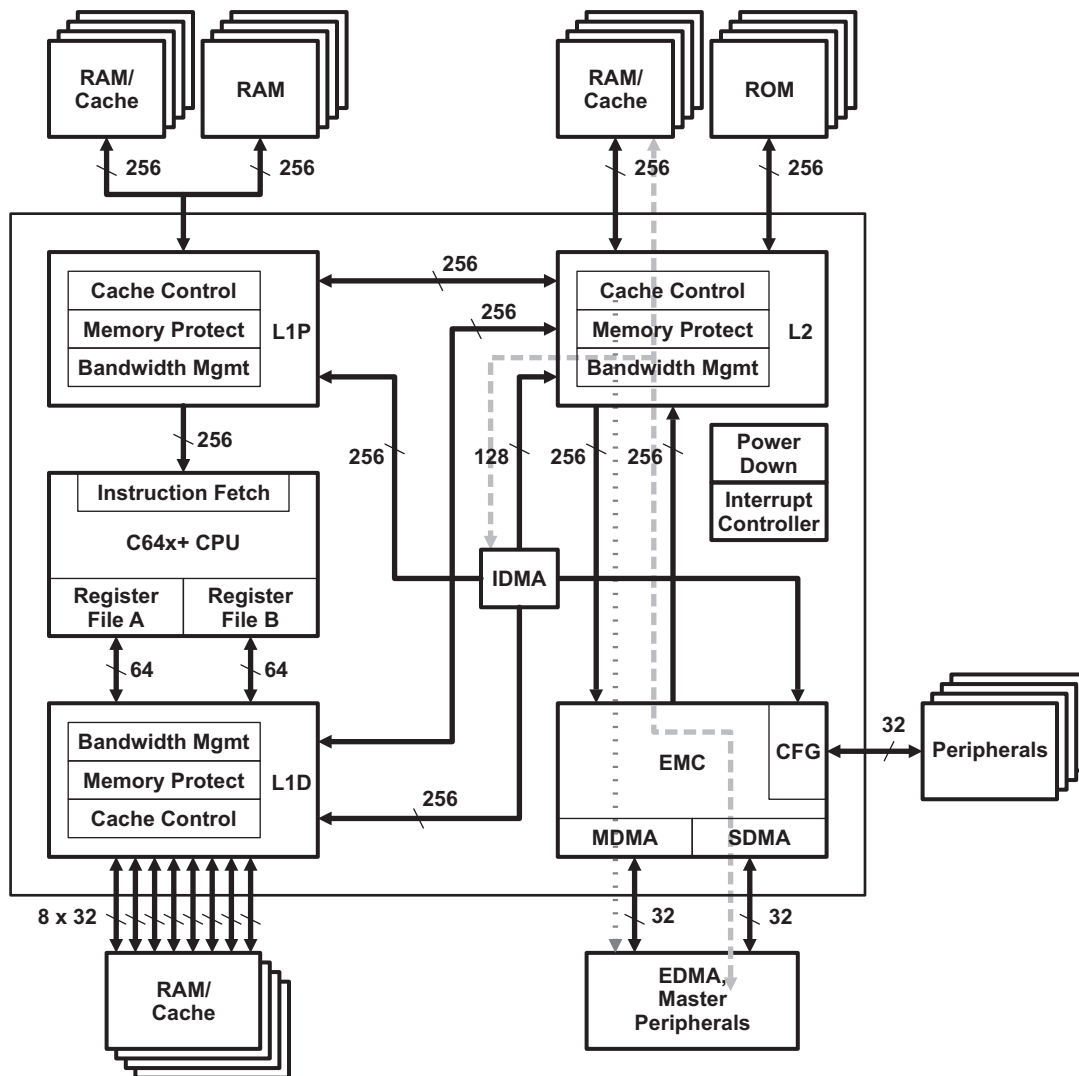
Figure 5. IDMA, SDMA, MDMA Paths

Ideally, the MDMA (dotted line in [Figure 5](#)) and SDMA/IDMA paths (dashed lines in [Figure 5](#)) operate independently with minimal interference. Normally, MDMA accesses may stall for extended periods of time due to expected system level delays (e.g., bandwidth limitations, DDR2 memory refreshes). However, when using L2 as RAM, SDMA and IDMA accesses to L2/L1 may experience unexpected stalling in addition to the normal stalls seen by the MDMA interface. For latency-sensitive traffic, the SDMA stall can result in missing real-time deadlines. In a more severe case, the SDMA stall can produce a deadlock condition in the device. An IDMA stall cannot produce a deadlock condition.

[Figure 5](#) is provided for illustrative purposes and is incomplete for simplification. The SDMA/IDMA (dashed lines) path could also go to L1D/L1P memories and IDMA can go to DSP CFG peripherals. MDMA transactions can also originate from L1P or L1D through the L2 controller or directly from DSP.

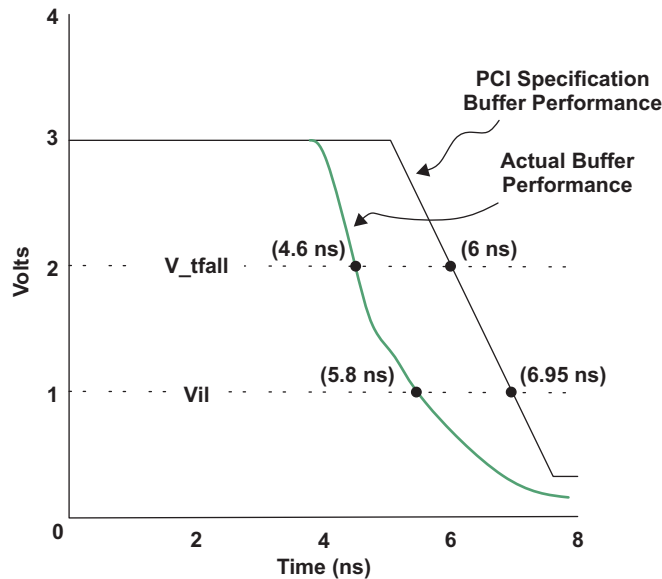
Figure 6. 66-MHz Buffer Slew and Timing Performance vs Specification Performance

PARAMETER	PCI SPECIFICATION VALUE	ACTUAL VALUE
Tval, maximum (33 MHz)	11 ns	6.8 ns
Tval, maximum (66 MHz)	6 ns	4.6 ns

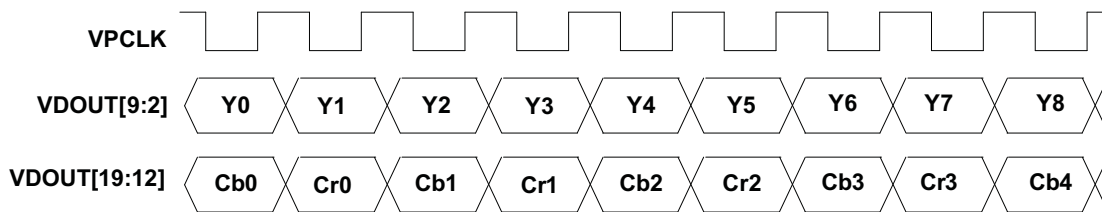
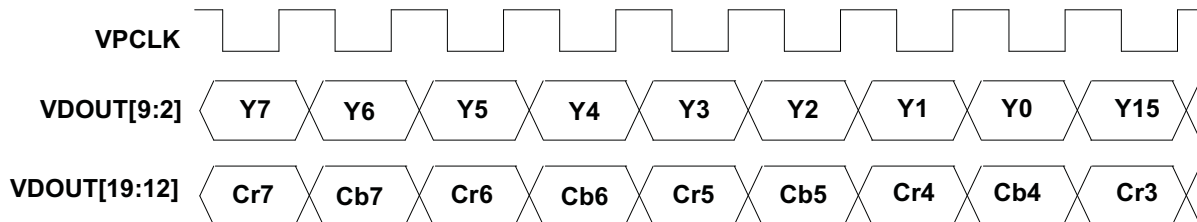
Figure 7 shows an example of what is expected out of Video Port in 8-bit Y/C display and Figure 8 and shows the actual output.

Figure 7. Expected Data at the VDOOUT Pins for Y/C 8-bit Display

Figure 8. Actual Data at the VDOOUT Pins for Y/C 8-bit Display
