AM389x Sitara™ ARM® Microprocessors (MPUs) Silicon Revisions 2.1, 2.0, 1.1, 1.0

Silicon Errata

Literature Number: SPRZ327H
November 2010–Revised March 2015

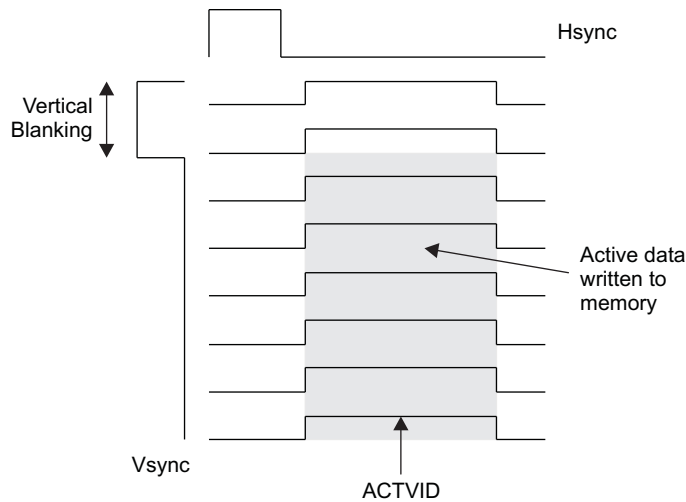
Figure 3. ACTVID Signal Active for All Lines of Incoming Data

Details: The VIP port supports a discrete sync capture mode where the ACTVID signal is used to determine the active region of the video and then the VPDMA writes this active video frame to memory. However, with some external video decoders, this mode does not work by default.

Workaround: The VIP parser requires that the ACTVID signal is active for all lines of the incoming data, including the vertical blanking region. The vertical blanking region, itself, is not written to memory by the VPDMA. [Figure 3](#) illustrates this.

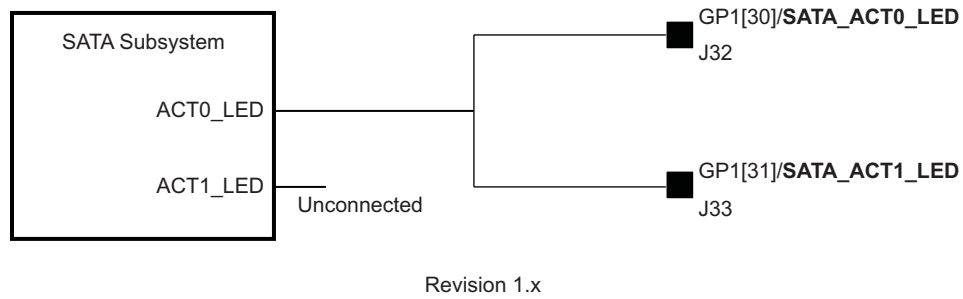
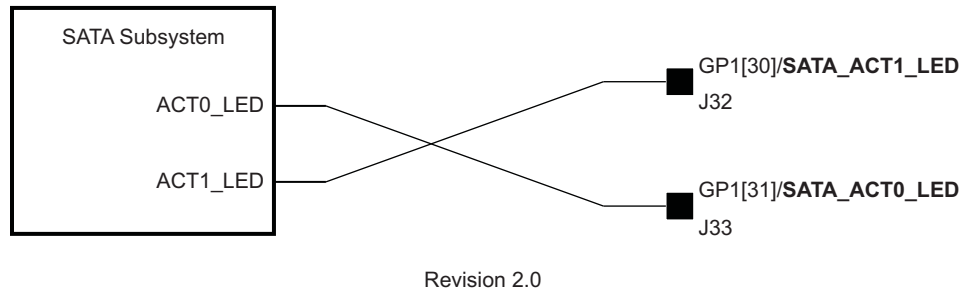
Figure 4. SATA Activity LED Connectivity

This issue is corrected on revision 2.0, but with the output pins reversed. SATA_ACT1_LED is mapped to pin J32 and SATA_ACT0_LED to pin J33 (see [Figure 4](#)).
