F29H85x and F29P58x Real-Time MCUs Silicon Errata (Silicon Revision 0)

ABSTRACT

This document describes the known exceptions to the functional specifications (advisories). This document may also contain usage notes. Usage notes describe situations where the device's behavior may not match presumed or documented behavior. This may include behaviors that affect device performance or functional correctness.

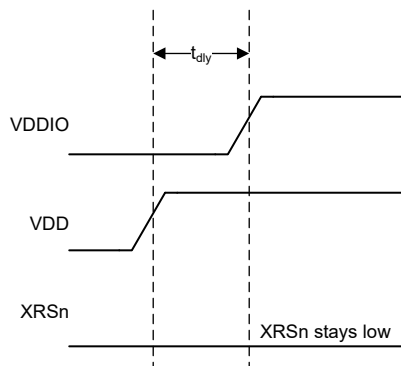
Figure 3-3. Incorrect Power-up Sequence Leading to Stuck Reset

The device XRSn reset signal can remain in a low (reset asserted) state when the VDD supply voltage is ramped up before or simultaneously with the VDDIO supply. As a result, the device fails to boot, and draws a large current on the VDD supply.

Ensure the VDDIO supply is fully ramped up at least 1ms before ramping up the VDD supply voltage.
