Errata

AWR1443 DeviceSilicon Errata
Silicon Revisions 1.0, 2.0, and 3.0

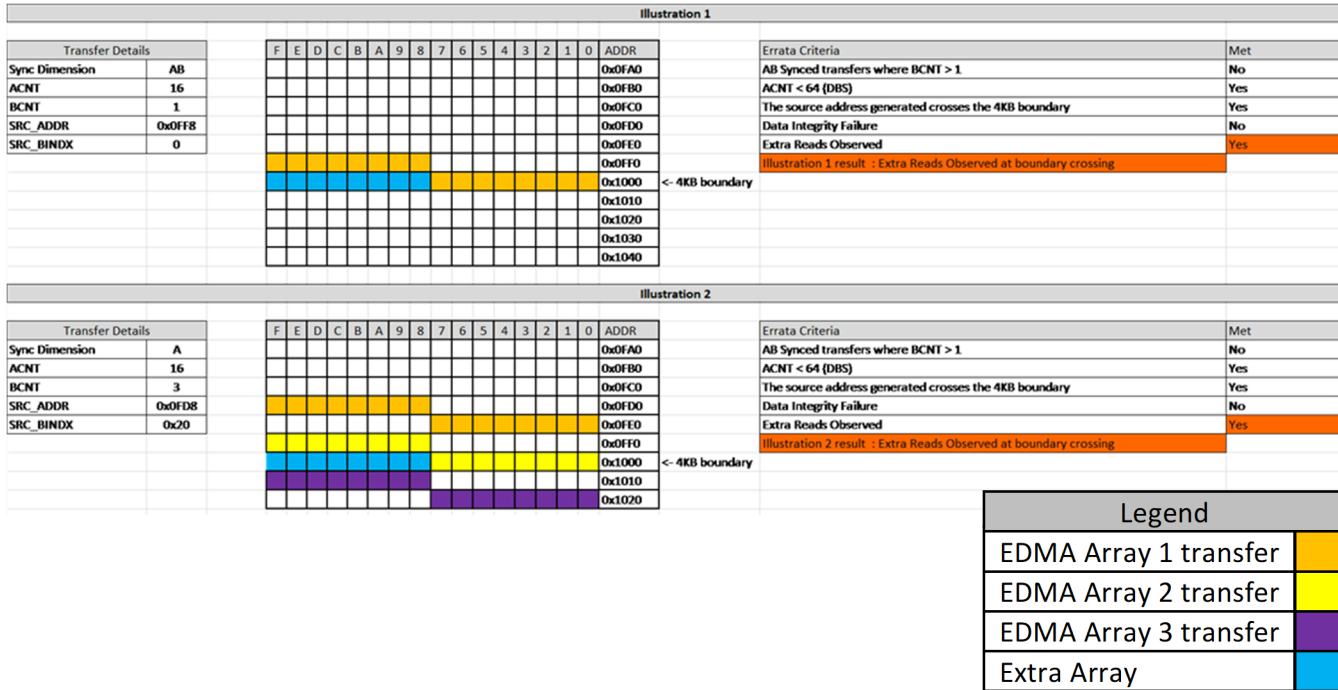
Figure 6-1. Scenario ID #3 – Extra Reads

For each extra read in **Scenario ID #3** for which **Condition [1]** is applicable, each index i above that satisfies the condition results in extra read from starting address SRC_ADDR + (i + 1) * SRCBIDX and of length equal to the distance from the start address to the boundary [that is, 0x1000 – X(i)]. Note: length < ACNT.

For **Scenario ID #3, Scenario ID #4, and Scenario ID #5**– EXTRA READS, another workaround besides avoiding the 4-KB boundary cross conditions, is to ensure that buffers involved in this kind of transfer are positioned so that extra reads stay within the physical memory boundaries. If the extra reads go to Reserved space or space blocked by the Memory Protection Unit (MPU), the TPTC generates a bus error interrupt to the processor.

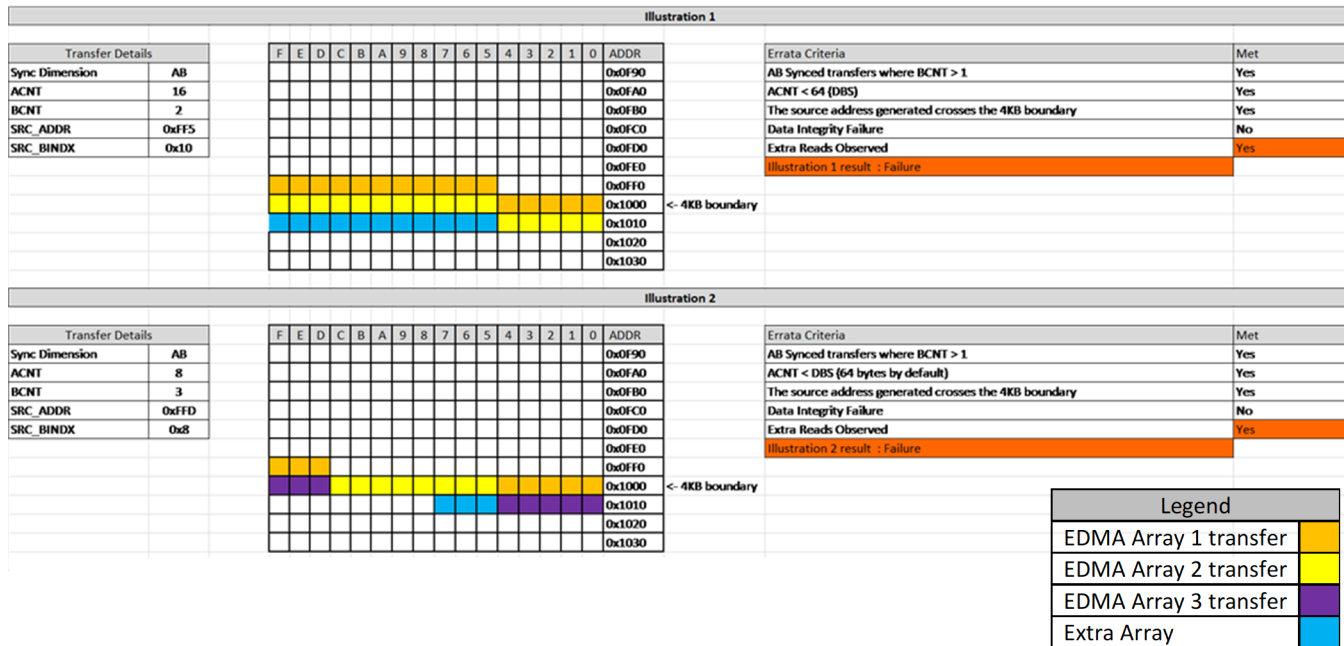
Figure 6-2. Scenario ID #4 – Extra Reads

For each extra read **Scenario ID #4** in for which **Condition [1]** is applicable, there is an extra read from starting address SRC + BCNT * ACNT (=SRCBIDX) of length equal to the distance of the start address to the boundary [that is, length is 0x1000 – X(i)], where i is the index of one and only 4-KB boundary crossing condition. Note: length < ACNT.

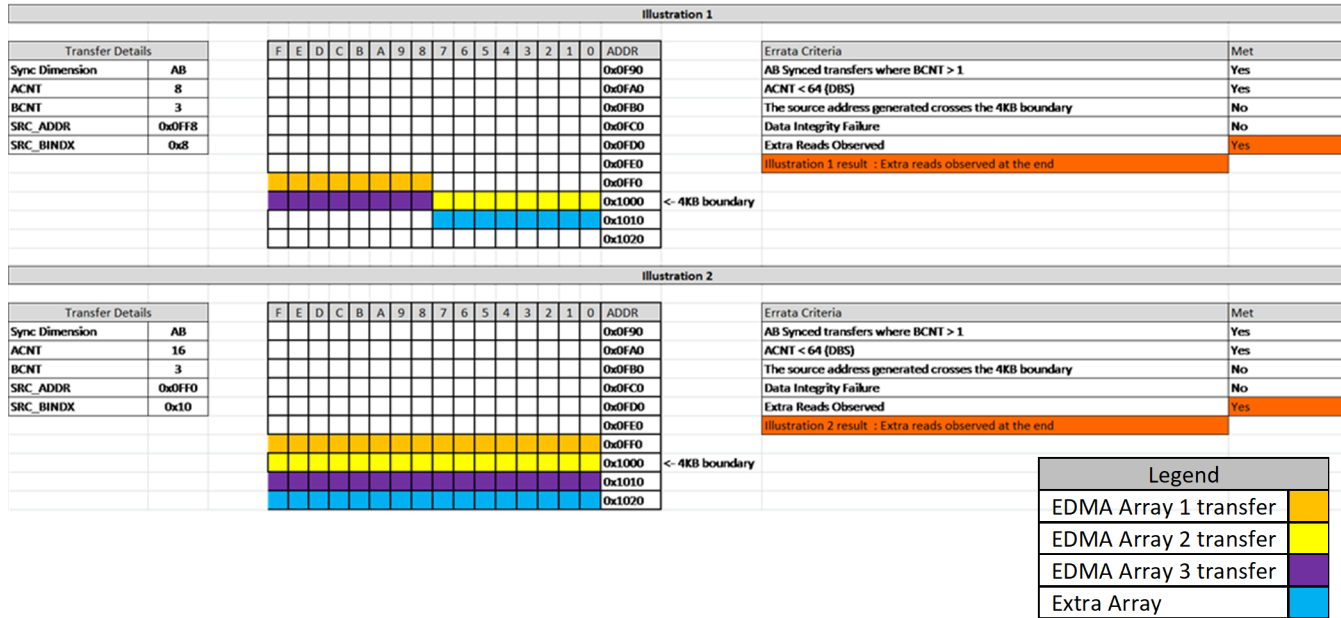
Figure 6-3. Scenario ID #5 – Extra Reads

For the extra read **Scenario ID #5** in for which **Condition [2]** is applicable, there is an extra read from starting address SRC + BCNT * ACNT (=SRCBIDX) of length equal to the distance of the start address and is of length ACNT.
