TMS320F280015x Real-Time MCUs Silicon Errata

Silicon Revisions B, A, 0

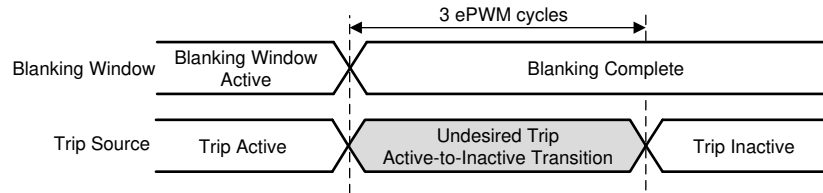
Figure 3-1. Undesired Trip Event and Blanking Window Expiration

Details The blanking window is typically used to mask any PWM trip events during transitions which would be false trips to the system. If an ePWM trip event remains active for less than three ePWM clocks after the end of the blanking window cycles, there can be an undesired glitch at the ePWM output.

Figure 3-1 illustrates the time period which could result in an undesired ePWM output.

Workaround Extend or reduce the blanking window to avoid any undesired trip action.
