AM574x, AM576x Sitara™ Processors Silicon Revision 1.0

Errata

Literature Number: SPRZ447E
JULY 2017 – REVISED JULY 2024

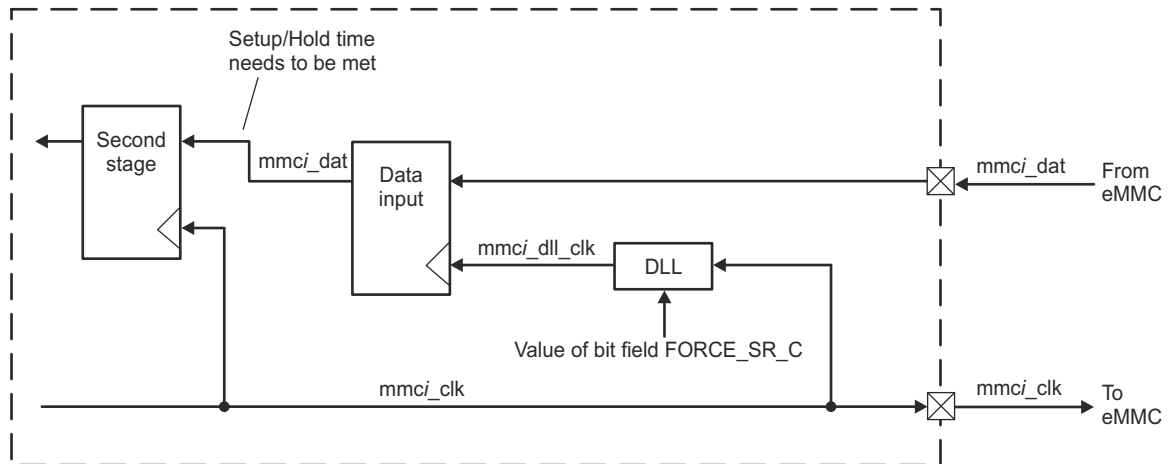
Figure 2-1. Simplified SoC 192-MHz Mode DLL Block Diagram

DESCRIPTION Internal to the MMC module, a second stage latch is used to recapture data captured by DLL delayed clock, `mmc_i_dll_clk`. The second stage latch captures with the original transmitting clock, `mmc_i_clk`.

`mmc_i_dll_clk` and `mmc_i_clk` both run at the same clock frequency. This results in a narrow range of tuning ratio elements, where the delayed `mmc_i_dll_clk` comes in phase with `mmc_i_clk`. If the clocks are in phase, the data captured by the first clock violates the setup and hold time requirements needed for the second stage latch, resulting in incorrectly read data. This is known as tuning re-timing errors.

A DLL tuning algorithm has been implemented that can avoid the tuning re-timing errors. More details on this can be found in App Note [SPRACA9](#). The following notes summarize the updated algorithm:

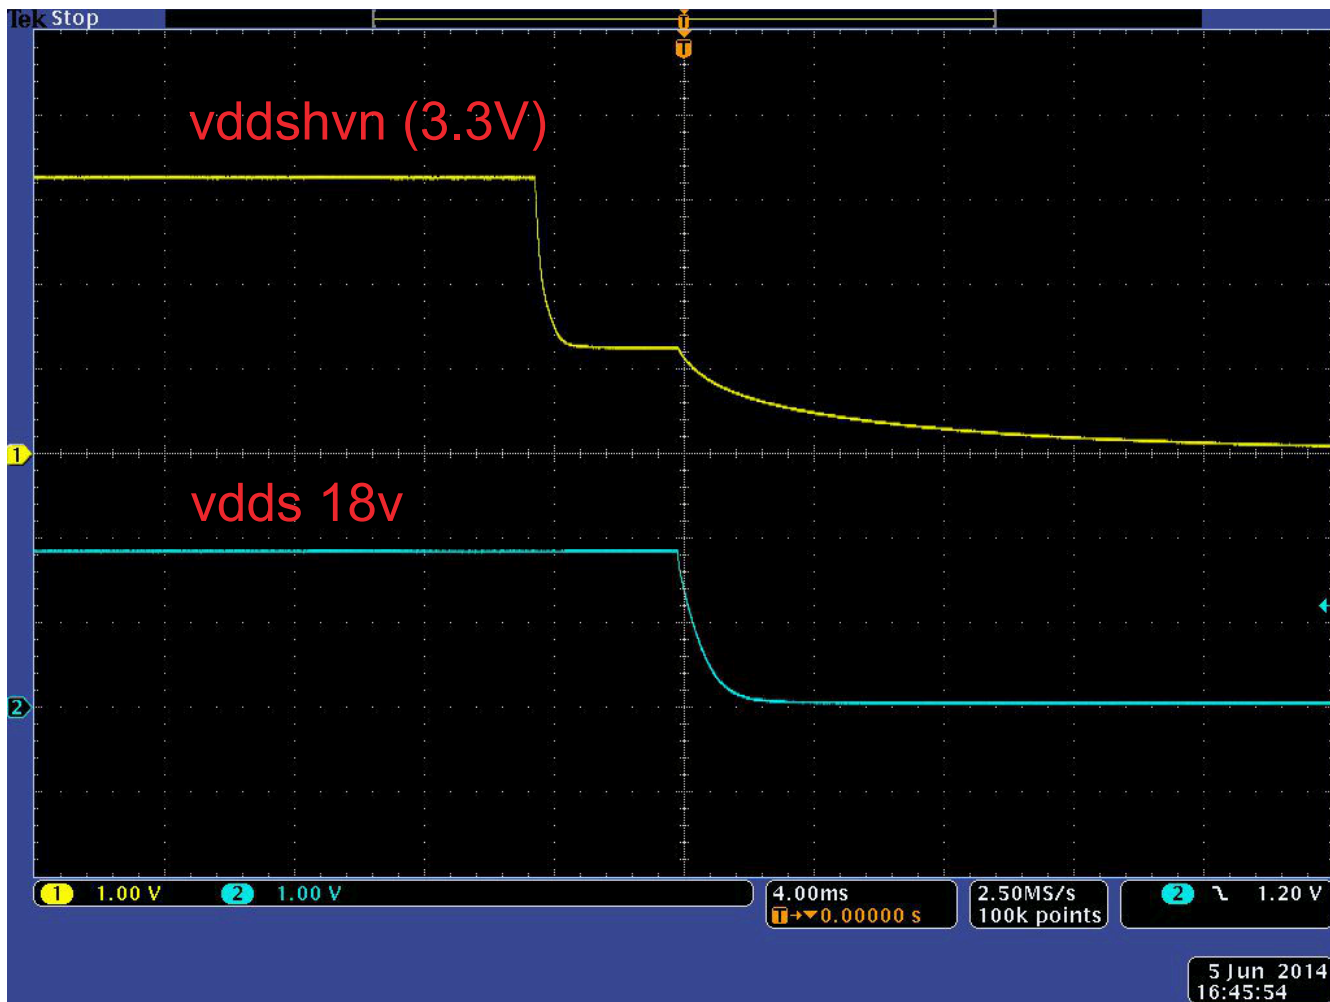
Figure 4-1. PAB_RevA

The Data Manual allows the vddshvn rail (in either 3.3V or 1.8V mode) to power down at the same time or before the vdds18v rail. When the vddshvn rail is powered down before the vdds18v rail, the vddshvn rail stays at Plateau Level (<1.5V) until the vdds18v rail is disabled, as shown in the waveform below.

A subset of the SOC's LVCMOS IOs (refer to DM for details) have a pull-up resistor that is active by default, including during reset and power-down. The SOC's IOs that have internal or external pull-ups will stay at Plateau Level (<1.5V) during the power-down. If other ICs on the board that are interfaced to the SOC's LVCMOS signals use a separate supply then it's possible that the other IC's signals can be pulled to the Plateau Level while its power supply is off.

The root cause of the plateau is related to the LVCMOS IO buffer Dual Voltage detection circuitry. The LVCMOS Dual Voltage IO includes voltage comparator circuitry to determine

In general, TI recommends using the same supply source for connected components. E.g., a single LDO should drive vddshvn and the related 3.3V external components.

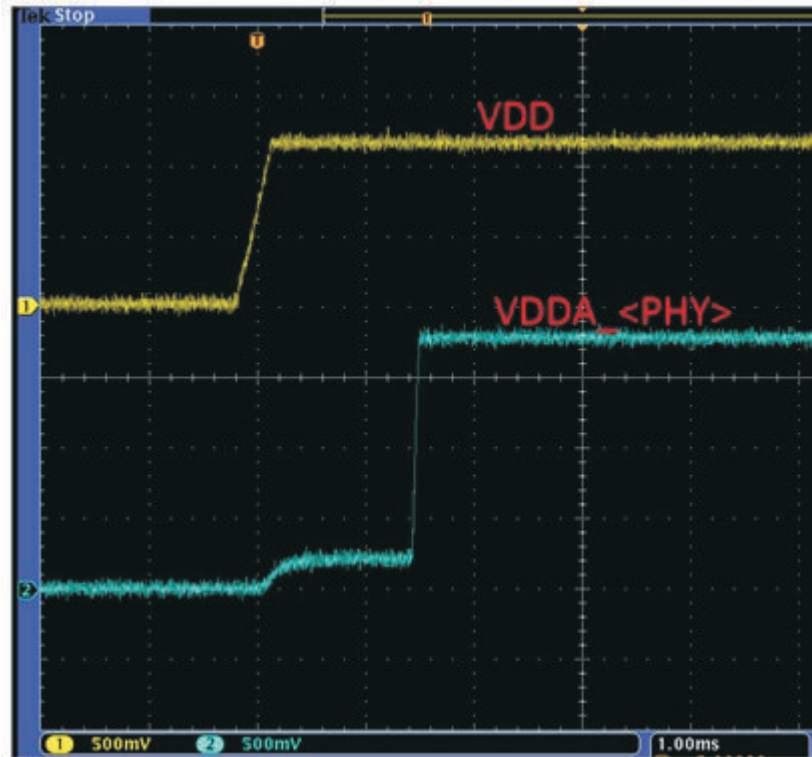
Figure 4-2. Leakage Voltage

A current path exists between VDD and the high speed analog PHY domain (VDDA_HDMI, VDDA_PCIE, VDDA_SATA, VDDA_USB2/3) during the supply power up and power down sequences.

The device-specific Data Manual requires Core AVS rail (VDD) to power up before the 1.8 V high speed analog PHY domain(s). When this sequence is followed, the high speed analog PHY domain will have a small step-up to a voltage plateau (< 0.5 V) that aligns to the beginning of the VDD ramp-up, and is maintained until the ramp-up of high speed analog PHY rail, as shown in [Figure 4-2](#). Note the leakage value will differ from system to system, but will be less than 500 mV. The leakage voltage in the provided capture is approximately 250 mV.

A similar condition exists during supply power down sequence. The high speed analog PHY domain(s) are required to be powered down prior to Core AVS rail (VDD), and may cause a small plateau to exist until Core AVS rail (VDD) is ramped down.

The root cause of the voltage plateau during power-up/down sequencing is related to the parasitic diodes in logic blocks which have multiple power sources. This leakage path is not a reliability concern for this device.
