ABSTRACT

This document describes the known exceptions to the functional specifications (advisories). This document may also contain usage notes. Usage notes describe situations where the device's behavior may not match presumed or documented behavior. This may include behaviors that affect device performance or functional correctness.

1.1 Devices Supported

- AM62x
- AM625SIP

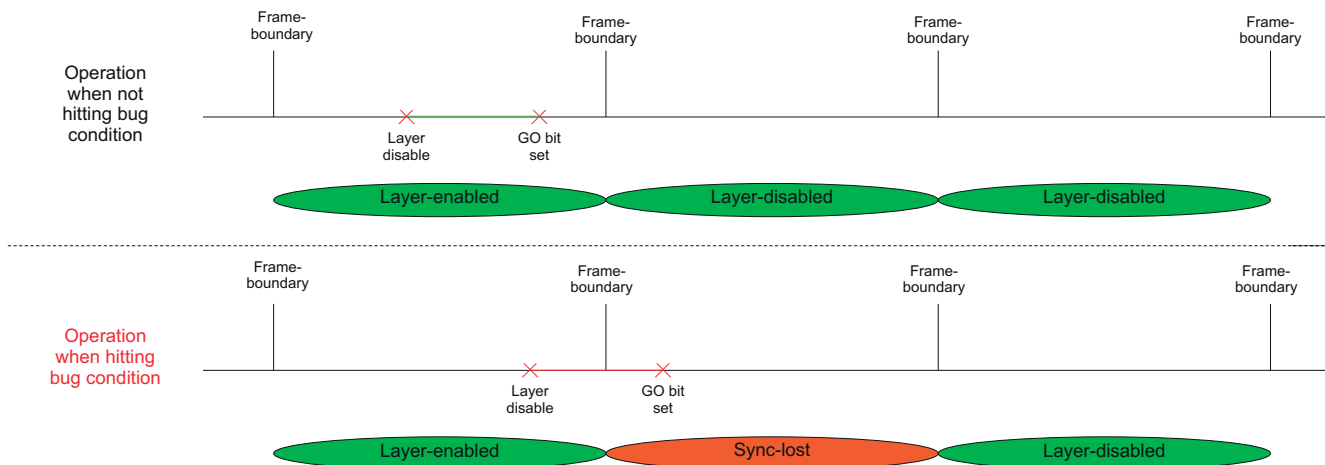
Figure 2-1. Bug Condition

Disabling a layer (for example VID1) connected to an OVR (that is toggling DSS_VID_ATTRIBUTESx[0] ENABLE from 1 to 0) may result in synclost during the next frame. The synclost may result in a corrupted or blank frame (all pixel data sent out of DSS during the frame is 0x0). The occurrence of synclost is dependent on the timing of setting the GO bit (that is DSS_VP_CONTROL[5] GOBIT to 1) vis-à-vis the disabling of the layer. If the “disable layer” MMR write operation and “set GO bit” MMR write operation happens within the same frame boundary, no synclost occurs. If the operations happen across the frame boundary, then synclost occurs (for one frame). The design automatically recovers and returns to normal operation from the next frame after GO bit is set, see [Figure 2-1](#).

A simple software workaround exists. In the workaround, prior to disabling a layer on the OVR, it is moved to the “non-visible” area of the OVR (for example: DSS_OVR_ATTRIBUTES_x[17-6] POSX = max_value_of_posx or DSS_OVR_ATTRIBUTES_x[30-19] POSY = max_value_of_posy). This avoids the synclost when the layer is disabled.

A sample software workaround pseudo-code is shown on [Figure 2-2](#). In this case, the regular “disable layer” MMR write operation and “set GO bit set” MMR write operation are replaced with macros which implement the software workaround.

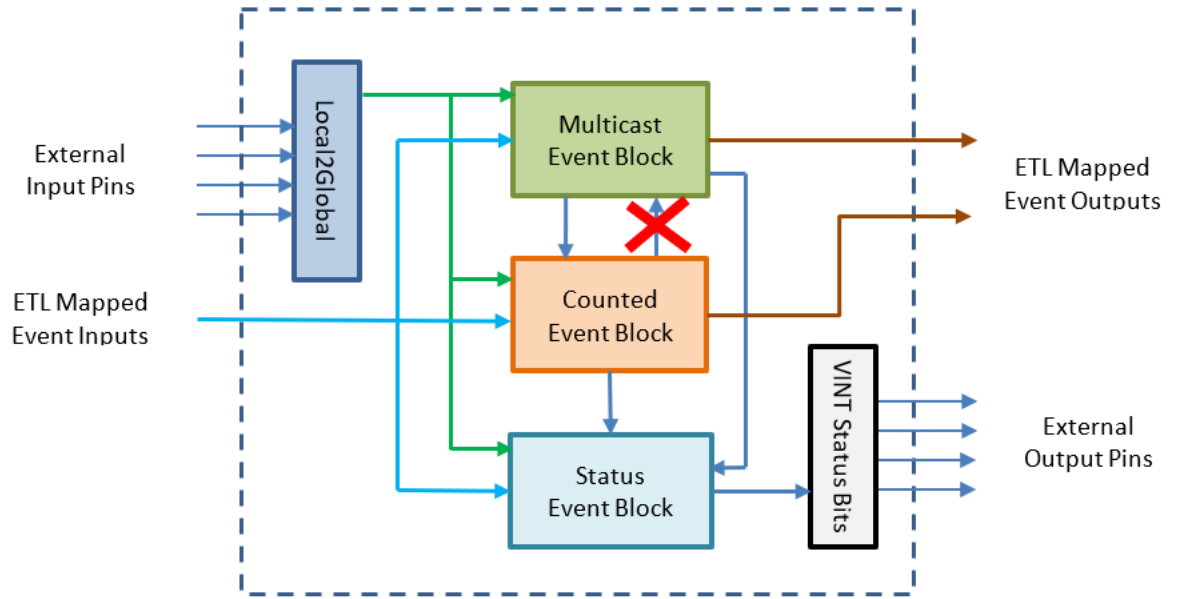
Figure 2-3. Interrupt Aggregator Version 1.0

An issue was found after design that could cause the IA to deadlock. The issue occurs when event “loops” occur between these three processing blocks. It is possible to create a situation where a processing block can not output an event because the path is blocked, and since it can not output an event, it can not take any new input events. This inability to take input events prevents the output path from being able to unwind, and thus both paths remain blocked.

[Figure 2-3](#) shows the conceptual block diagram of IA 1.0. Potential loops are avoided by adopting the policy of not allowing the counted event block to send events to the multicast block. This method was chosen because it is more common to split an event first, and then count one while sending the other elsewhere. With this path blocked by convention, it is not possible for a single event to visit any block more than once and thus not possible for paths to become blocked so long as the outputs remain unblocked.

By following the conventions outlined here, the system is safe from looping hazards that can create a deadlock scenario.
