**ABSTRACT**

This document describes the known exceptions to the functional specifications (advisories).

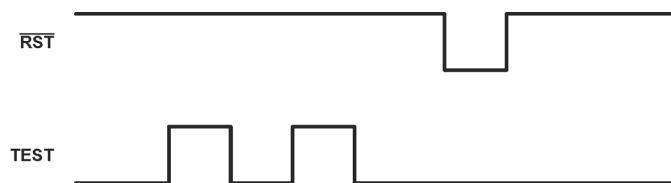
- Toggle the TEST pin twice when nRST is high and after 50us pull nRST low.

Note: This toggling of TEST pins is not subject to timing constraints. The appropriate level transitions on TEST pin, followed by a RST pulse after 50us, are sufficient to trigger an exit from BSL mode.
