ABSTRACT

This document describes the known exceptions to the functional specifications (advisories).

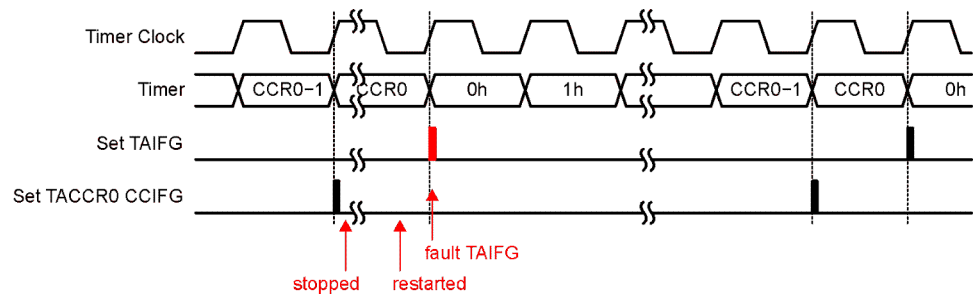
TA21 *TA Module*

Function TAIFG Flag is erroneously set after Timer A restarts in Up Mode

Description In Up Mode, the TAIFG flag should only be set when the timer counts from TACCR0 to zero. However, if the Timer A is stopped at TAR = TACCR0, then cleared (TAR=0) by setting the TACLRL bit, and finally restarted in Up Mode, the next rising edge of the TACLK will erroneously set the TAIFG flag.

Workaround None.

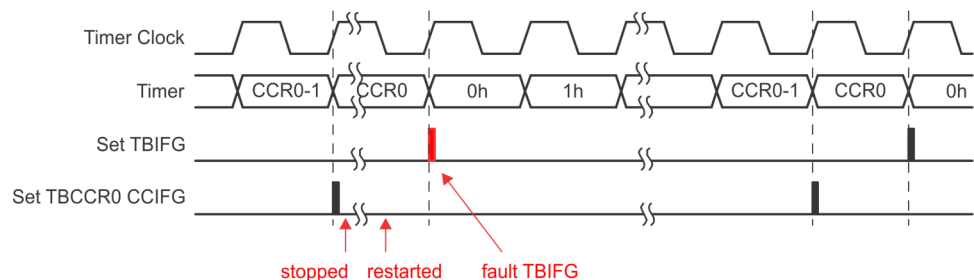
TB24 *TB Module*

Function TBIFG Flag is erroneously set after Timer B restarts in Up Mode

Description In Up Mode, the TBIFG flag should only be set when the timer resets from TBCCR0 to zero. However, if the Timer B is stopped at TBR = TBCCR0, then cleared (TBR=0) by setting the TBCLR bit, and finally restarted in Up Mode, the next rising edge of the TBCLK will erroneously set the TBIFG flag.

Workaround None.
