MSP430F4270 Device Erratasheet

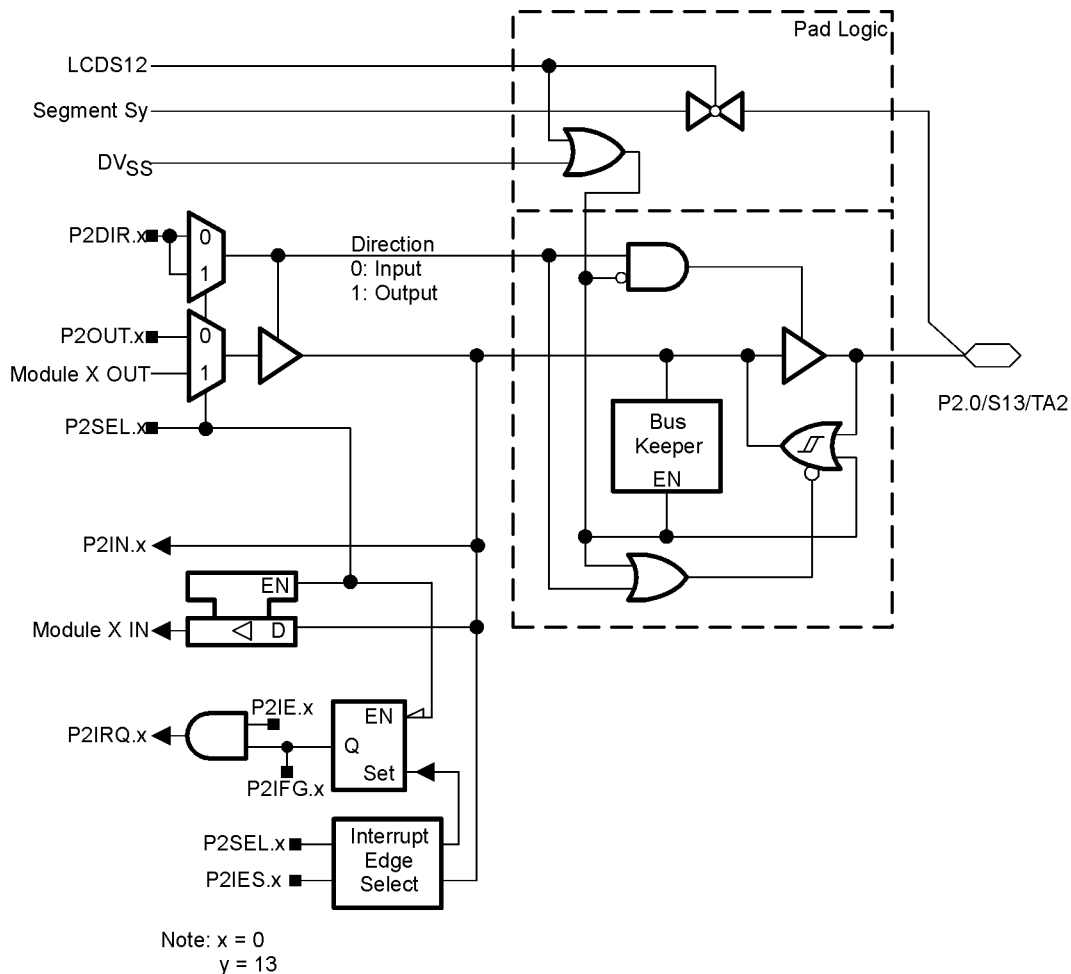
Function P2.0 module function

Description In addition to GPIO and LCD functionality, P2.0 also has Timer_A3 module output capability. When $\text{P2SEL.0} = 1$ and $\text{P2DIR.0} = 1$, P2.0 becomes a TA2 output.

Workaround N/A
