ABSTRACT

This document describes the known exceptions to the functional specifications (advisories).

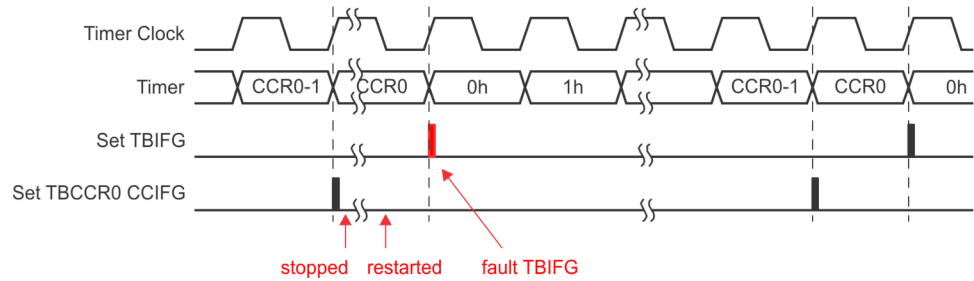
TB24

TBIFG Flag is erroneously set after Timer B restarts in Up Mode

In Up Mode, the TBIFG flag should only be set when the timer resets from TBCCR0 to zero. However, if the Timer B is stopped at TBR = TBCCR0, then cleared (TBR=0) by setting the TBCLR bit, and finally restarted in Up Mode, the next rising edge of the TBCLK will erroneously set the TBIFG flag.

None.
