## ABSTRACT

This document describes the known exceptions to the functional specifications (advisories).

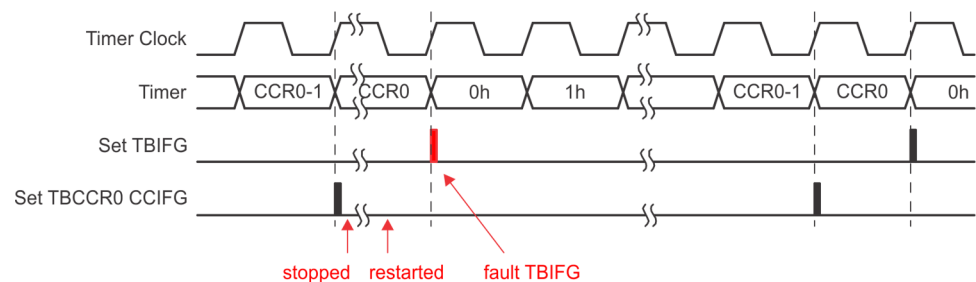
**TB24**
**TB Module**
**Category**

TBIFG Flag is erroneously set after Timer B restarts in Up Mode

In Up Mode, the TBIFG flag should only be set when the timer resets from TBCCR0 to zero. However, if the Timer B is stopped at  $TBR = TBCCR0$ , then cleared ( $TBR=0$ ) by setting the TBCLR bit, and finally restarted in Up Mode, the next rising edge of the TBCLK will erroneously set the TBIFG flag.

None.
