**TMS320VC5401**  
**Digital Signal Processor**  
**Silicon Errata**

*SPRZ004*  
August 2001

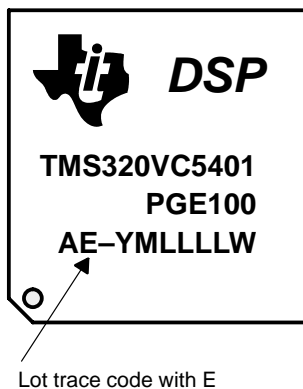
Figure 1. Example, Typical Lot Trace Code for TMS320VC5401 (PGE)

Lot trace code with E

Lot Trace Code	Silicon Revision	Comments
E (second letter in prefix is E)	Initial Silicon
