### 1 Introduction

This document describes the silicon updates to the functional specifications for the TMS320F2810, TMS320F2811, and TMS320F2812 digital signal processors (DSPs).

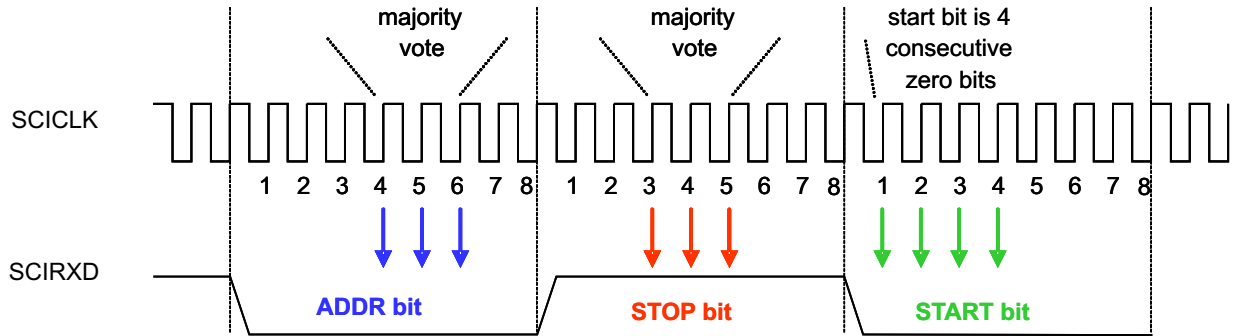
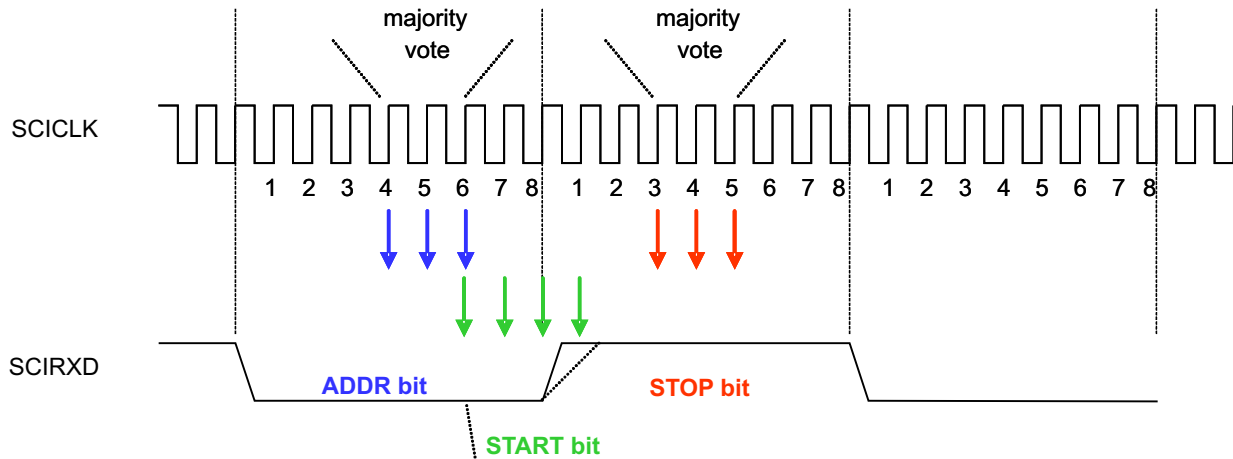
**Figure 5-1. Difference Between Expected and Erroneous Operation of START Bit**

The SCI does not look for the STOP bit after the ADDR bit. Instead, the SCI starts looking for the start bit beginning on sub-sample 6 of the ADDR bit. Slow rise time from the ADDR bit to the STOP bit can cause a false START bit to occur since the 4th sub-sample for the start bit may be sensed low.

Program the baud rate of the SCI to be slightly slower than the actual. This will cause the 4th sub-sample of the false START bit to be delayed in time, and therefore occur more towards the middle of the STOP bit (away from the signal transition region). The amount of baud-slowng needed depends on the rise time of the signal in the system. Alternatively, the IDLE mode of the SCI module may be used, if applicable.
