TMS320VC5507
Digital Signal Processor
Silicon Errata

SPRZ217C
April 2004 – Revised April 2008

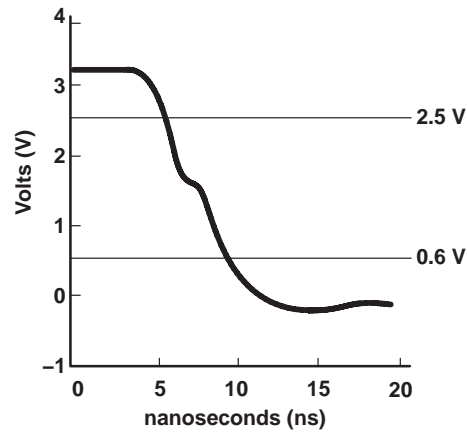
**Figure 3. Bad TCK Transition**

This phenomenon is observed when an erroneous clock edge is generated from the TCK signal inside the C55x™ DSP. This can be caused by several factors, acting independently or cumulatively:

A TCK edge that can cause this problem might look similar to the one shown in Figure 3. A TCK edge that does not cause the problem will look similar to the one shown in Figure 4. The key difference between the two figures is that Figure 4 has a clean and sharp transition whereas Figure 3 has a “knee” in the transition zone. Problematic TCK signals may not have a knee that is as pronounced as the one in Figure 3. Due to the TCK signal amplification inside the chip, any perturbation of the signal can create erroneous clock edges.

As the problem may be caused by one or more of the above factors, one or more of the steps outlined below may be necessary to fix it:

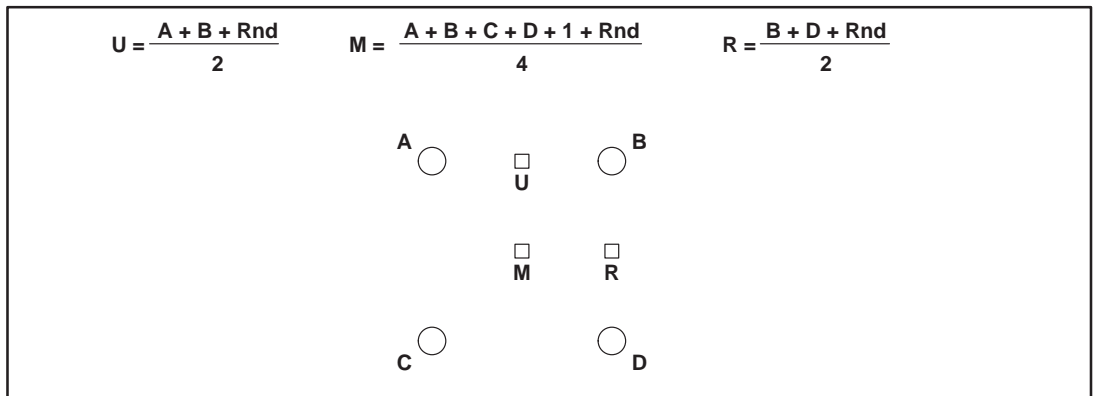
Details: The pixel interpolation computation is wrong by one pixel unit in “Decoder” mode, when “Rounding Mode” is set to zero and when half-pixel interpolation is performed in the middle of four full-resolution pixels (i.e., in the middle of two rows of pixels).

U and R results are interpolated from lines and columns, respectively. M is computed from two following full-resolution pixels lines. Two U, R, or M results are computed during each cycle by the data path, according to the instruction being executed by the accelerator for the M results set (the results are denoted as M0 and M1). When “Rounding Mode” (Rnd in the above picture) is set to 1, the faulty data path section is implemented, $M0 = (A+B+C+D+2)/4$, which is the correct result; but when “Rounding Mode” is set to 0, the data path section implements $M0=(A+B+C+D)/4$. This is not correct and generates a bit exactness issue. The M1 result is always correct, regardless of the “Rounding Mode” state.
