*TMS320DM335*  
*Digital Media System-on-Chip (DMSoC)*  
**Silicon Revision 1.1, 1.3, and 1.4**

## **Silicon Errata**

Literature Number: SPRZ287B  
July 2008—Revised June 2010

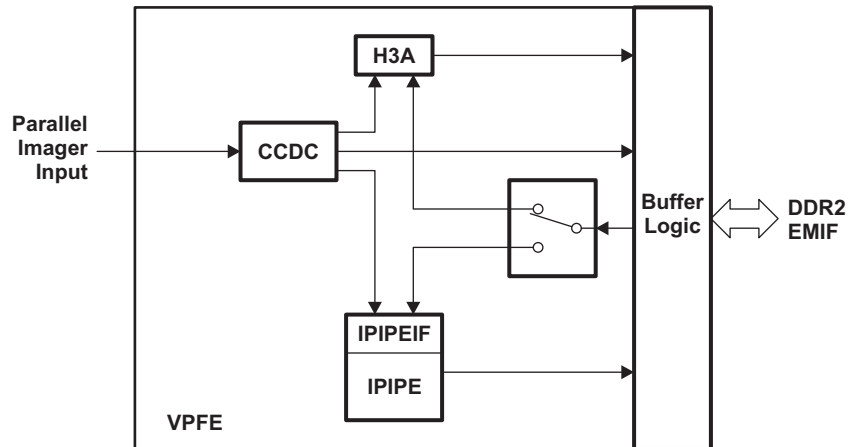
**Figure 2. Video Processing Front End (VPFE) Block Diagram and Data Flows**

**Details** This problem affects H3A auto white balance, auto exposure, and auto focus when the image sensor data is large (i.e. greater than approximately 10 mega pixels) and the data path is from imager to CCDC to H3A .

When the H3A module receives more than 4096 pixel clock cycles between consecutive HD rising edges, the H3A internal line buffer may become corrupt. The internal line buffer address is reset to zero at HD rising edge, is incremented every pixel clock cycle, and wraps back to address zero after 4096 pixel clocks. H3A calculations may not be correct when the line buffer is corrupt.

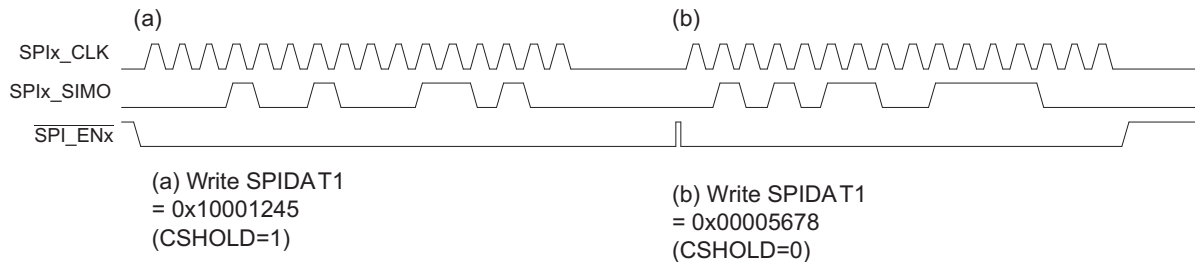
**Figure 8. Actual CSHOLD Behavior—32-Bit Writes to SPIDAT1**

Instead, what actually occurs is that  $\overline{\text{SPI\_ENx}}$  is momentarily de-asserted at the beginning of the second write, as illustrated in Figure 8.

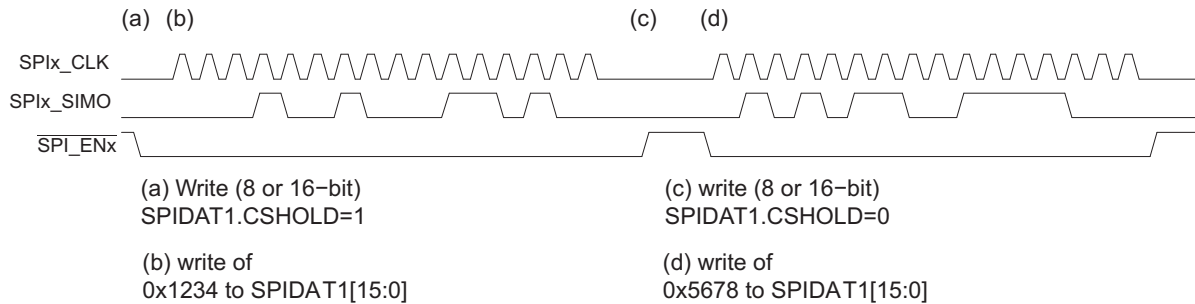
Figure 9. Actual CSHOLD Behavior—Halfword Writes to SPIDAT1

Both Figure 7 and Figure 8 assume that SPIDAT1 is written using a single 32-bit write instruction. If SPIDAT1 is instead written using an 8-bit or 16-bit instruction to write to the CSHOLD field, followed by a 16-bit write to the transmit shift register field of SPIDAT1, then what actually occurs is illustrated in Figure 9. This is the same case illustrated in Figure 8 except that the de-assertion of SPI\_ENx lasts for the duration between writing a '0' to the CSHOLD field and writing new data to the transmit shift register.
