# DMVA3/4 DaVinci™ Digital Media Processor Silicon Revisions 1.1, 1.0

## Silicon Errata

Literature Number: SPRZ406A  
October 2013–Revised December 2013

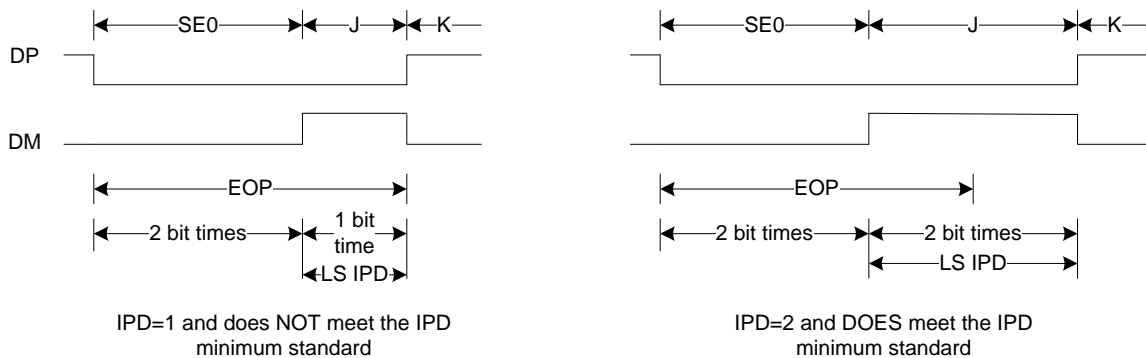
The problem is due to the length of the IPD between the Receiver-to-Transmitter (Rx-to-Tx) transactions. The Host IPD between Rx-to-Tx transactions for LS transactions should range from 2 to 6.5 LS bit times. It has been verified that the controller’s LS IPD for Rx-to-Tx is only 1. This is shown in the following figure.

IPDs are measured from the SE0-to-J transition at the end of EOP to the J-to-K transition that starts the next packet.

The impact is that this specific mouse will not work with the processor’s USB port.

**Workaround:**      There are many USB mice on the market that work with an Rx-to-Tx IPD of 1. Switching from the problem mouse to a different mouse will solve the problem. Another solution is to connect a hub between the Host USB port and the Device USB port. The hub will add additional IPD to allow the original mouse to work.
