DRA75xP, DRA74xP, DRA77xP, DRA76xP SoC for Automotive Infotainment Silicon Revision 1.0

Errata

This document describes the known exceptions to the functional specifications for the device.

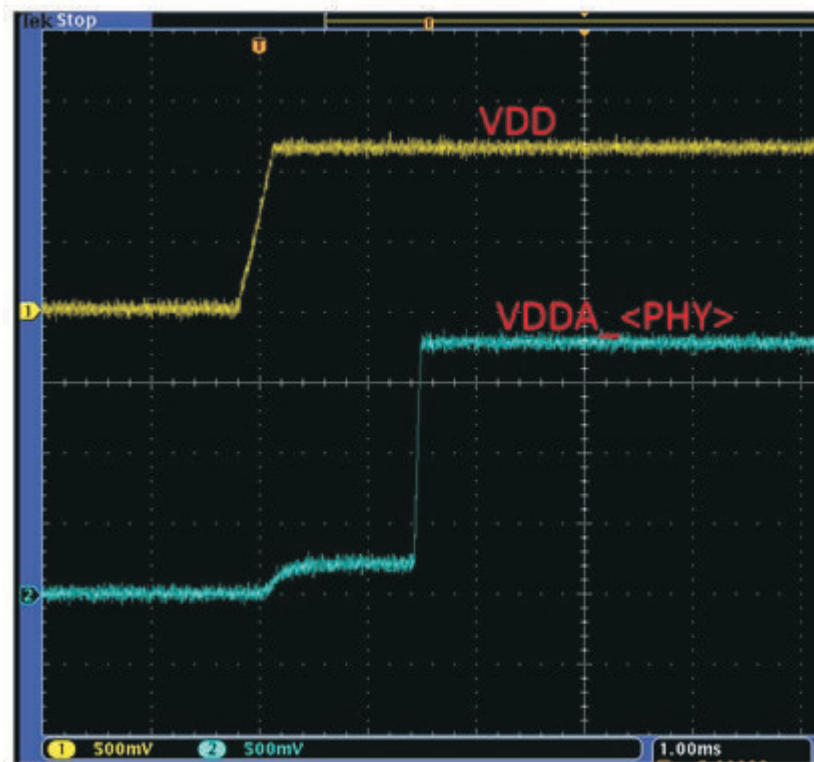
Figure 4-2. Leakage Voltage

DESCRIPTION A current path exists between VDD and the high speed analog PHY domain (VDDA_HDMI, VDDA_PCIE, VDDA_SATA, VDDA_USB2/3) during the supply power up and power down sequences.

The device-specific Data Manual requires Core AVS rail (VDD) to power up before the 1.8 V high speed analog PHY domain(s). When this sequence is followed, the high speed analog PHY domain will have a small step-up to a voltage plateau (< 0.5 V) that aligns to the beginning of the VDD ramp-up, and is maintained until the ramp-up of high speed analog PHY rail, as shown in Figure 4-2. Note the leakage value will differ from system to system, but will be less than 500 mV. The leakage voltage in the provided capture is approximately 250 mV.

A similar condition exists during supply power down sequence. The high speed analog PHY domain(s) are required to be powered down prior to Core AVS rail (VDD), and may cause a small plateau to exist until Core AVS rail (VDD) is ramped down.

The root cause of the voltage plateau during power-up/down sequencing is related to the parasitic diodes in logic blocks which have multiple power sources. This leakage path is not a reliability concern for this device.
