Errata

AM263x Sitara™ Microcontroller Silicon Revision 1.0A, 1.1

This document describes the known exceptions to the functional specifications (advisories). This document may also contain usage notes. Usage notes describe situations where the device's behavior may not match presumed or documented behavior. This may include behaviors that affect device performance or functional correctness.

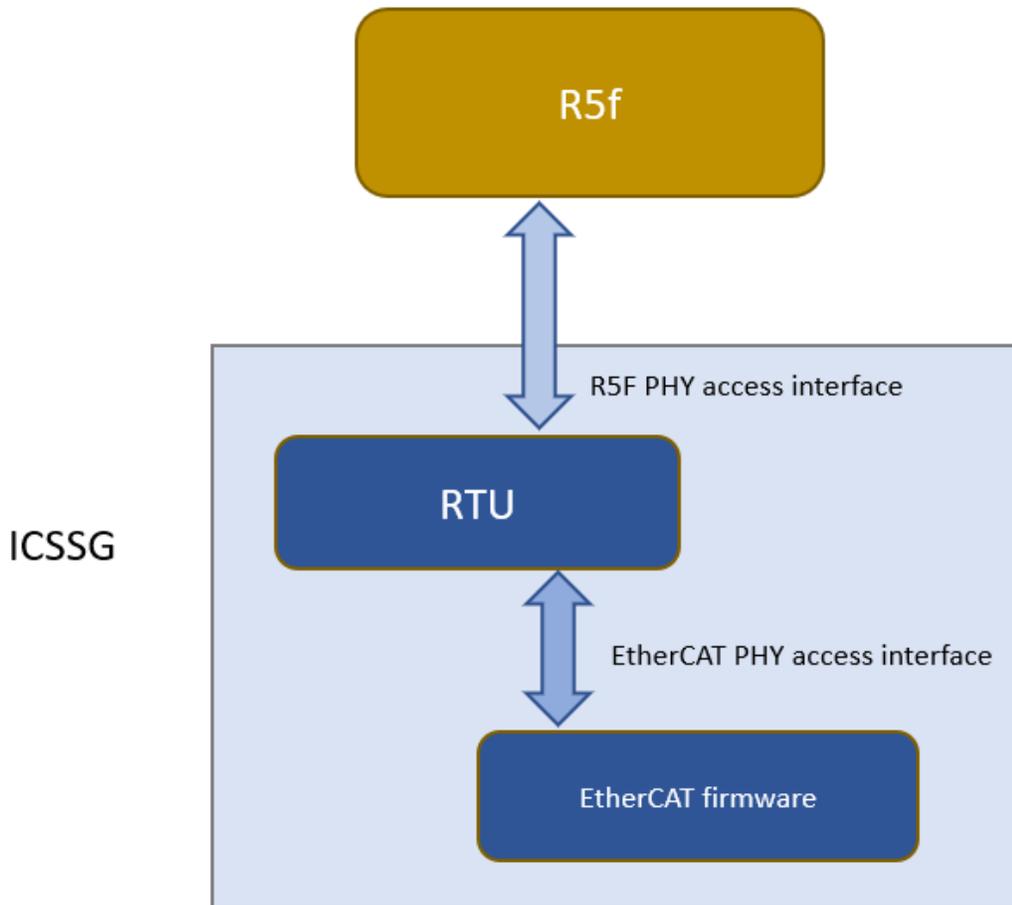
Figure 3-1. MDIO Emulation via Manual Mode using PRU Core

Details: It is possible that the MDIO interface of all instances of CPSW and PRU-ICSS peripherals (if present) returns corrupt read data on MDIO reads (e.g. returning stale or previous data), or sends incorrect data on MDIO writes. It is also possible that the MDIO interface becomes unavailable until the next peripheral reset (either by LPSC reset or global device reset with reset isolation disabled in case of CPSW).

Possible system level manifestations of this issue could be (1) erroneous ethernet PHY link down status (2) inability to properly configure an ethernet PHY over MDIO (3) incorrect PHY detection (e.g. wrong address) (4) read or write timeouts when attempting to configure PHY over MDIO.

MDIO protocol can be emulated by reading and writing to the appropriate bits within the MDIO_MANUAL_IF_REG register of the MDIO peripheral to directly manipulate the MDIO clock and data pins. Refer to TRM for full details of manual mode register bits and their function.

In this case the device pin multiplexing should be configured to allow the IO to be controlled by the CPSW or PRU-ICSS peripherals (same as in normal intended operation), but the MDIO state machine must be disabled by ensuring MDIO_CONTROL_REG.ENABLE bit is 0 in the MDIO_CONTROL_REG and enable manual mode by setting MDIO_POLL_REG.MANUALMODE bit to 1.

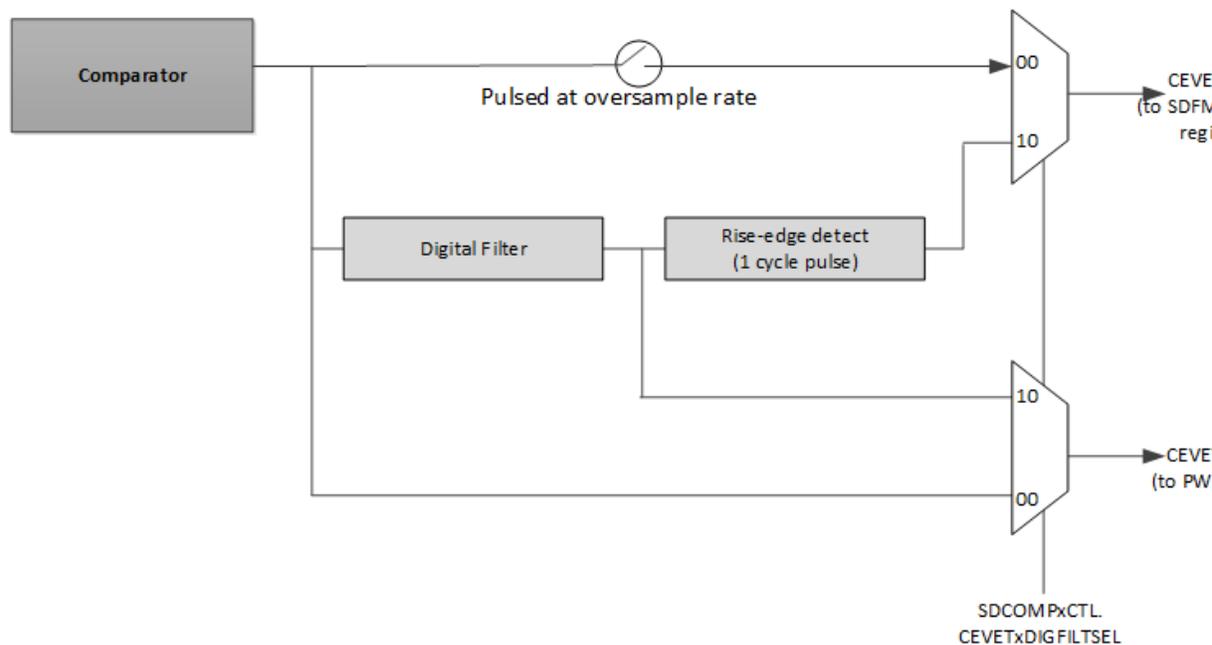
This issue is not present on the CEVETxOUT event going to XBAR.

Also this issue is not present if the raw output path is chosen (i.e CEVTxDIGFILTSEL = 0).

If SDFM digital filter is used in application the following workaround options can be considered:

XBAR status can be observed instead of the event flag register.

1. After selecting the digital filter, wait for the interrupt/Trip.
2. When the interrupt occurs, read the event flag and take appropriate application action to rectify the cause of comparator trip.
3. Before clearing the event flag register, program the unfiltered path.
4. Clear the event flag.
5. Read the event flag and if it stays cleared for at-least one oversampling duration, reprogram the digital filter path.

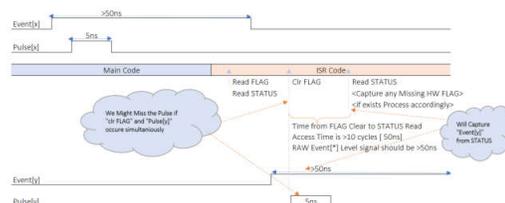
Potential race condition in capture registers resulting in events getting lost while other events in the same register are being cleared by writing to the register. Following registers are impacted by this issue:

Capture any missing HW event FLAG

If exists, process accordingly
