TMS320F280015x Real-Time MCUs Silicon Errata

Silicon Revisions B, A, 0

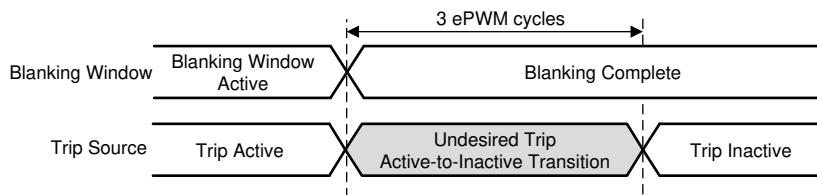
Figure 3-2. Undesired Trip Event and Blanking Window Expiration

The blanking window is typically used to mask any PWM trip events during transitions which would be false trips to the system. If an ePWM trip event remains active for less than three ePWM clocks after the end of the blanking window cycles, there can be an undesired glitch at the ePWM output.

Figure 3-2 illustrates the time period which could result in an undesired ePWM output.

Workaround Extend or reduce the blanking window to avoid any undesired trip action.
